# North Pond Resiliency Project

## Appendix B

## Appendix B: Remote Sensing Data Set Inventory

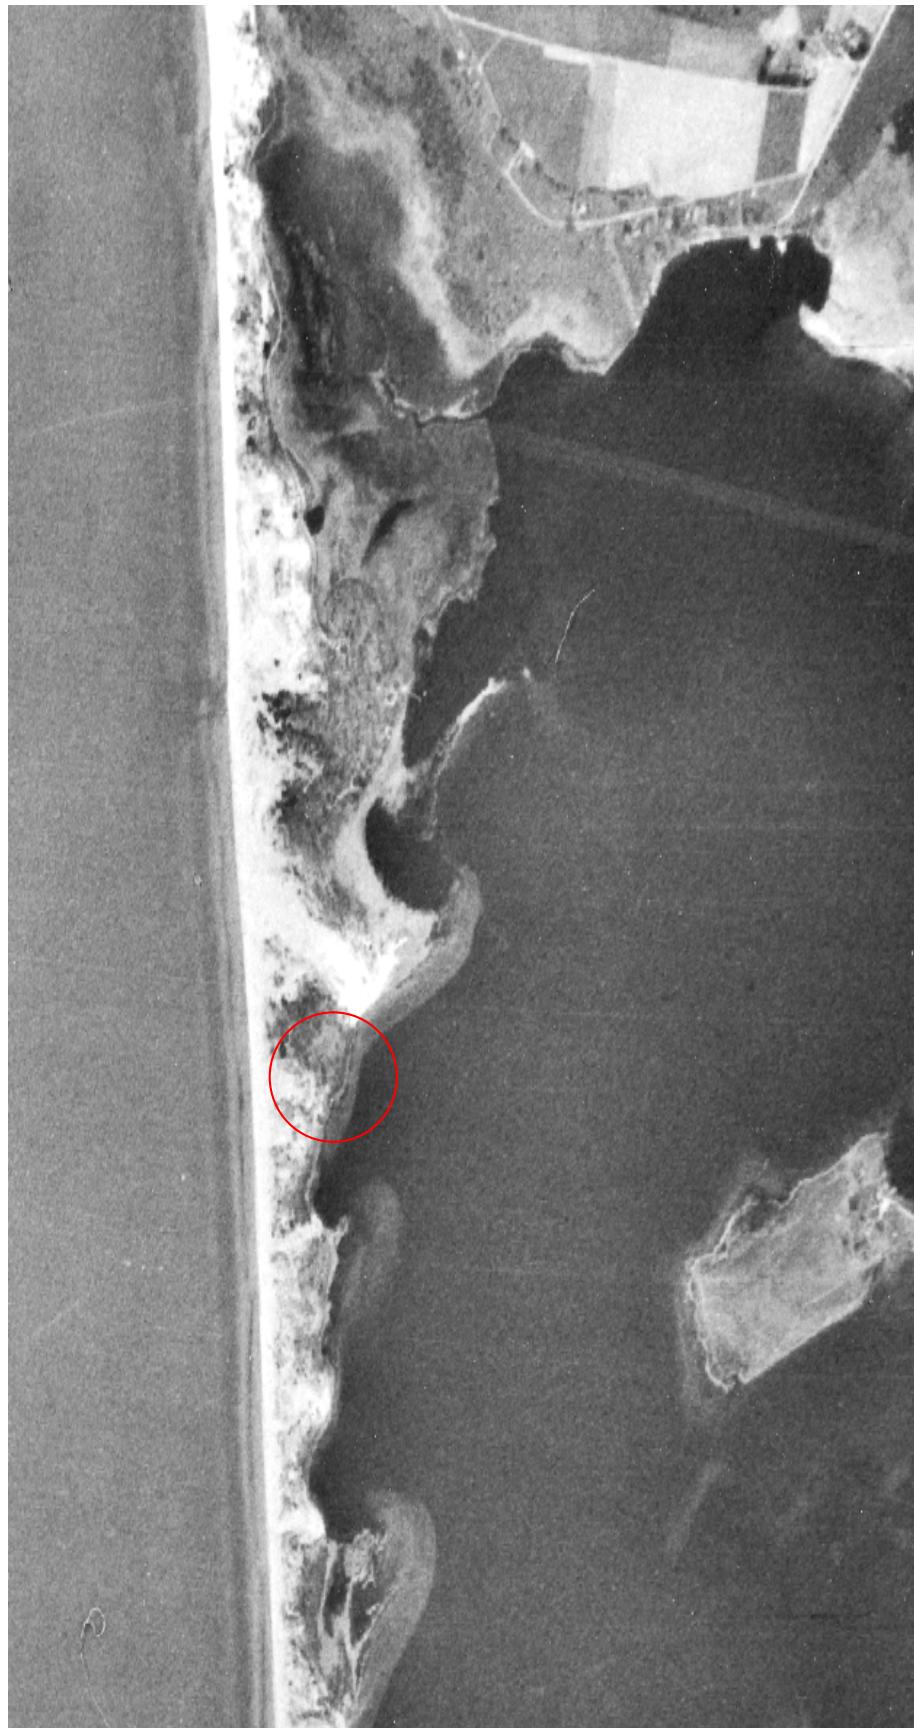
## 1938 Continued

On the northern barrier spit, there are multiple locations where overwash areas are clear. A possible prior inlet channel (shown in the red circle) as indicated by a deep-water channel backing the barrier island. A series of three bare sand areas are located further north, culminating with the large blow-out at the beginning of the high dunes where yet another large channel relict feature is on the pond side. The high dunes are also marked with many bare sand areas, which may be evidence of human disturbance.

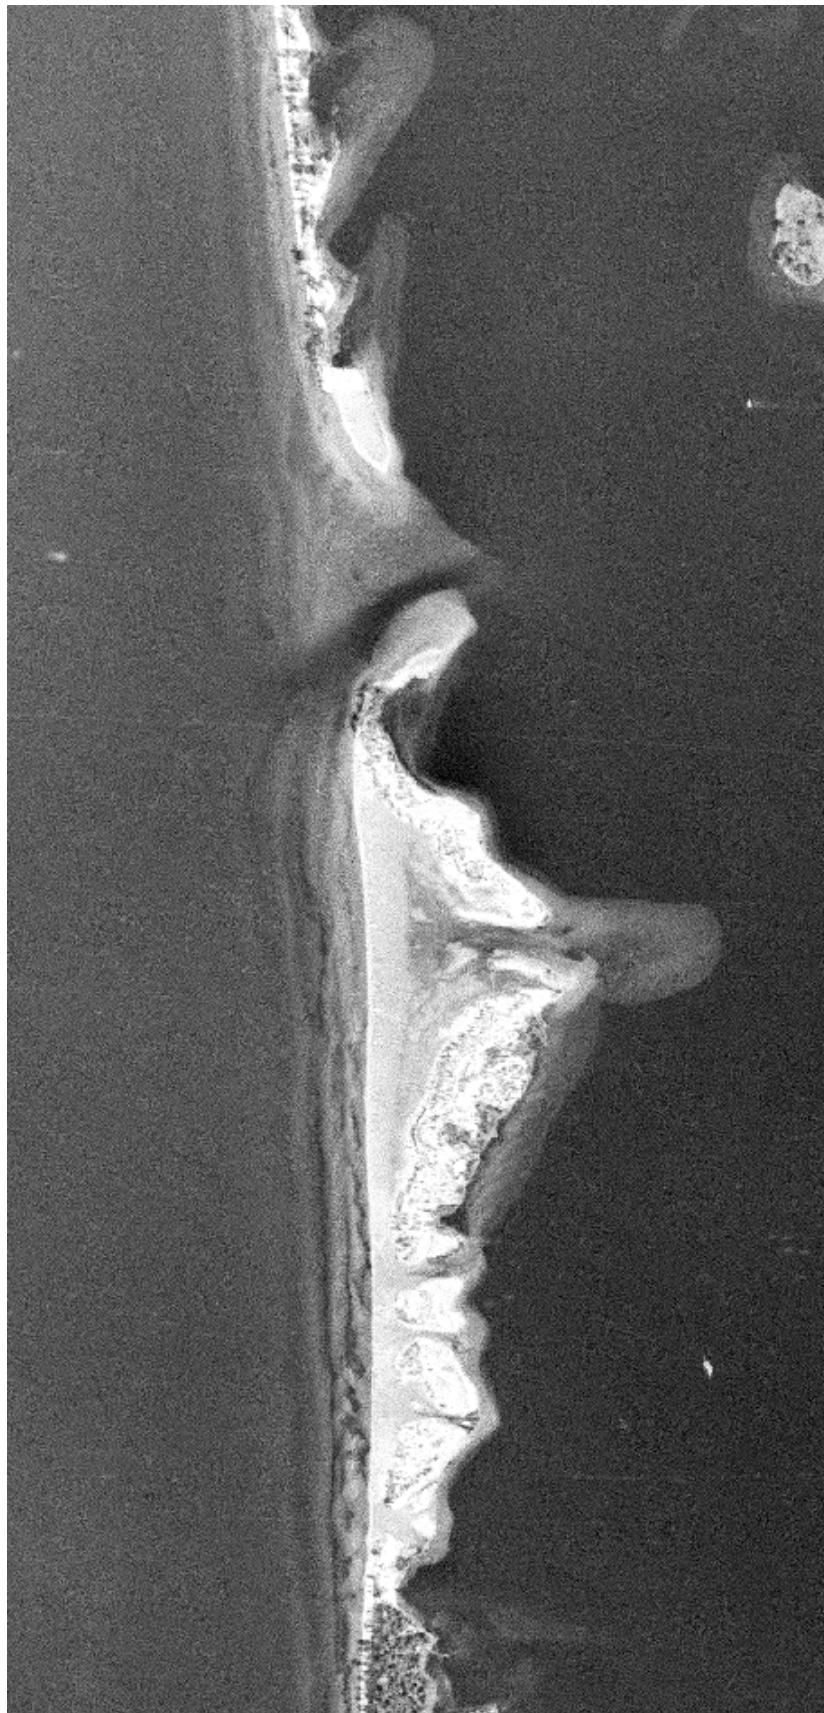
## 1960

Nearshore sand deposits have consolidated into a straight shore with large sand flats. High water overwashes these sand flats and nearshore sand bars are large and active. In addition to the dominant inlet to the north, the 1938 inlet remains open with clear water exchange. To the south, four minor inlets show flowing water. The north most of these is the 1950 dredge site, and the southernmost is the 1898 dredge site. The inlets create five separate islands, a phenomenon not seen on other imagery.

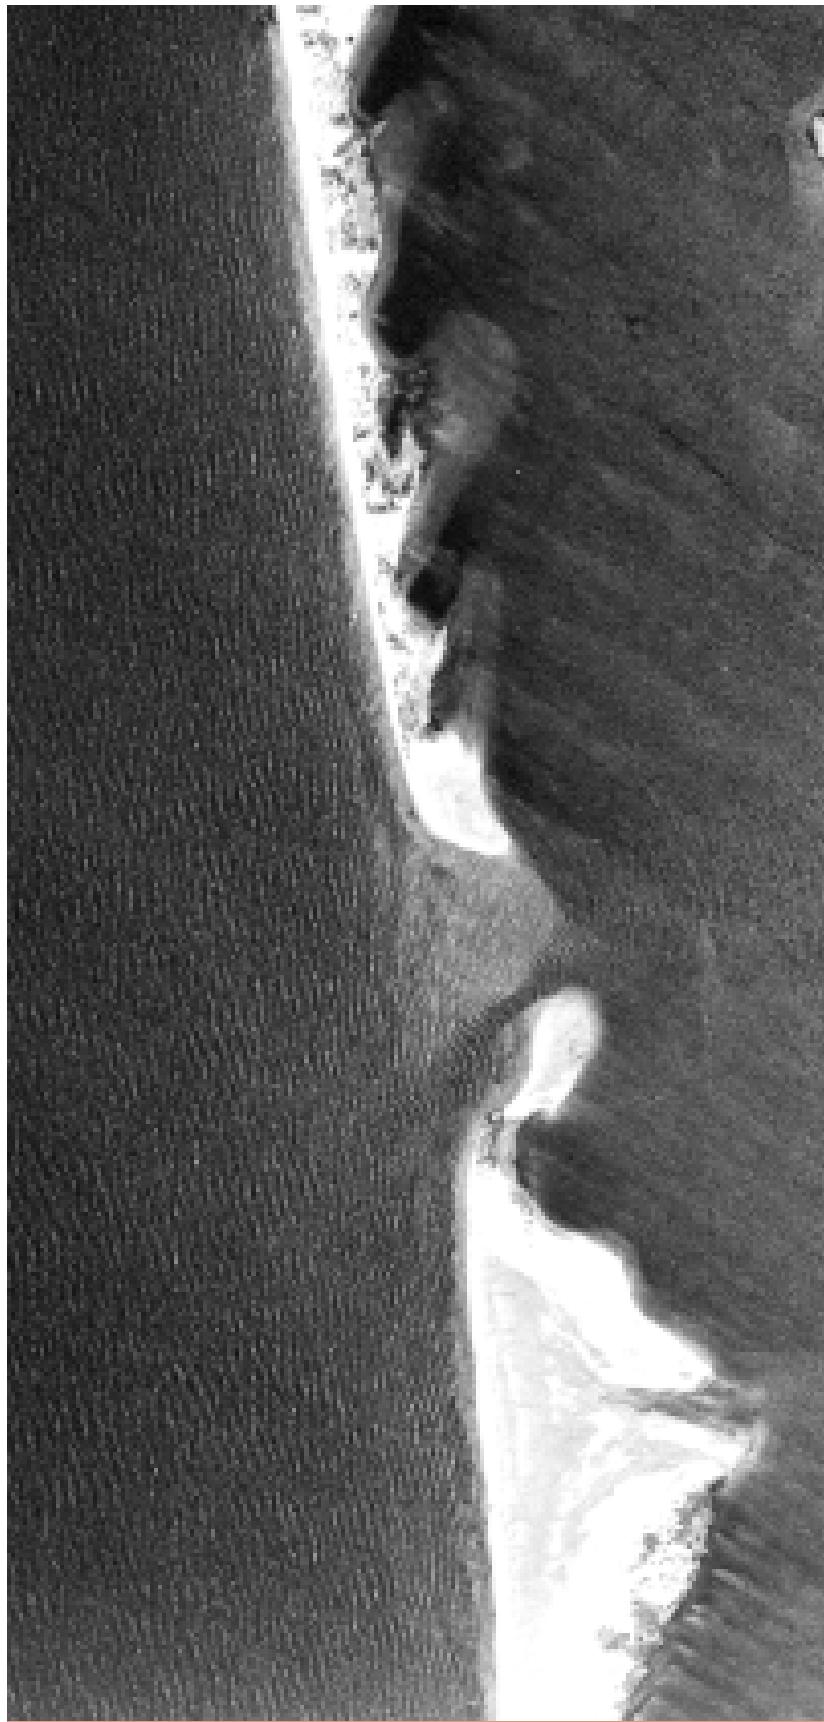
## 1961

With the same Lake elevation as the 1960 image the configuration and function of the inlet appears similar.

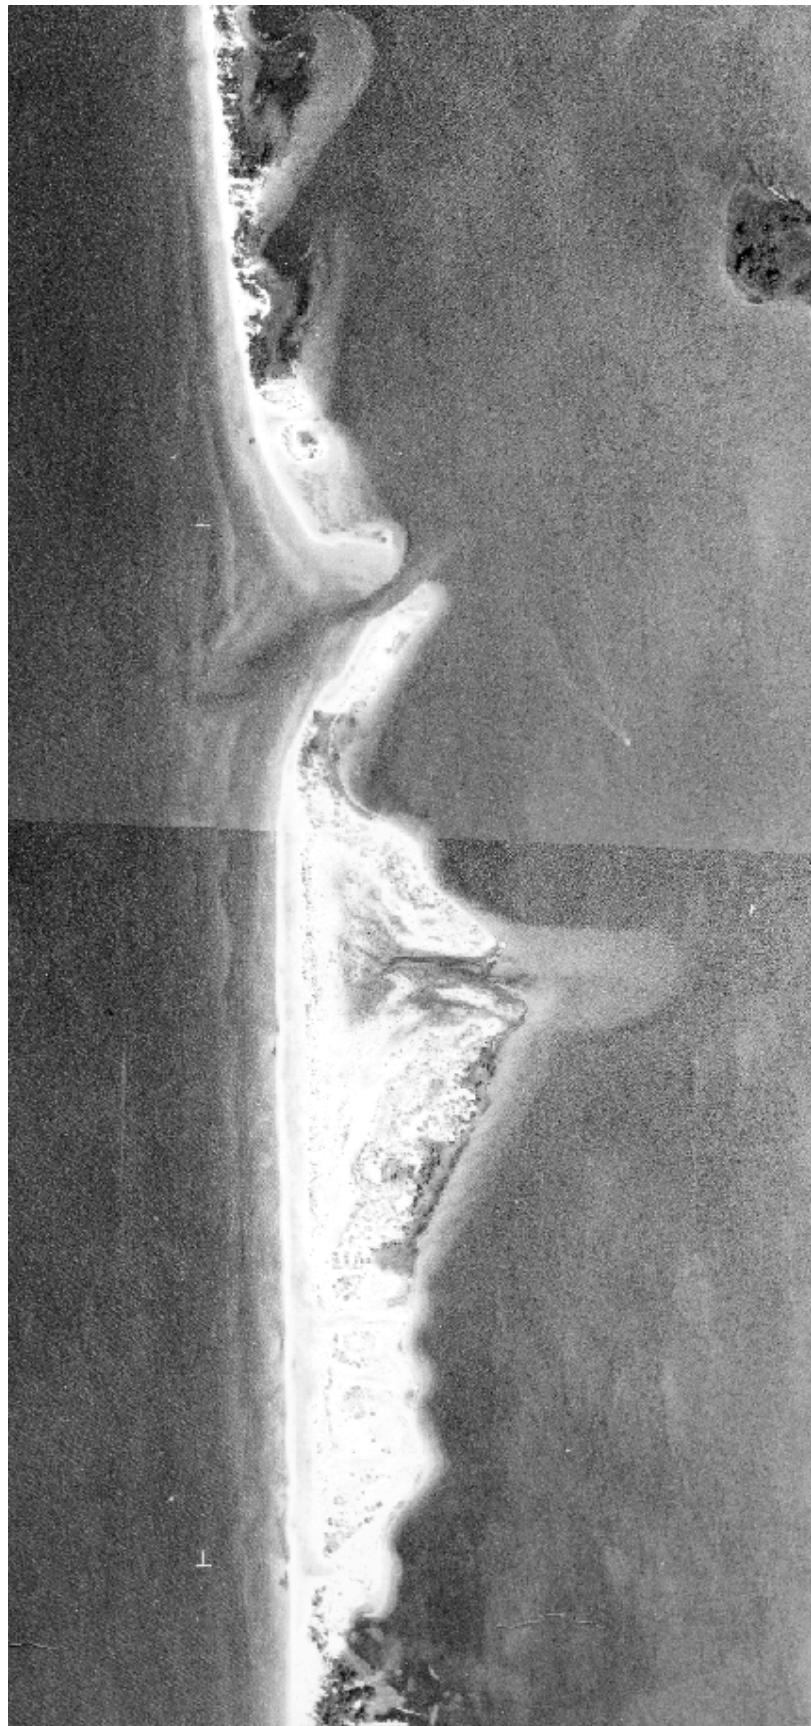
## 1965

The date of the imagery is not documented. Planting stage of upland fields nearby suggests mid-June at least. Lower water has led to the final closure of the 1938 inlet, a process that took about 8 years to complete. Nearshore sand bars are visible, but sand is less abundant compare to prior high-water years. The photography was taken with an unusual south wind with possible nearshore littoral drift cells showing sand movement.

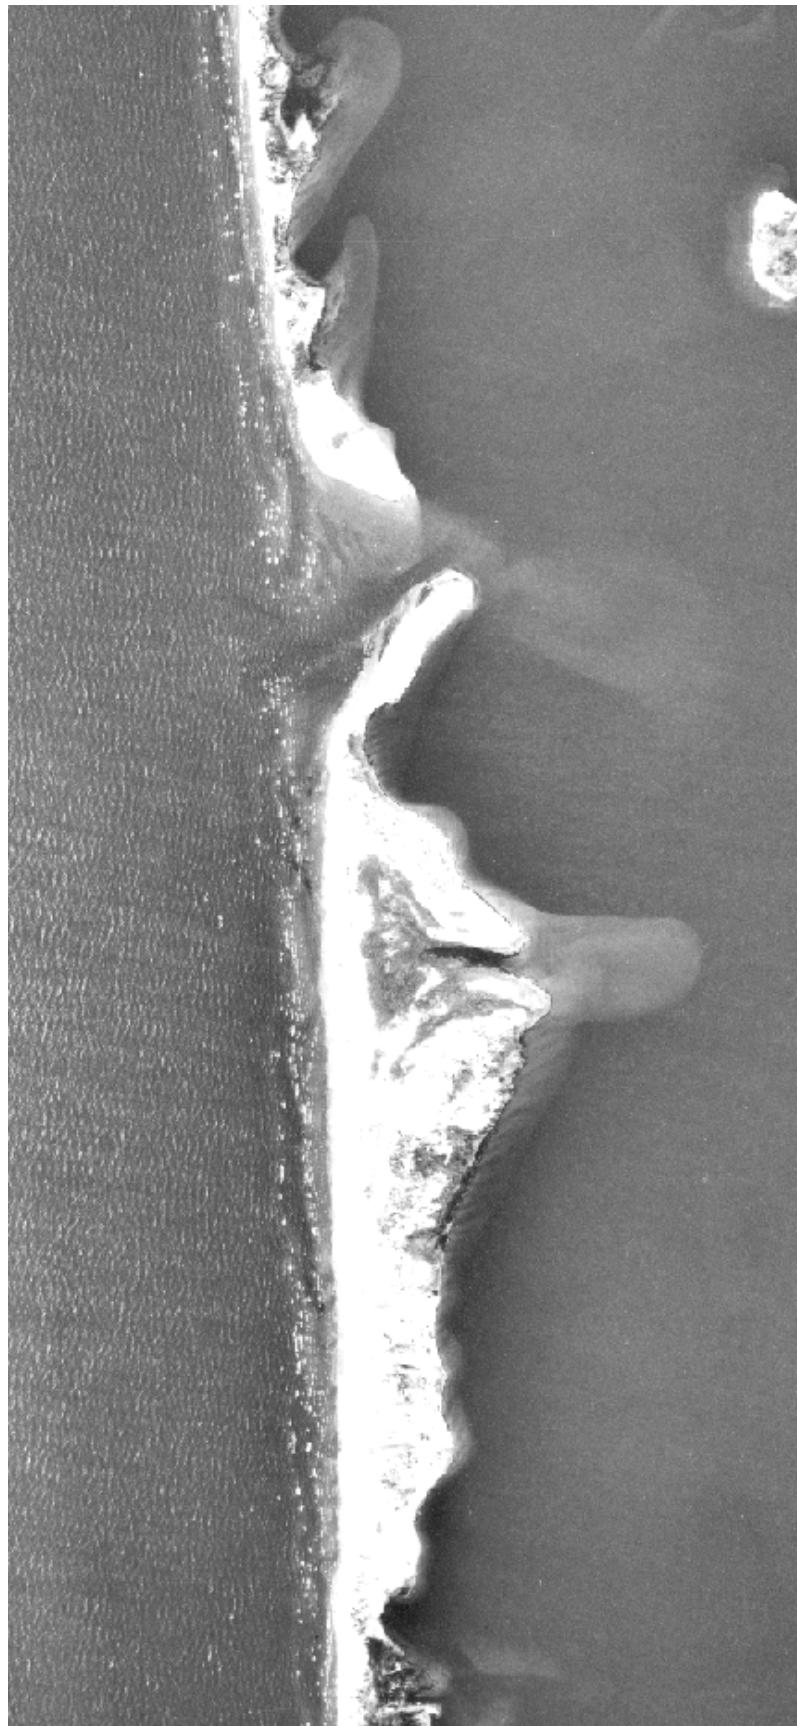
## 1967

The inlet is wider than the low water 1965 imagery. Wave environment is higher than in many other photography sets, with winds from the WNW based on langmuir cell directions. Higher waves show beach face runup and intrusion on two prior overwash areas south of the 1938 inlet. Nearshore sand is organized in large elongated bars with long troughs near shore rather than smaller circulation cells seen in other photography. Direction of littoral drift is to the south, differing from most other photography.

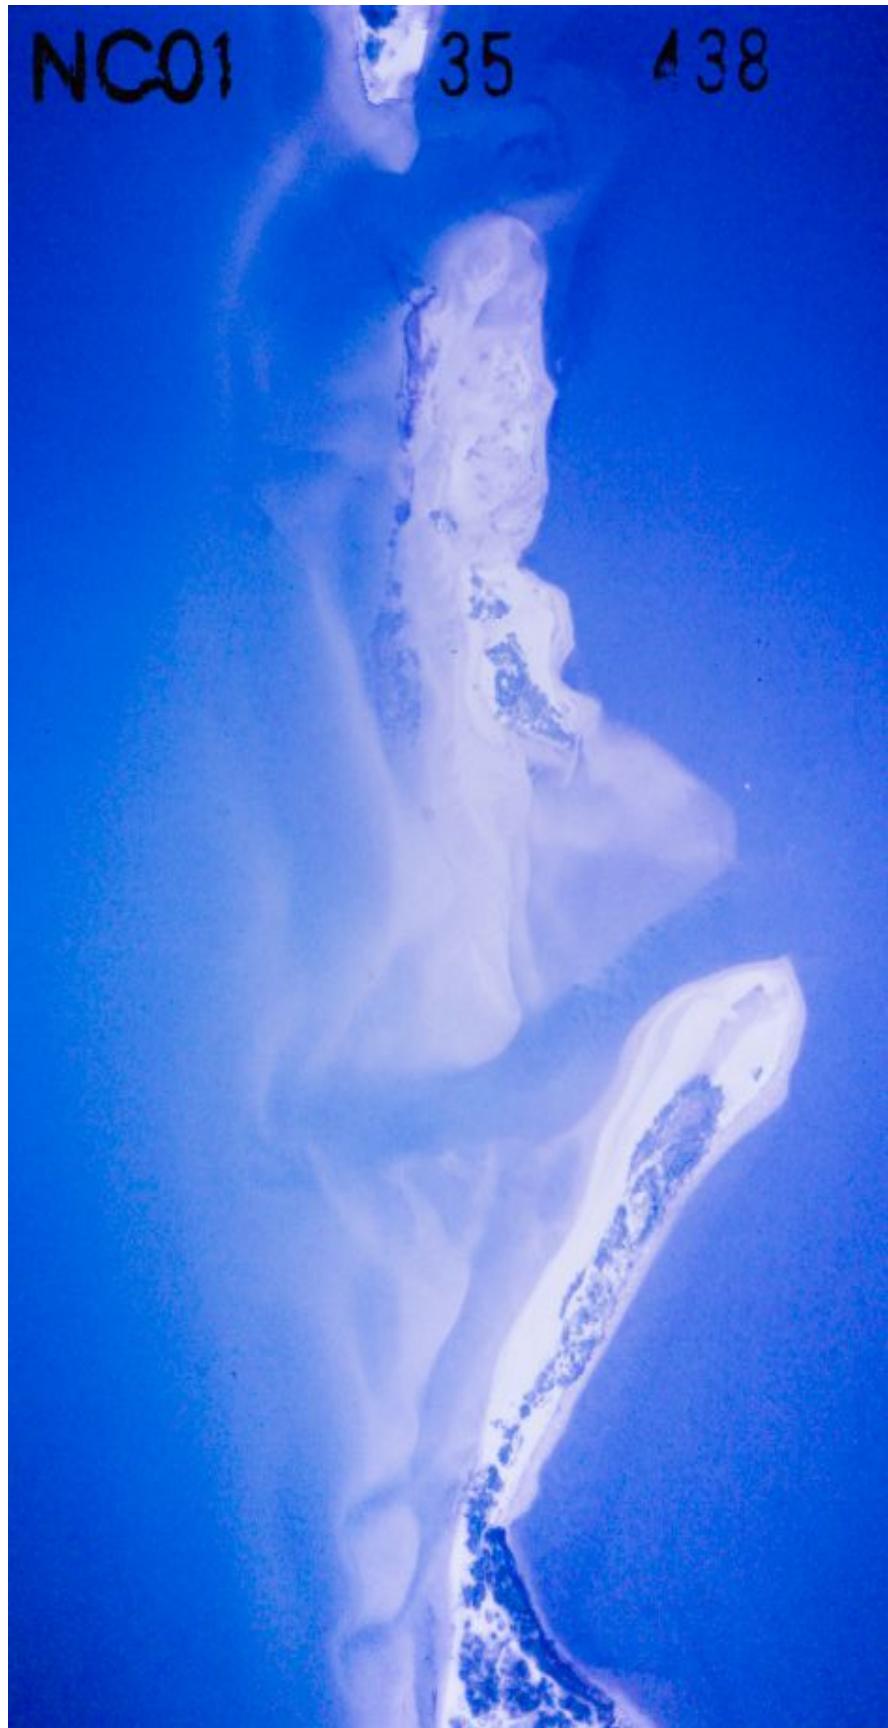
USGS single frame imagery at a scale of 1:10,390 is available via the USGS Earth Explorer online application. The imagery is excellent color-infrared imagery. At this scale, many images are necessary to cover the barrier beach, let alone the study area. With the amount of water occupying the edges of imagery, time was not available that would have been needed to accurately register the image set.

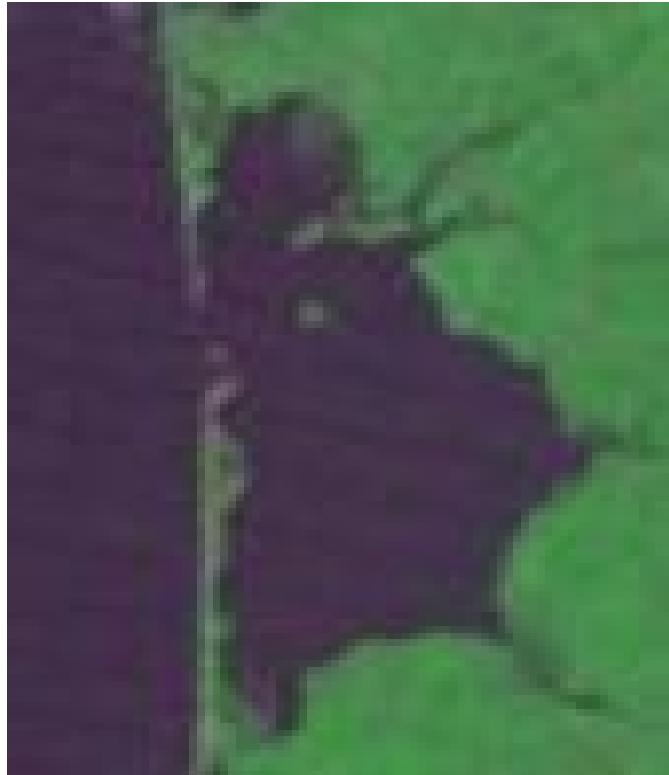
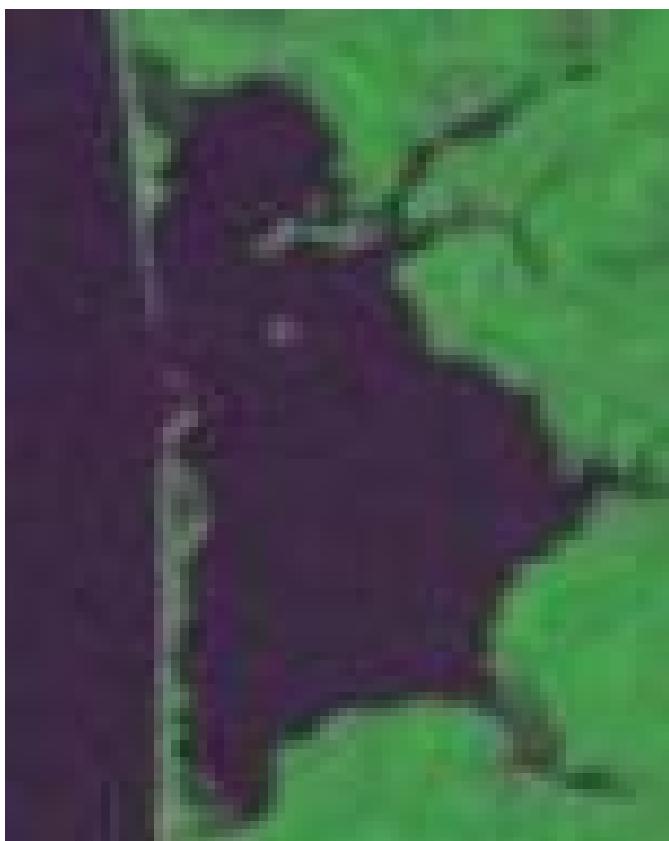
June 22 1976 (above); June 04 1976 (below);  
June 22 1976

The period of high water after 1974 is important to document. Landsat satellite imagery is available since 1972 and, though at a much coarser resolution, a June 1976 image confirms expansion of the inlet, establishing an inlet opening sequence from the early 1974 SWCD image, to the higher resolution 1974 imagery and the 1976 satellite images. The 1974 shoreline is shown on a relatively blurry landsat image showing retention of a shoal or island feature near the north end of the south spit and opening of the inlet further to the north at the cost of the north spit.

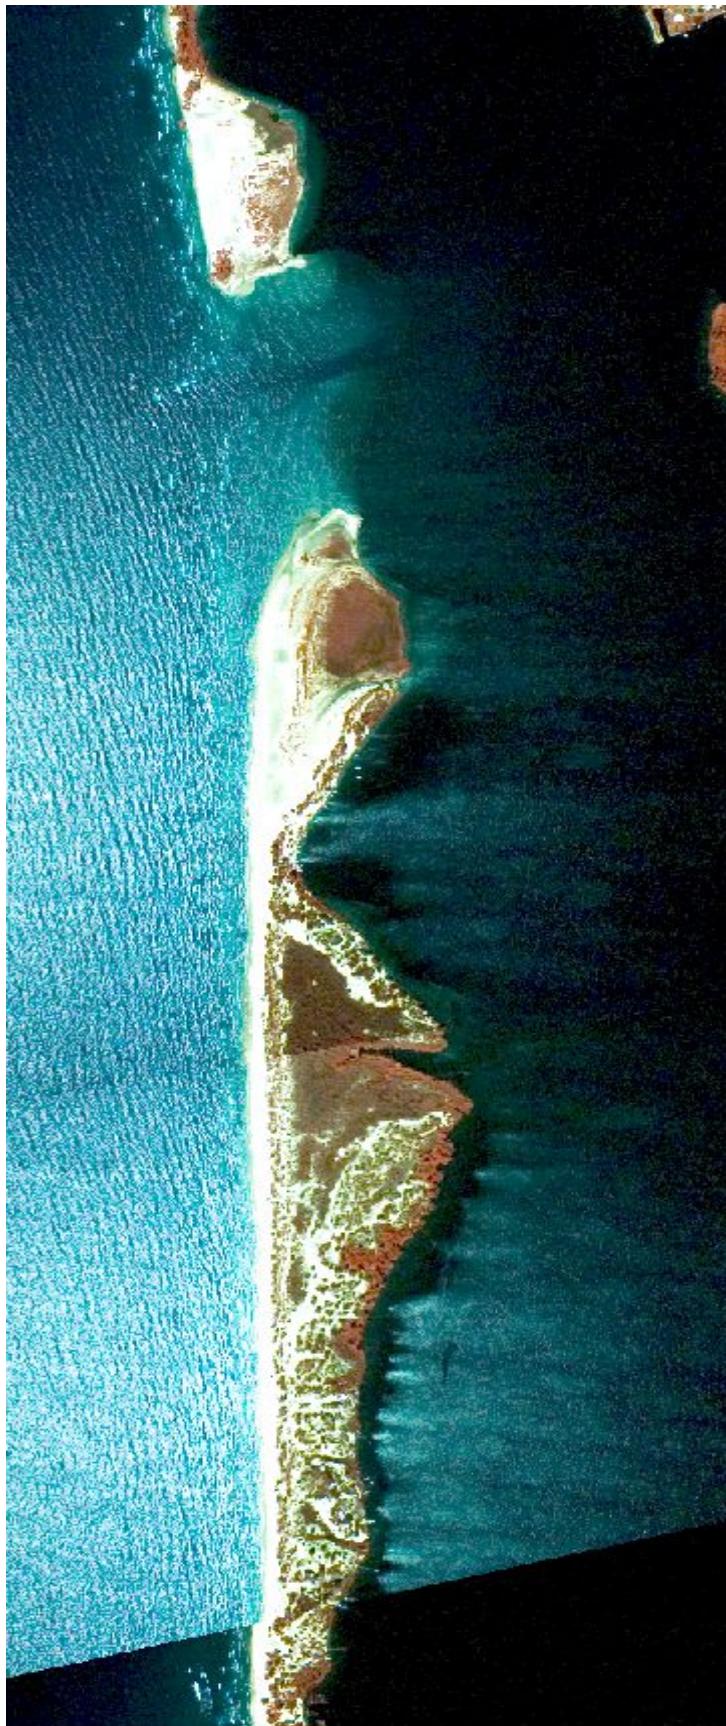
## 1983

The inlet remains 1500 feet wide, with a clear central channel and adjacent underwater shoals. Sand appears to have been stripped from the system during the prior decade of high water. The north spit shows a definite overwash area north of the inlet while the broader lobe of the northern spit may also have two overwash areas. The southern spit shows the northern extent of the 1970 inlet, a feature still evident on the barrier spit today. All vegetation north of this feature on the southern spit is from 1977 or is more recent. The imagery of the southern spit also shows the signature vegetation succession clearly demarking former overwash and inlet areas.

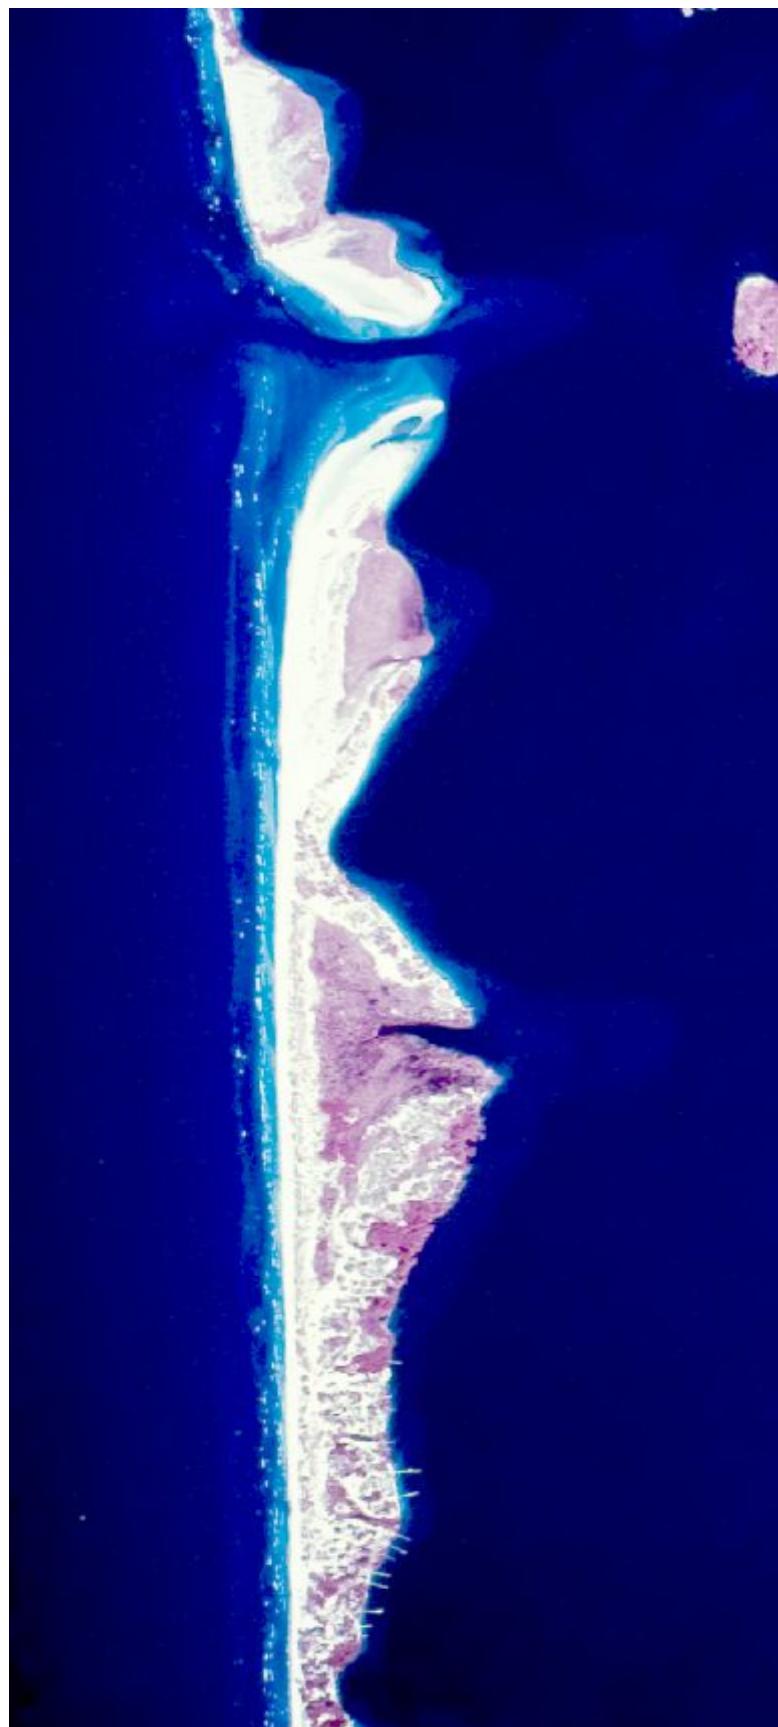
## 1994

Inlet sand bars on the north shoal area are absent while waves and drifts are from the south-west based on wave break direction on the north spit. Lake elevation is 0.2 feet higher compared to early May, showing additional submersion of the south spit inlet shoal.

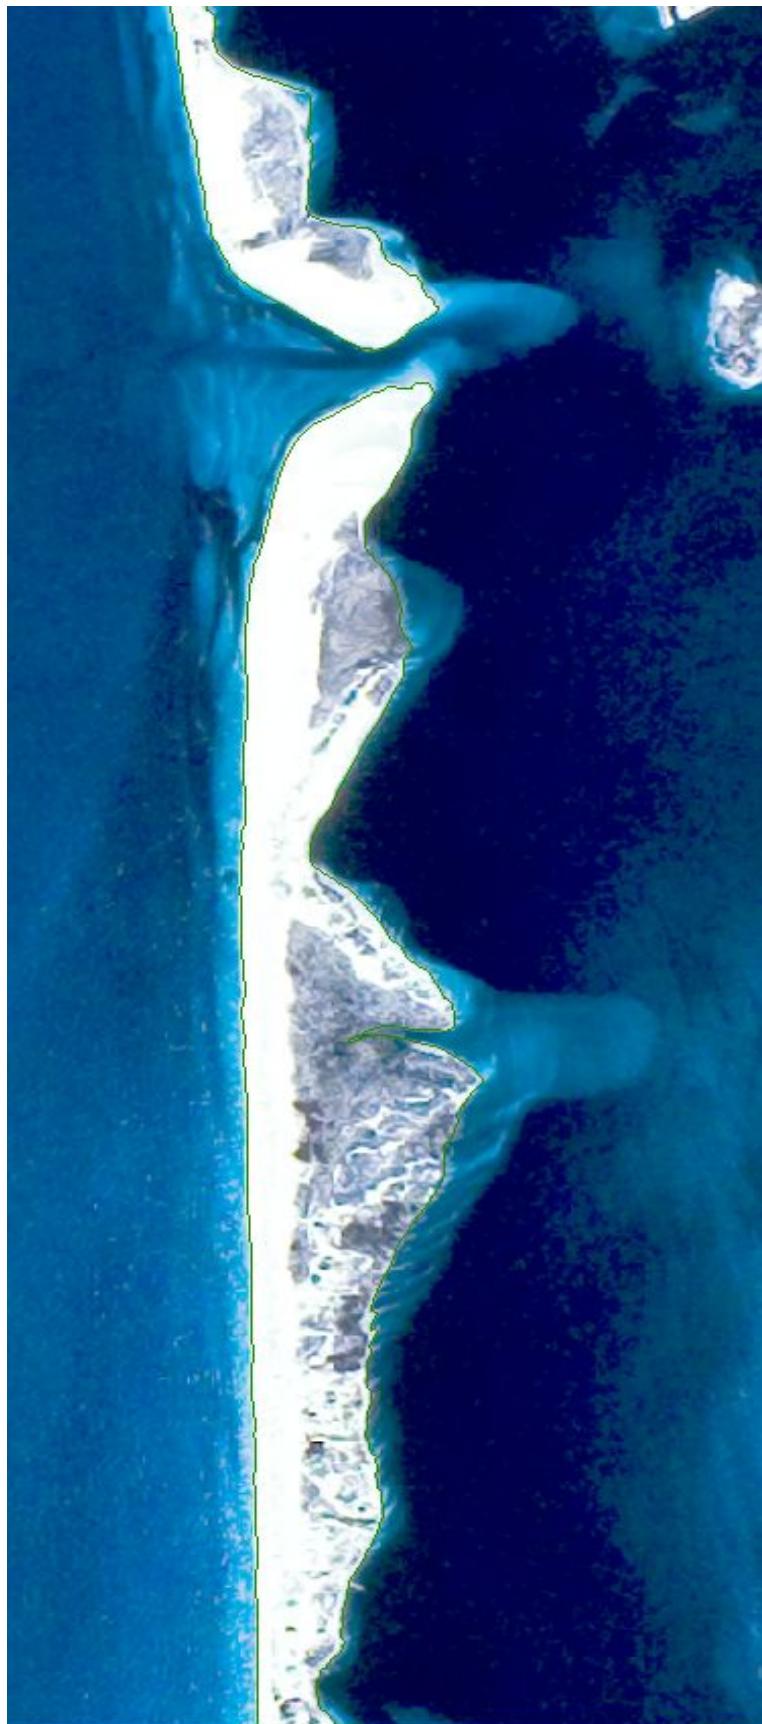
## 1995

Channels are complex with the central channel forking into two parts in the inlet while a small channel runs south from the inlet on the pond side. Deposition has increased in the inlet shoal and it appears that the winds are out of the north (based on surface streaking in the pond), and the flow of faintly discolored water to the south from the inlet. Bedrock is exposed at Lakeview, south of Cranberry Pond lakefront, and at the rock outcrop short of a mile north of Carl Island on the lakefront. This is unusual, and may show a southerly littoral drift at low lake level exposing these submerged bedrock shoals.

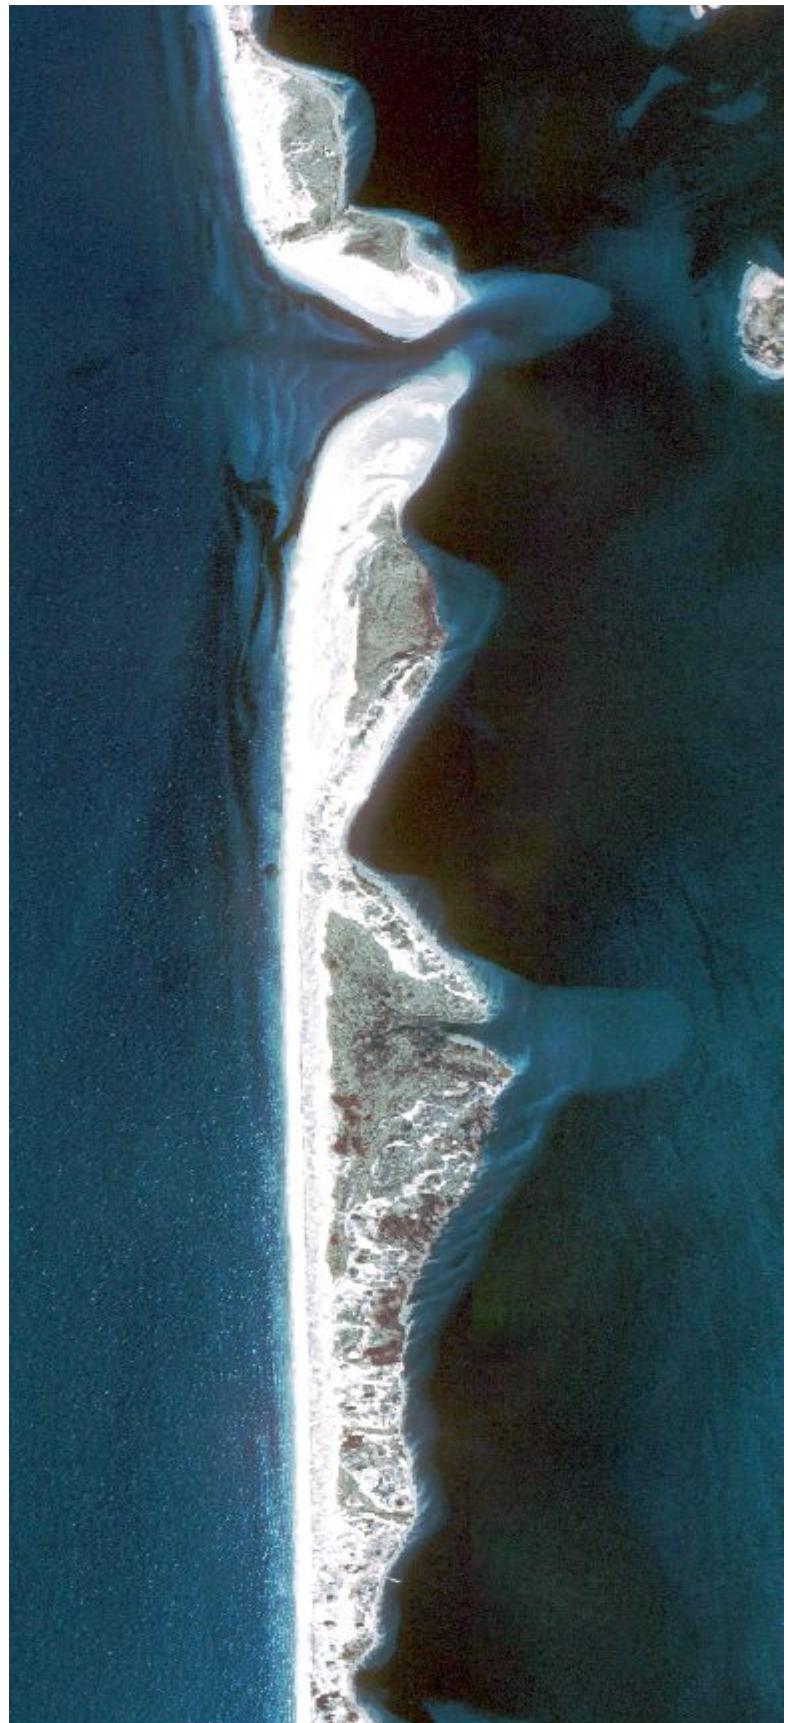
1994

The shoreline is readily discerned from this CIR imagery which also shows extension of the depositional lobe while sand bars are stacked in the inlet's lakeside mouth. The existing shoal in front of Carl Island may have been moved towards the island by higher energy wave forcing but pre-existed the current inlet location as shown in 1948 bathymetry. Winds appear to be directly onshore, showing complex bar formation at the inlet and possibly illustrating a migration of suspended sand into the pond.

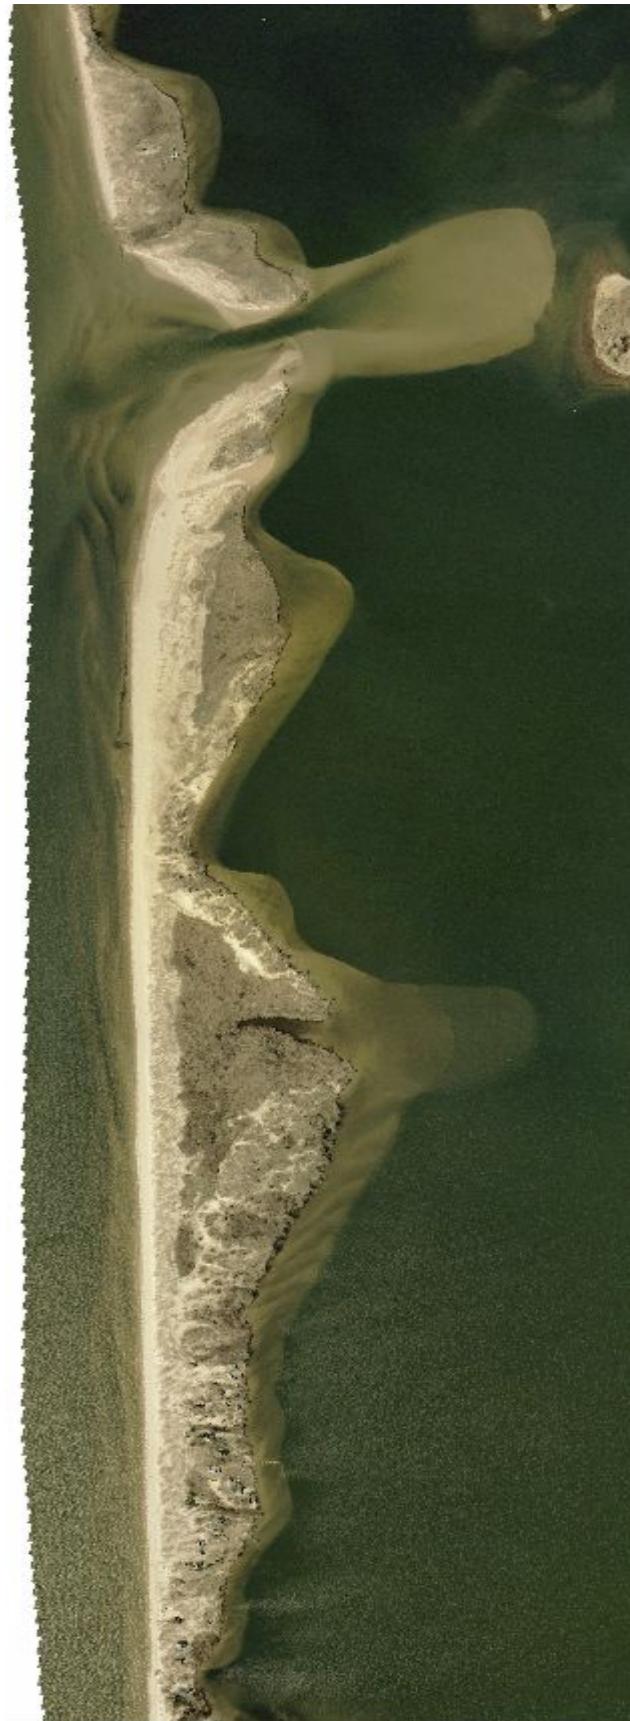
## 2001

Recent high lake elevation, storm, or wind-driven waves may have been occurred to account for several overwash areas. One area north of the inlet shows an overwash fan into the pond. A much larger overwash south of the inlet shows an overwash channel of approximately 40' width. This southern overwash represents the northern end of the 1983 inlet and the current path at the pond boat landing. The overwash fan has since disappeared while tree trunks litter the northern shore and a trough of detritus runs between the beach and the first sand bar along the southern barrier.

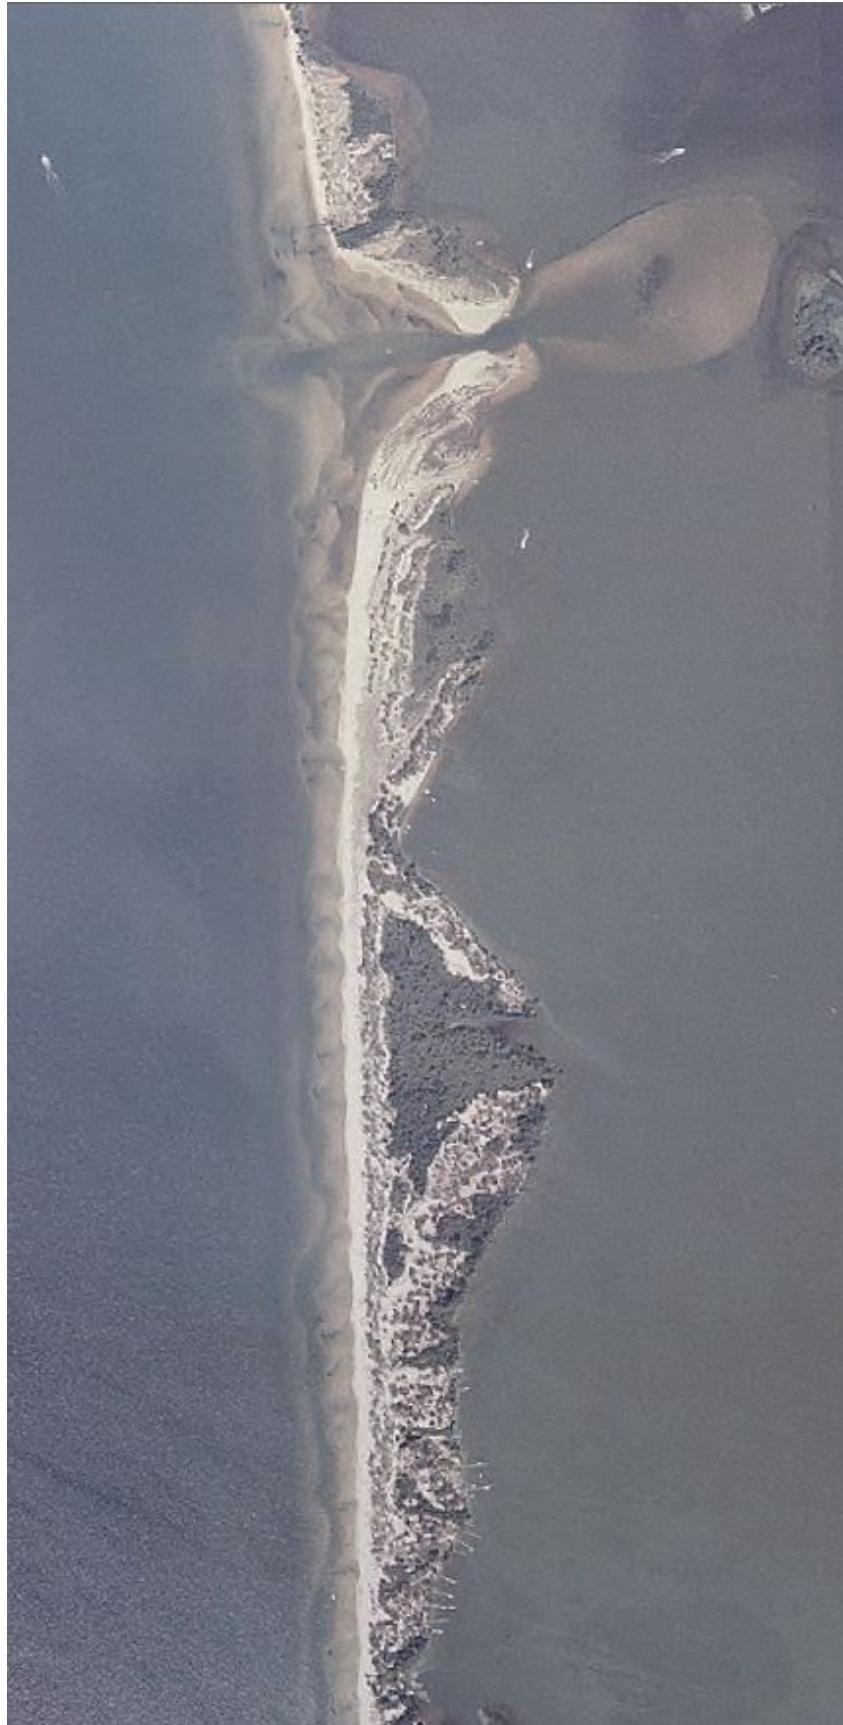
## 2004

This calm wave and wind state image shows complex sand cells in front of the barrier beaches and well-formed bars within the inlet and a clear channel. The channel is pinched by intruding lobes at the recurring point of the inlet arms. The depositional fan shoal shows some expansion, but maintains similar form to the 2001 fan. One exception is the appearance of side channels to the north and south, making a 'T' shaped configuration. Water clarity is poor in the pond, obscuring bottom features.

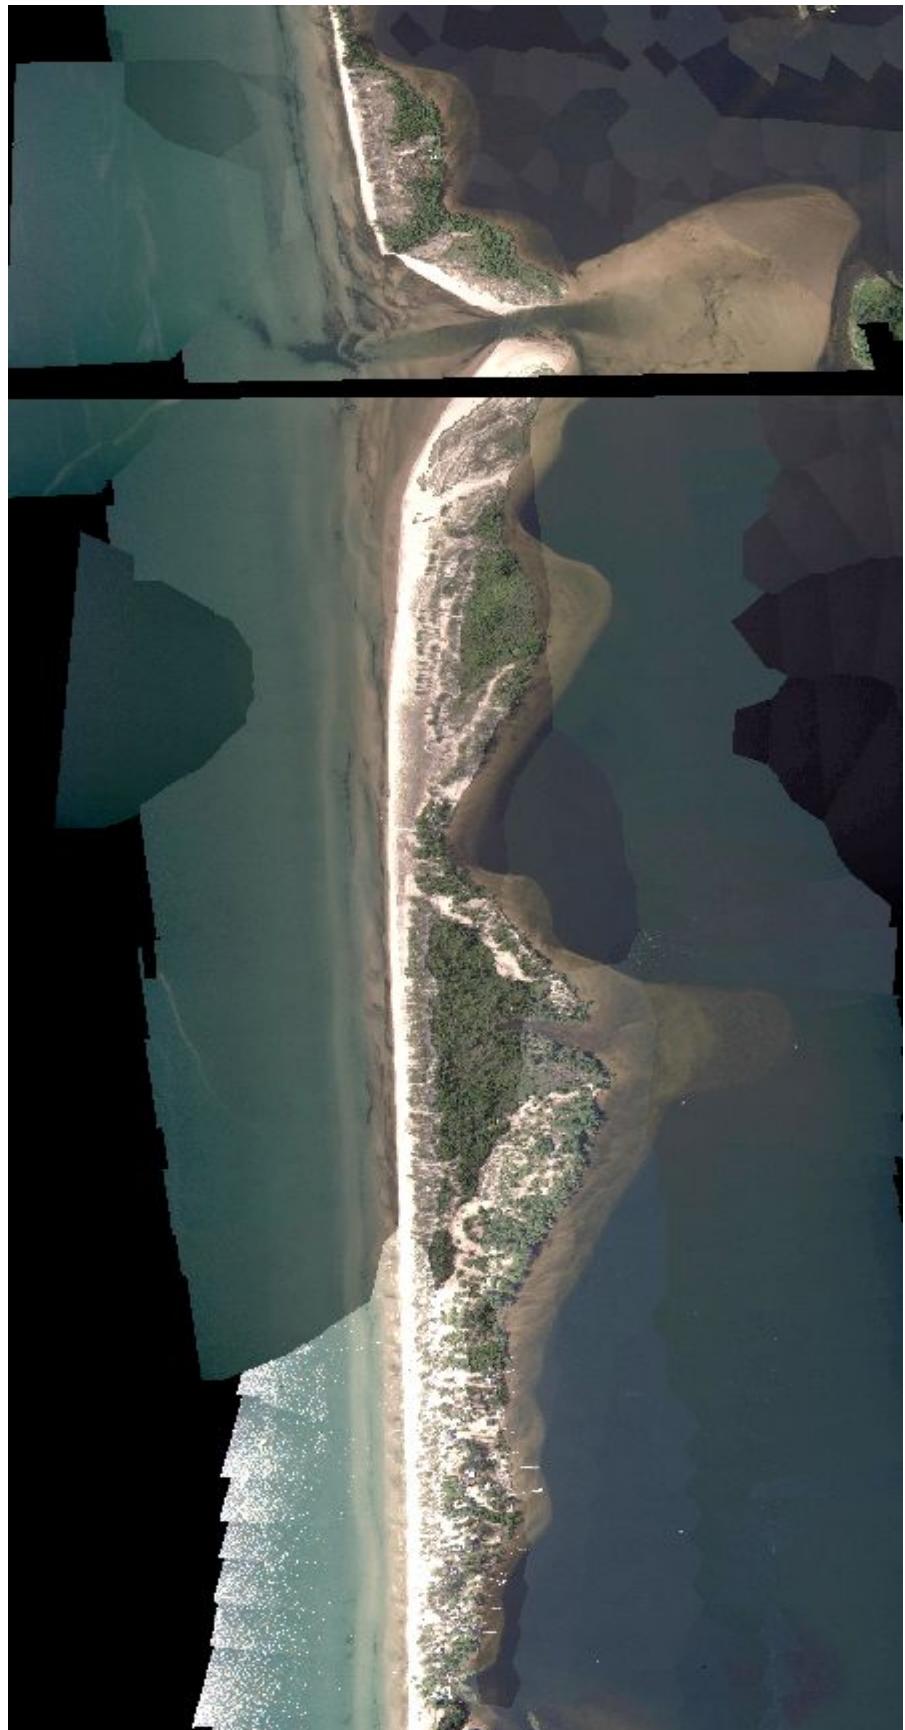
## 2007

Features near shore, on the barrier beach, and within the deposition shoal are remarkably clear. More sand has been obviously deposited in the shoal since prior images.

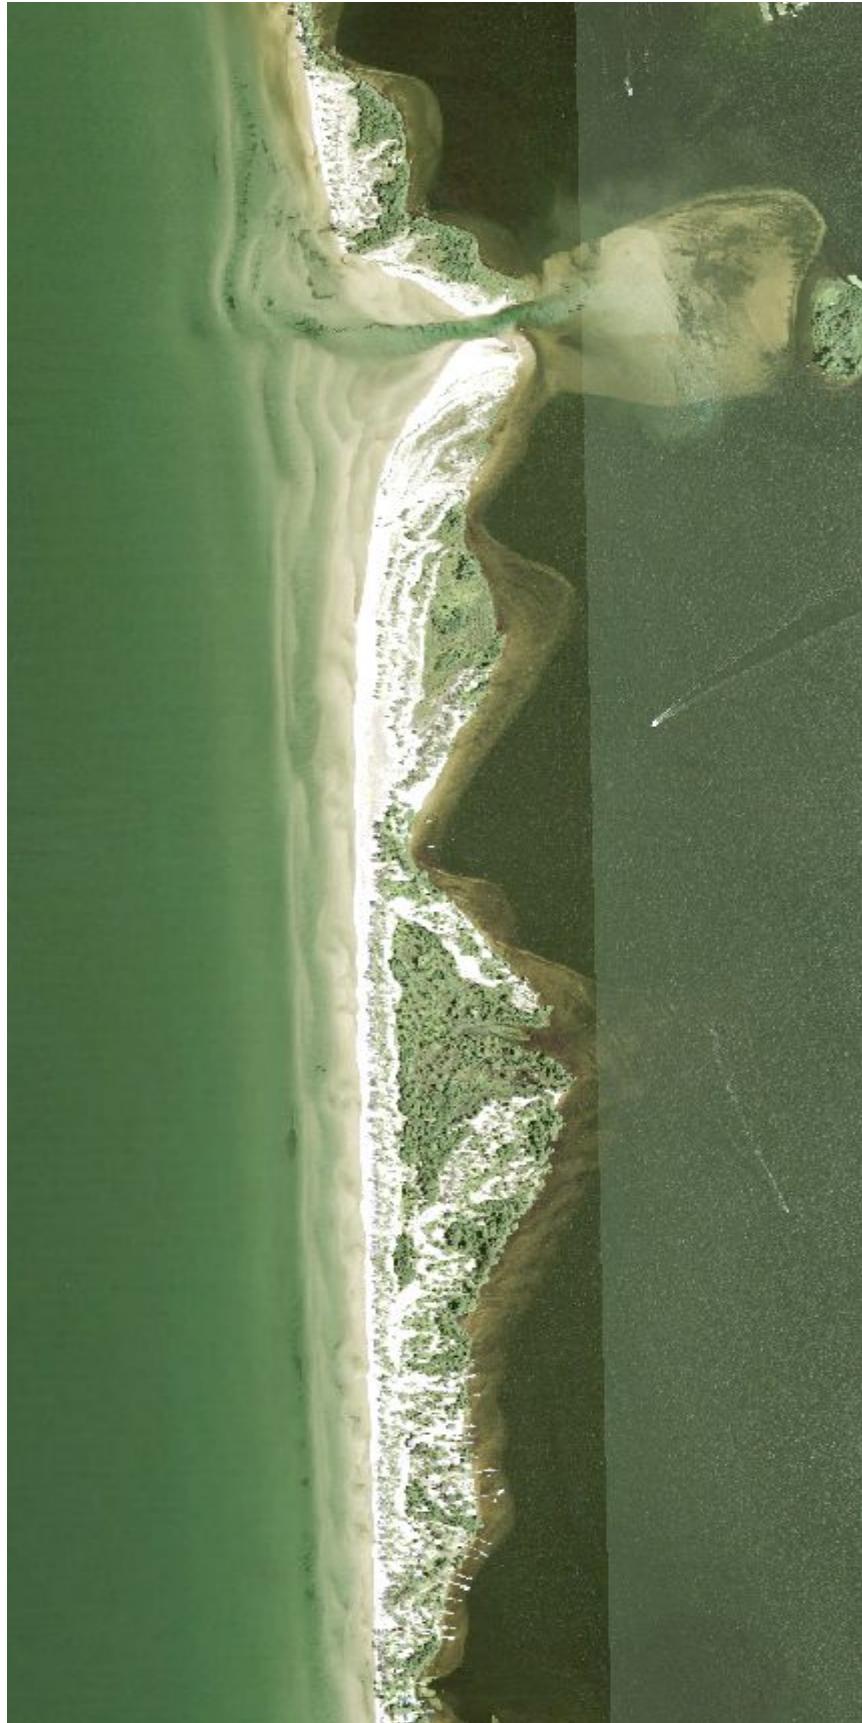
## 2009

Calm water provides an opportunity to see rock shoals offshore, including a possible small area offshore from the southern high dunes visible for the first time. The inlet has significant shoaling with a series of sand waves present in the base of the channel. On the north spit, a high wrack line may be present and several new deposits of sand are evident on the backside of the barrier, shown by lighter colored unvegetated fans. The northern most of these is a broad area, likely due to wind transport of sand, while the more southerly area may be either from overwash or wind-borne processes. Suspension of sand in the water column is shown on the north side of the deposition shoal with wave overwashing to the northwest. Boat propeller tracks are seen across the shoal in front of Carl Island. On the lake side, nearshore sand cells are backed by a deeper single sand bar.
