# North Pond Resiliency Project

## Appendix B

## Appendix B: Remote Sensing Data Set Inventory

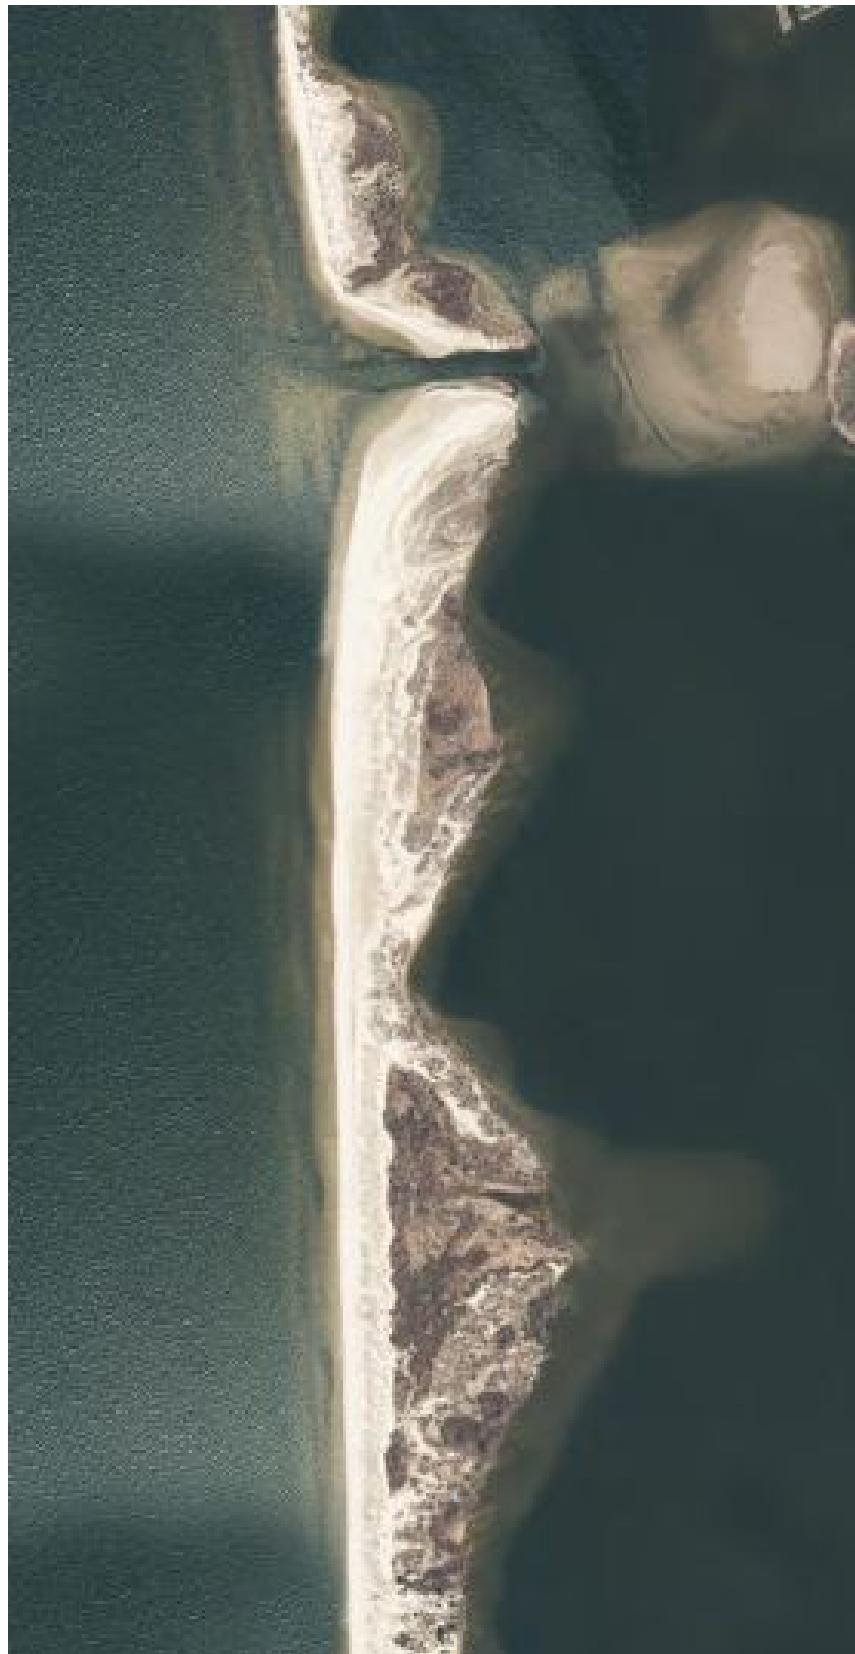
## 2015

NYS DOP imagery was taken with winds from the north-west. Wind-driven waves obscure much of the nearshore lake bottom, although very little sand seems to be entrained in the north-west wind set. Calmer winds lead to much clearer imagery of the depositional shoal taken several weeks later and merged with the earlier imagery. The extent of exposed area of the shoal is substantial.
