### North Pond Resiliency Project

A Comprehensive Analysis of Shoreline Change and Inlet Dynamics on the Eastern Shore of Lake Ontario

Prepared by Thomas Hart and Geoffrey Steadman

Final Report September 2017

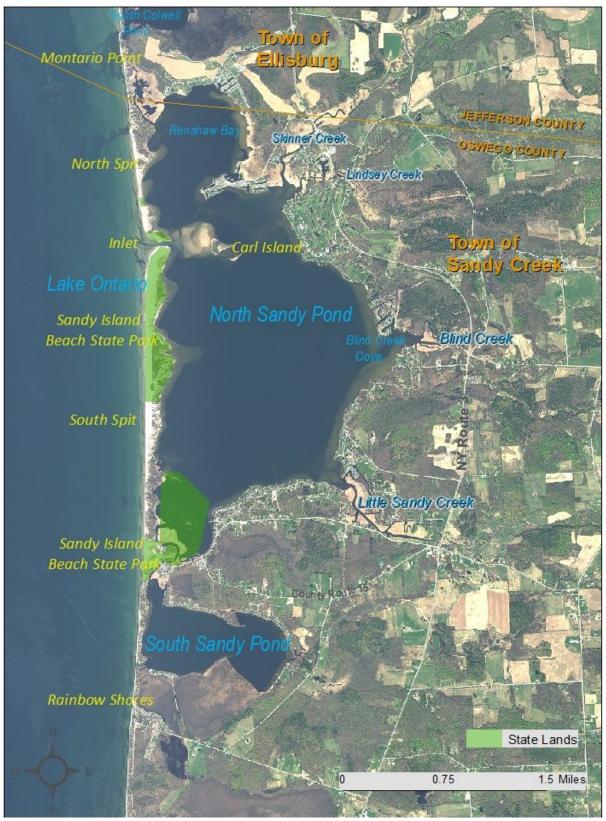
Figure 1: Inlet Management Study Area reference map

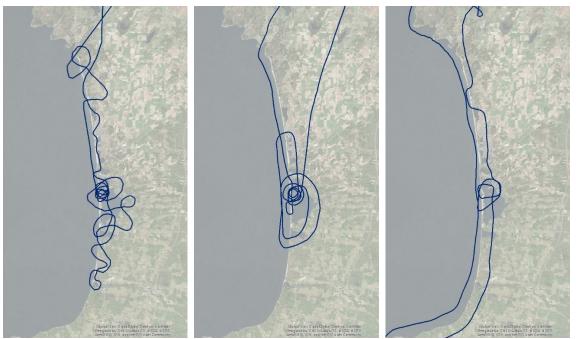
Figure 2: Flight Lines for 2015 (left), 2016 (middle) and 2017 (right)

Oblique photo surveys were performed on: 17 September 2015; 09 August 2016 and 12 June 2017 with 567, 221 and 730 photographs respectively. GPS tracks or simulated tracks were made for each flight to document the location of photographic coverage. The purpose of the first flight was to document conditions at the time of the study initiation. The second flight in 2016 was timed to capture the dredging operation performed at that time, while the last flight in 2017 documented high-water conditions. NYS Sea Grant provided additional funding to assist in collection of the 2017 overflight which was extended to cover from Stony Point to Braddock Bay west of Rochester. Each set of photos is intended to be made publicly available after completion of this study via internet access. Flight lines for each overflight within the Eastern Lake Ontario Dune region are shown for reference (Figure 2).

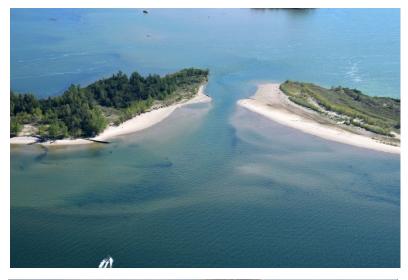
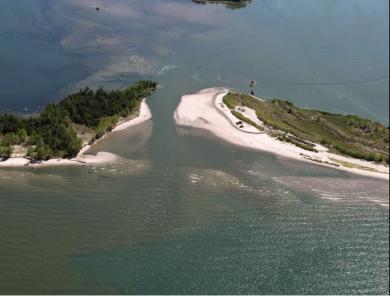
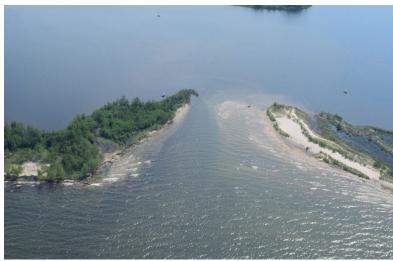
Figure 3: North Pond Inlet in September 2015 (top), August 2016 (middle), and June 2017 (bottom)

Multiple aerial photography collections add to the body of information collected over the last 30 years for each of the reports addressing the Eastern Ontario Dunes. These most recent photography sets provide good reference points for a dynamic system undergoing continuing evolution (Figure 3).

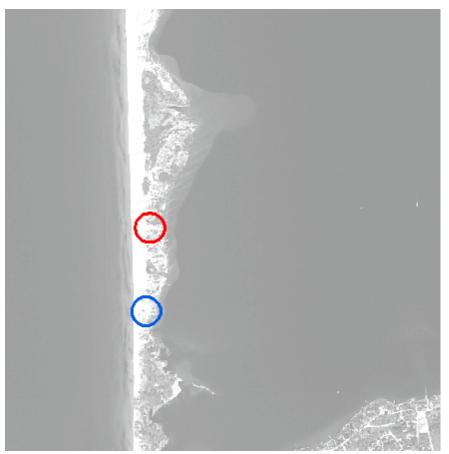
Figure 16: Locations of historic dredging projects: 1896 (bottom site, blue), 1950 (top site, red).

**1896 Dredging.** The inlet located at the south end of North Pond at Wigwam Cove, was prone to shoaling in the mid 1890's and an initiative to dredge a new channel ensued. Dredges arrived and entered the pond by digging through the existing channel. Once within the Pond, the "work of opening up the wind gap opposite Blind Creek Cove will be entered upon in earnest" (SCN, 14 May 1896). The work was supported by a grant from the State legislature for \$10,000 to create a harbor of refuge. The dredged inlet quickly filled in and the inlet remained at the outlet at Wigwam Cove until a new inlet was to form in 1929, 33 years later.

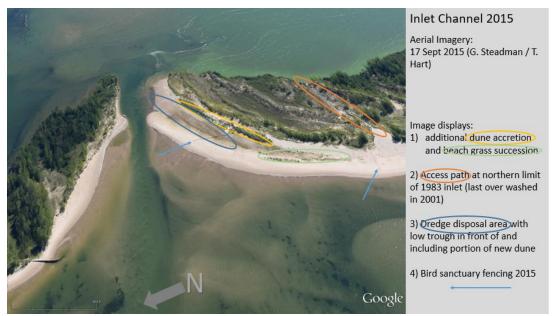
Figure 18: Inlet dredging plan map for 2016 project. Google Earth Pro used to display image only.

In 2016, dredging started 08 Aug and used mechanical means to move between 6,000 and 7,000 cubic yards at a cost of \$36,335.00 (Figure 18). A storm in September filled much of the inlet. The 2016 permit was the first accompanied by a comprehensive permit application for working on State Park lands and included a complete project plan with narrative descriptions, maps and operational conditions (Figure 19).

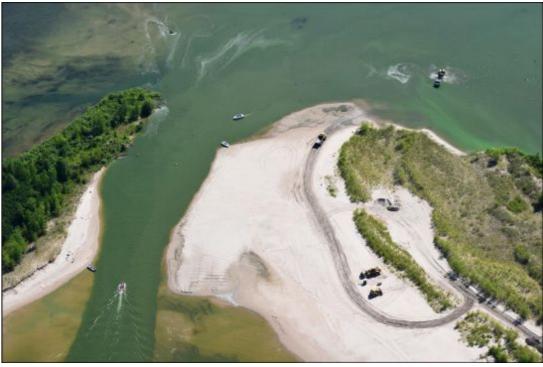
Figure 19: 2016 Inlet dredging operation

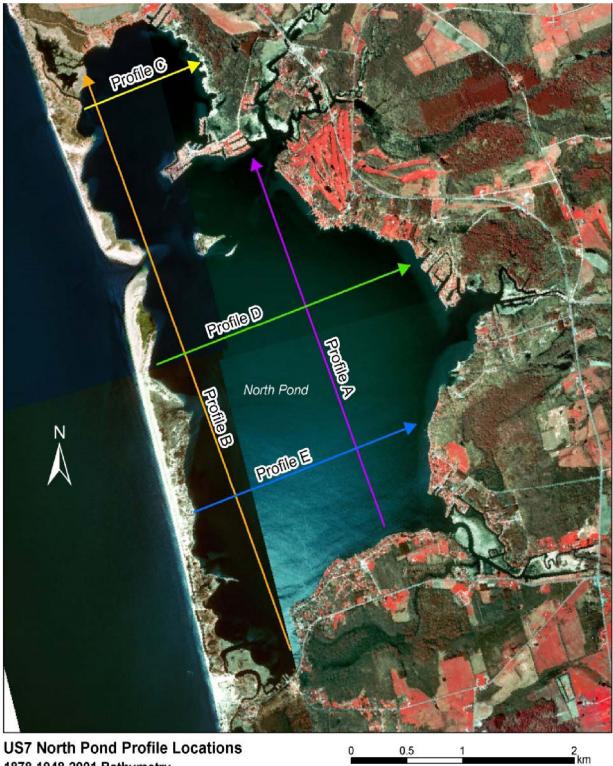
Figure 20: Bathymetry analysis for North Pond (Baird, 2006)

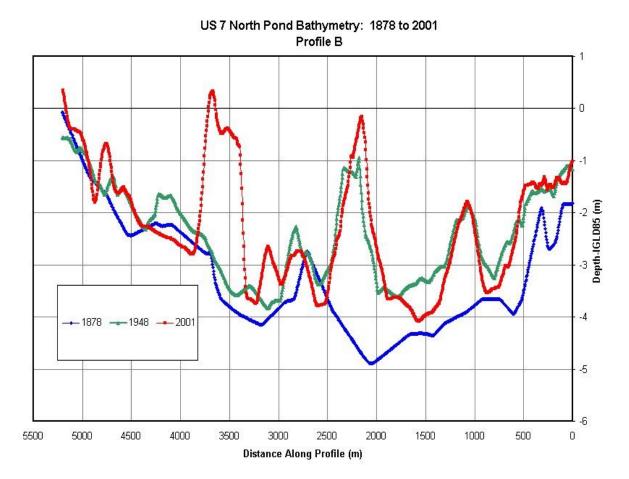
Figure 21: Profile B comparison from 1878 to 2001 at North Pond (0 on the x-axis corresponds to south) (from Baird, 2006)

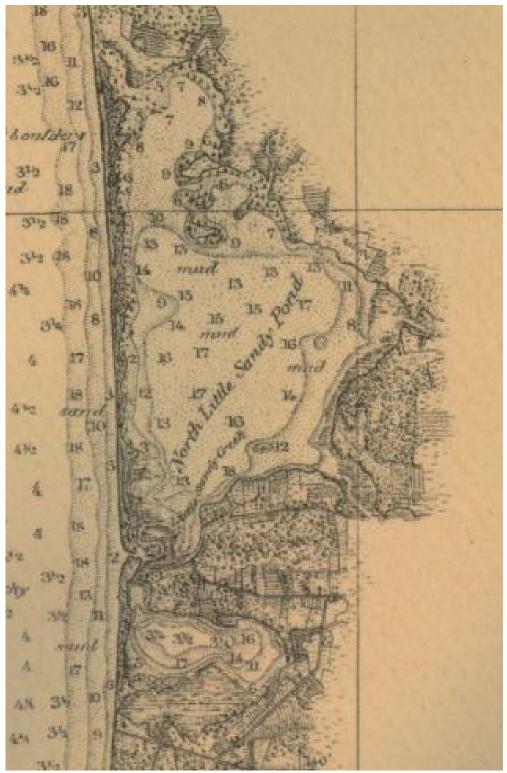
Figure 22: 1878 survey map showing depth data and inlet location

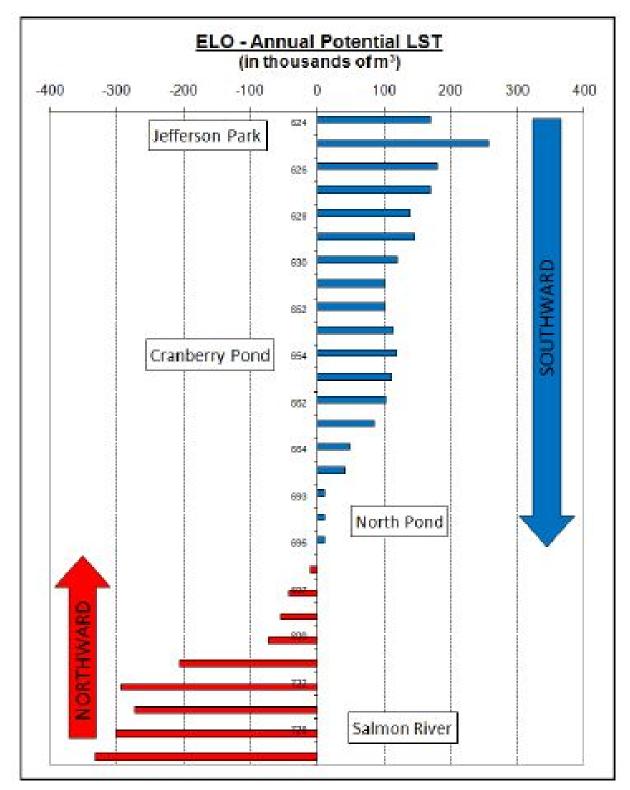
Figure 27: Annual Eastern Lake Ontario potential longshore sediment transport (Baird, 2011)

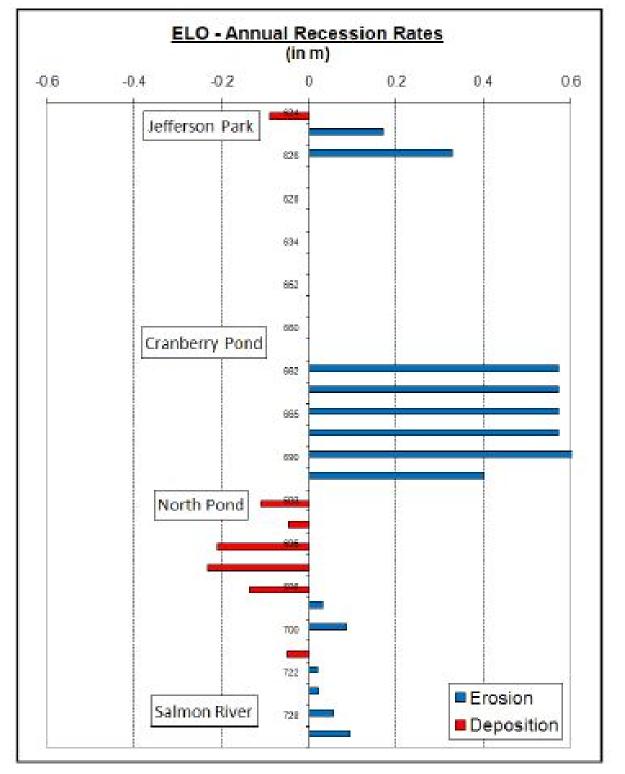
Figure 28: Annual Eastern Lake Ontario erosion rates at selected locations (Baird, 2011)

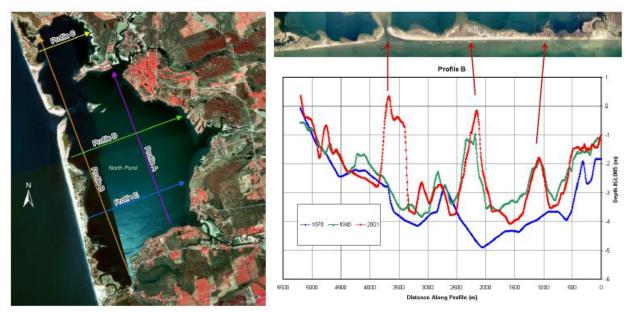
Figure 29: Profile analysis of sediment accumulation at North Pond (Baird, 2011)

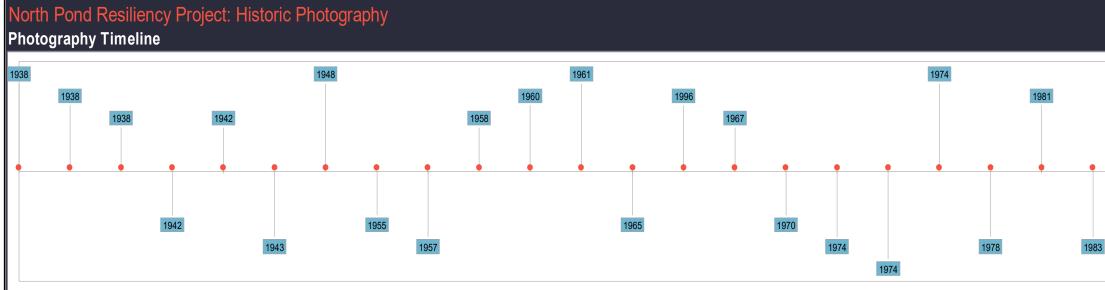
Figure 30: Digital orthoimagery acquisitions – image characteristics, accuracy, shoreline digitization status lake elevation and classification.

Twenty sets of digital orthoimagery were assembled and of these, digital shorelines were extracted for fifteen. Those not classified are so indicated and also not classified as indicated by an "x". Those data set not used for shoreline determinations are either duplicate forms of the same imagery (2 cases), a different format (reflectance, one case), within a few months of another data set (one case) or more recently collected (one case).

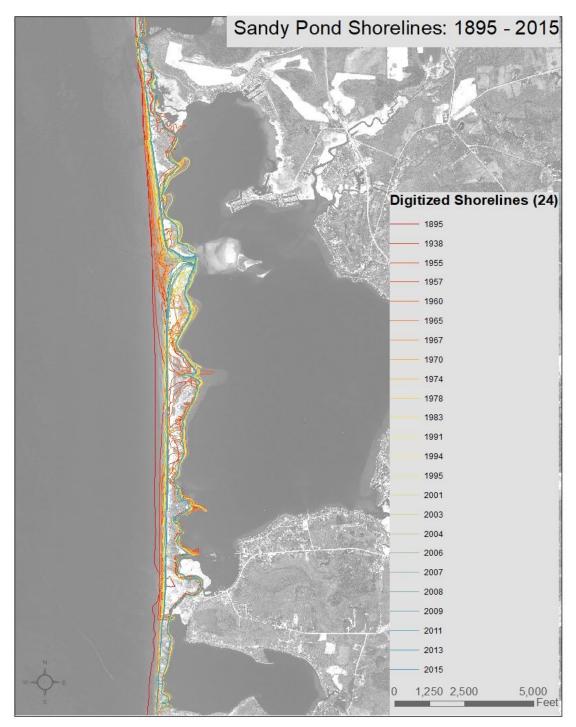
Figure 35: Digitized shorelines within the study area on 2015 base map

Mapping all shorelines at once for the study area creates a complex presentation of shorelines that generally shows the landward progress of the central area of the barrier system (Figure 35). The dynamic nature of shoreline change near the three major inlet areas is evident on closer inspection (Figure 36).

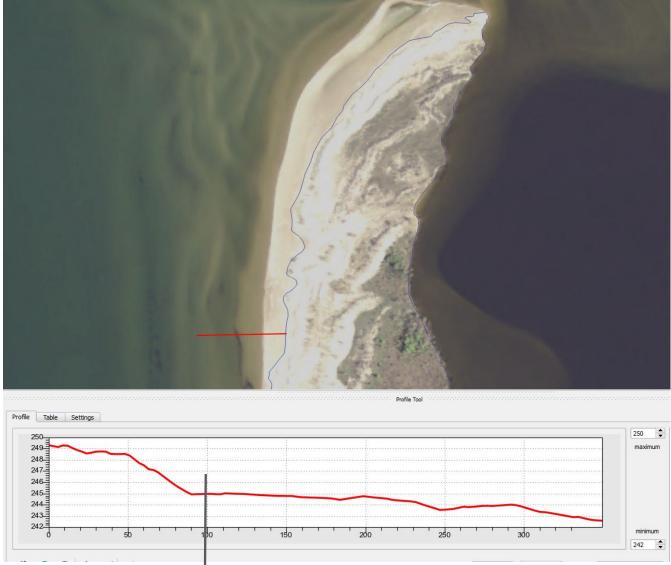
Figure 37: Beach and nearshore profile along beachfront section away from inlet. Vertical bar depicts shoreline location.

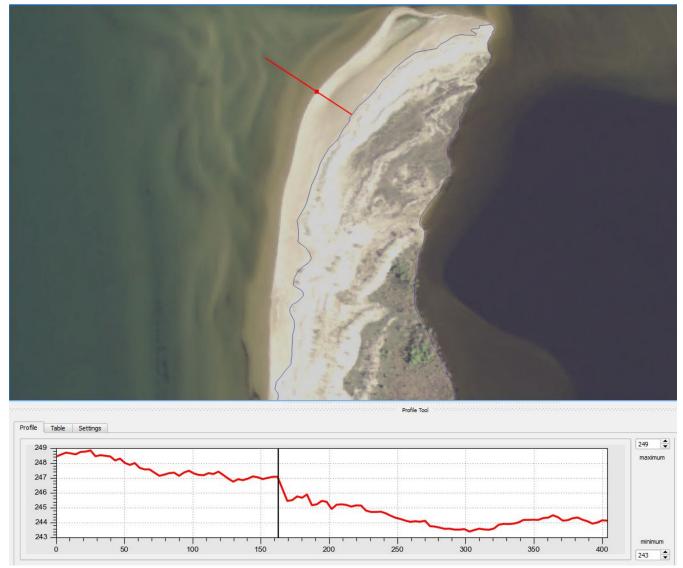
Figure 38: Beach and nearshore profile near inlet. Vertical bar depicts shoreline location.

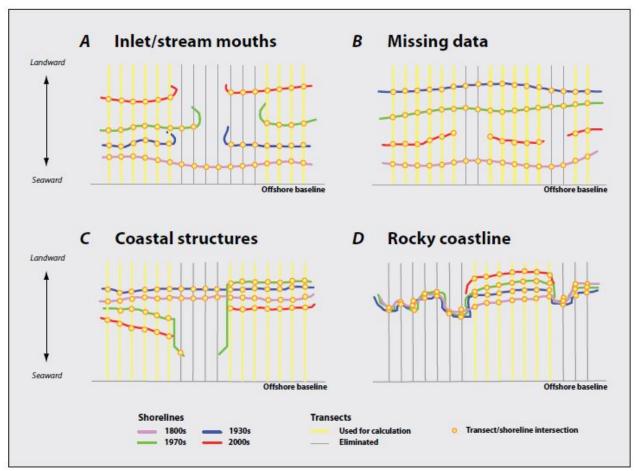
Figure 39: Schematic diagrams showing examples of common conditions where transects are eliminated in the absence of four shoreline intersections: (A) inlet/stream mouths, (B) missing data, (C) coastal structures, and (D) rocky coastline. (from (Hapke 2011)).

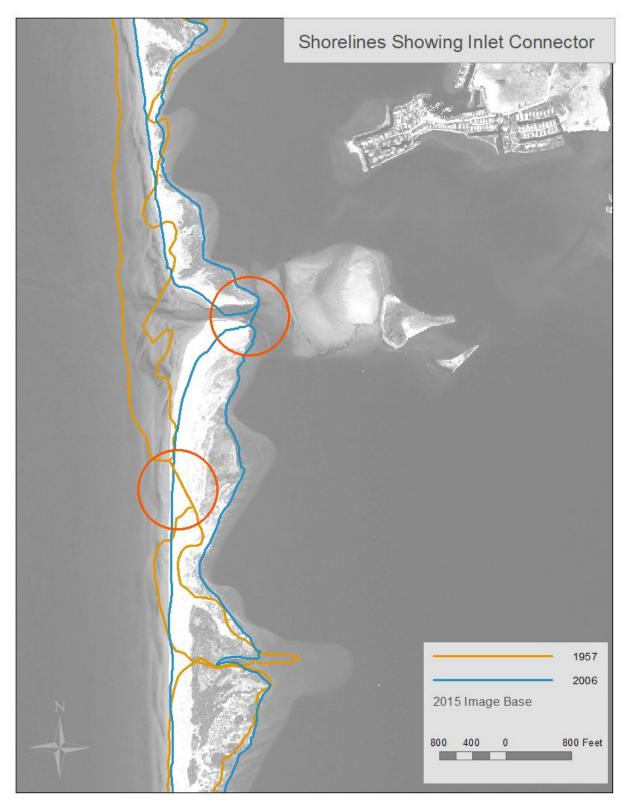
Figure 40: Method used to include inlet measurements in shoreline change using a line tangent to the landward limit of the inlet to connect pond shorelines

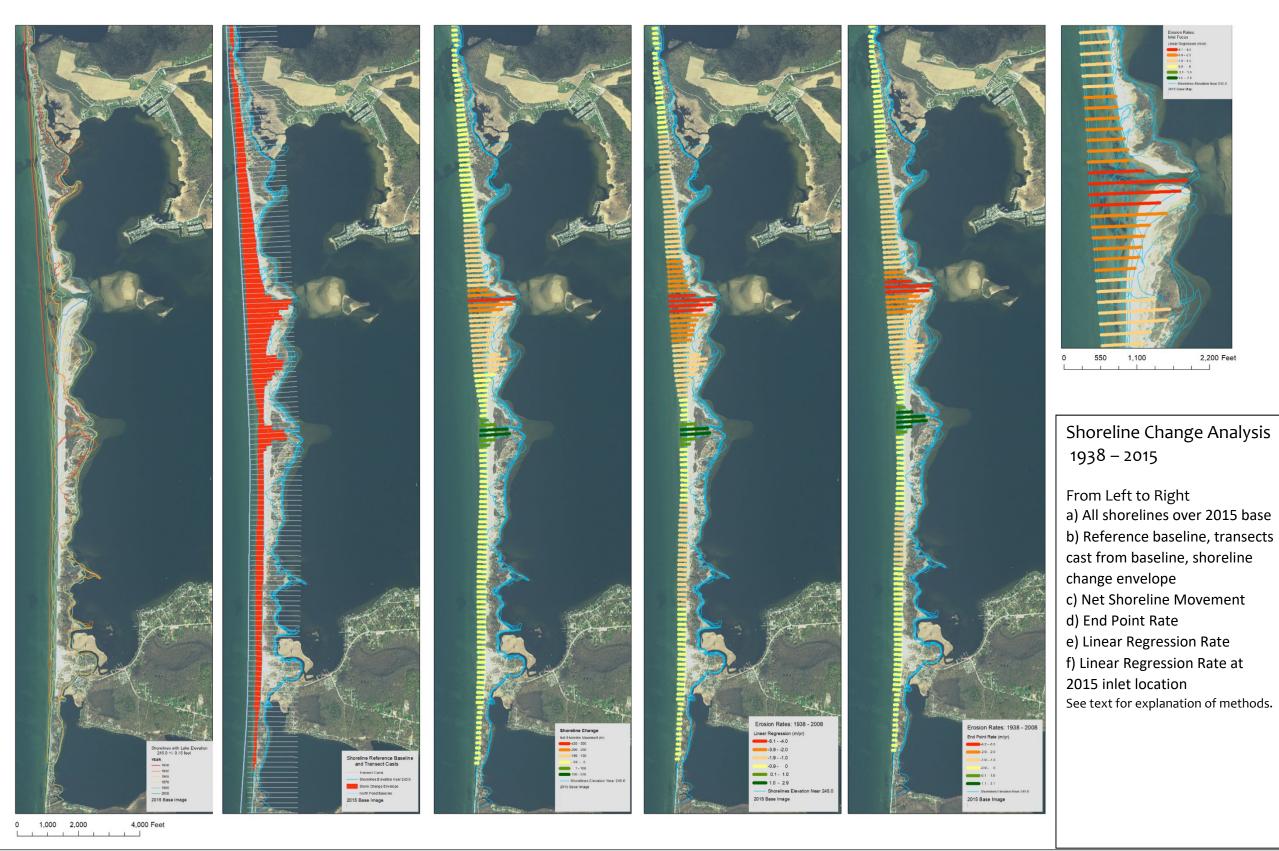
Figure 41: Shoreline change analysis 1938-2015 limited to shorelines with lake elevations near 245 feet IGLD

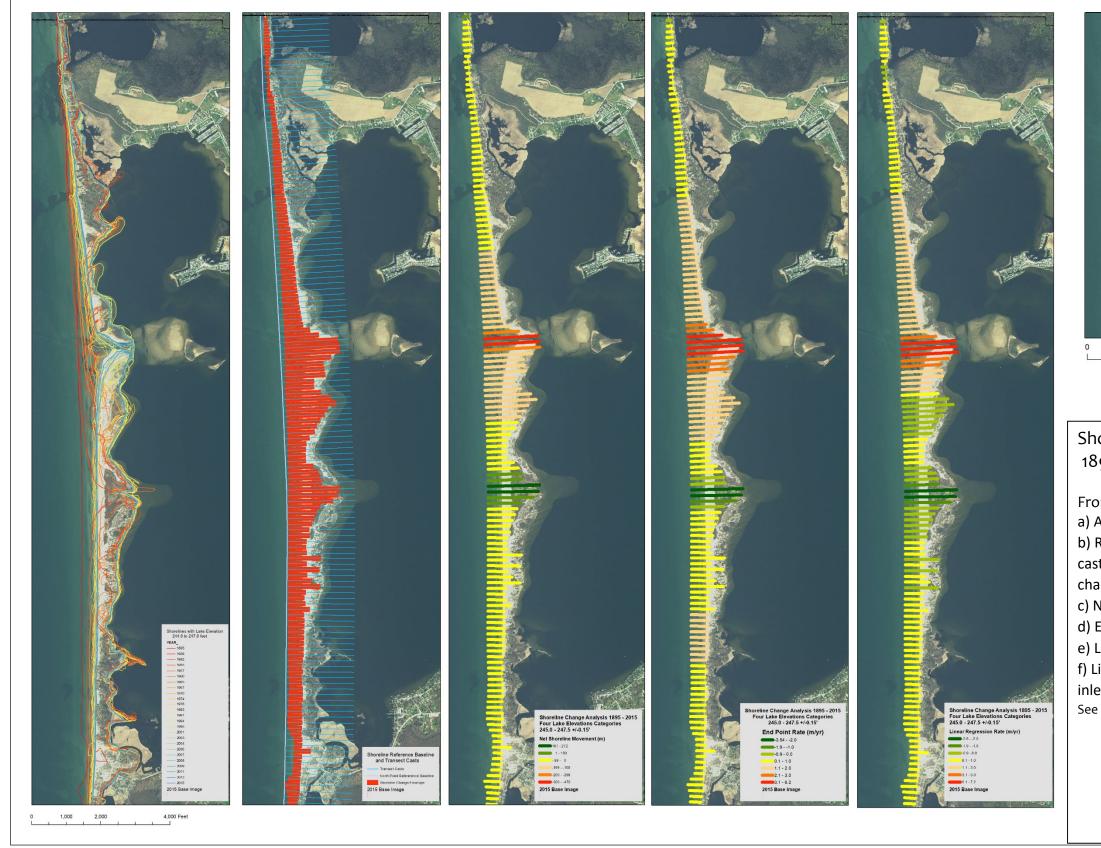
Figure 42: Shoreline change analysis 1985-2015. All shorelines included save for extreme low and high lake elevations

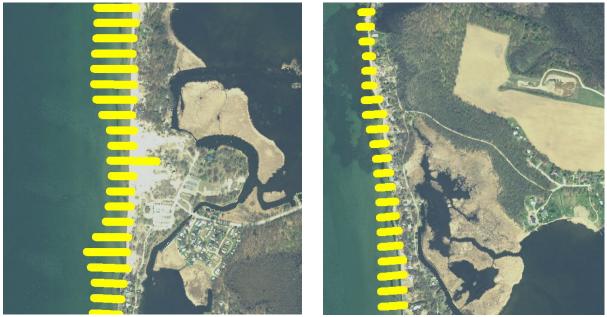
Figure 43: Dune blow-out showing lower shoreline retreat of ranging from 60 - 70 meters (left). Northern extent of study area with lower shoreline retreat ranging from 10 to 50 meters (right).

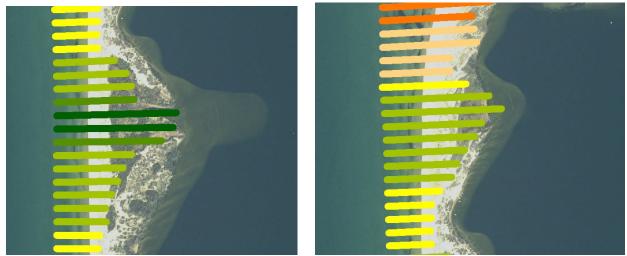
Figure 44: Former inlet locations show as shoreline gain areas. The shoreline has retreated in these areas, however the change analysis accounts for the gain in sediment on the pond side, showing a gain in barrier width. The process of the barrier system rolling towards the pond is documented by this analysis. The 1938 inlet closure shows significant growth (left), while the 1957 inlet shows less growth (right).

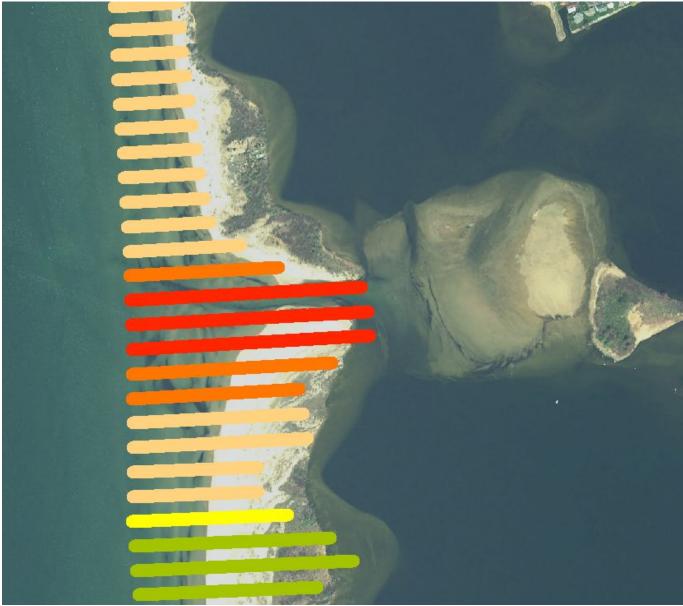
Figure 45: Shoreline recession at the 2015 inlet location. Barrier accretion is shown as fill in the 1957 inlet location, while landward recession at the 2015 inlet shows the highest losses.

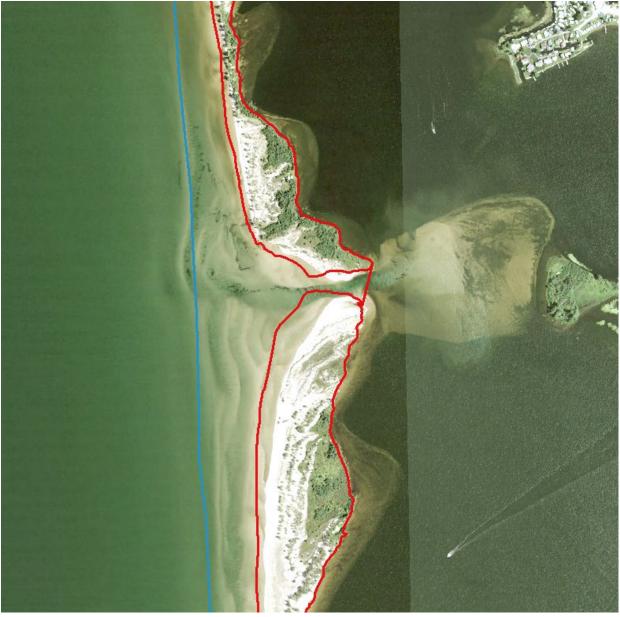
Figure 46: Comparison of shoreline locations - 1895 and 2015

The amount of shoreline recession documented in the shoreline analysis around the 2015 inlet is remarkable. Excluding the inlet transects, net shoreline movement in the immediate area of the inlet is between 200 and 280 m (Figure 45). There are two inlet morphological differences from prior inlets. One is the accumulation of sediment in the shoal fronting Carl Island, a feature not found in prior inlets. The second feature difference is the angular offset of the shore at the inlet location. With each new formed inlet, the shore and barrier system has rolled landward, effectively changing the angle of the shore leading to the inlet.

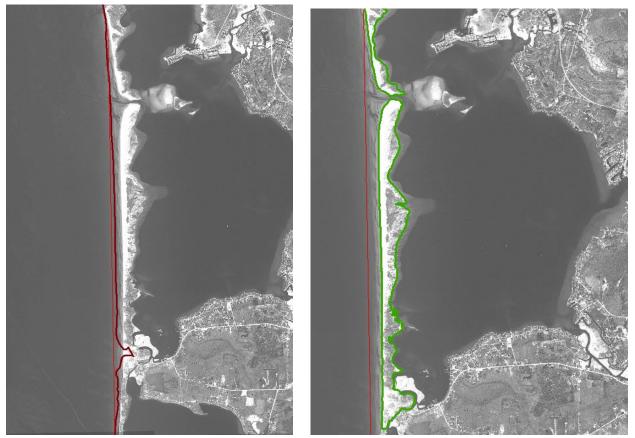
Figure 47: Shoreline offset from an artificial straight baseline compared to the shoreline in 1895 (left) and 2015 (right). 2015 background image.

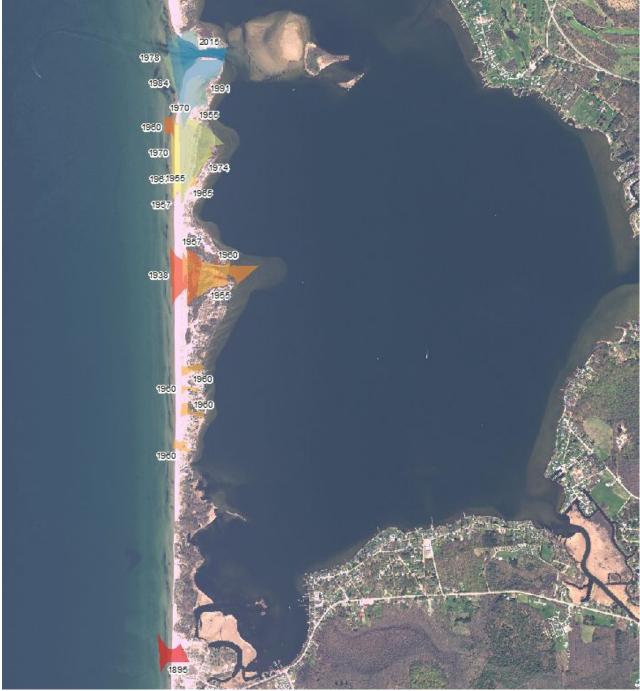
Figure 48: History of inlet and overwash locations - 1895 - 2015

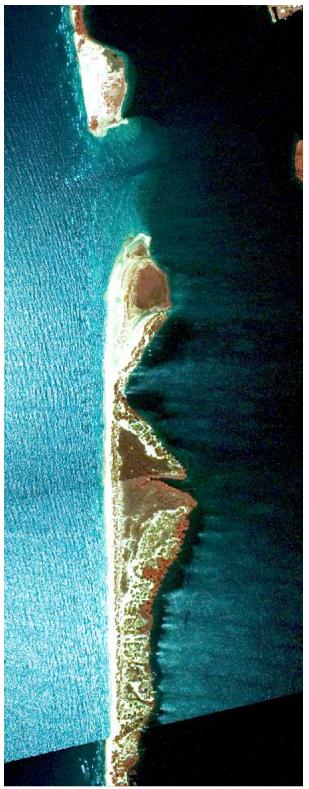
Figure 66: A return of higher lake levels in 1983 flooded low areas of new sand bars adjacent to the inlet which now was 1500 feet wide, with a small deeper channel at its center.

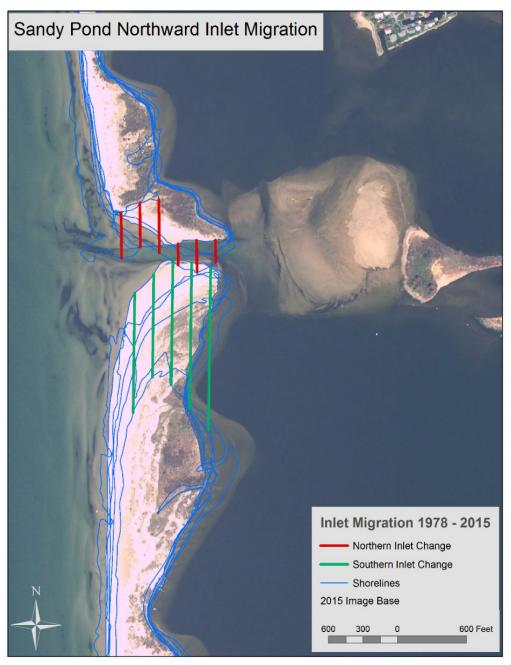
Figure 67: Northern inlet migration illustrated using Digital Shoreline Analysis System

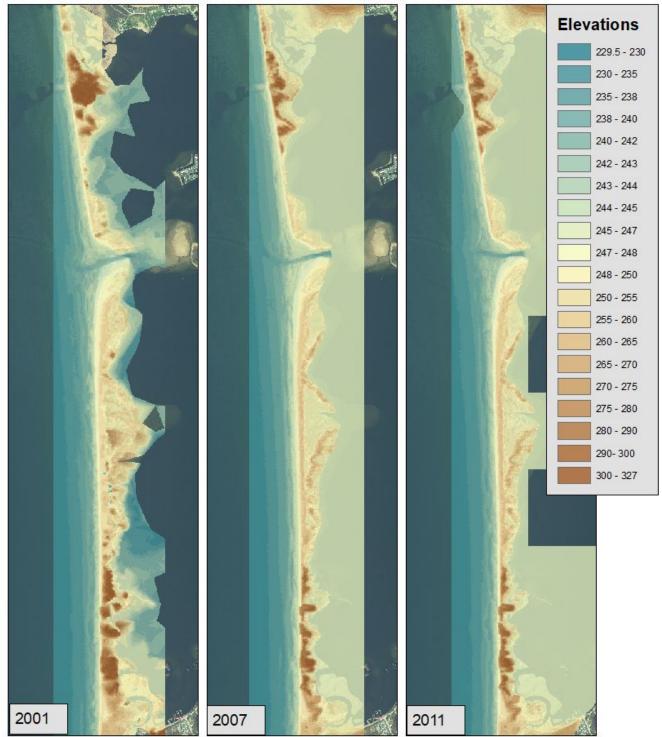
Figure 70: Digital terrain and hydrographic surfaces for the three available data sets.

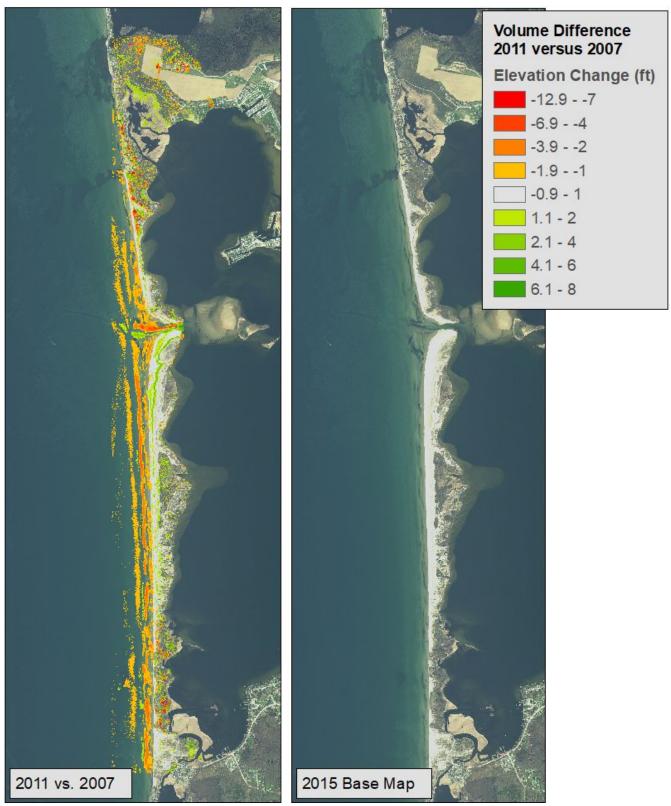
Figure 71: Volume Change based on difference in elevations. Green areas represent fill, while red and orange areas represent loss of mass.

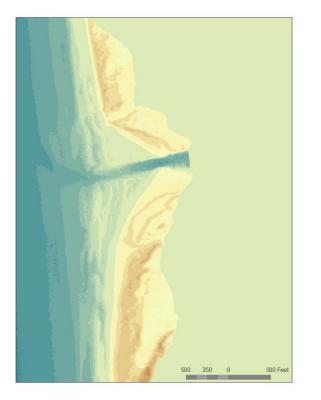
Figure 72: Elevations focused on inlet area 2007 (left) 2011 (right)

Differences show a dynamic environment with progressive filling and cutting of the northward migrating inlet channel; building of flats and dunes on the southern barrier; and, continued loss of material from the northern barrier (Figure 72)(

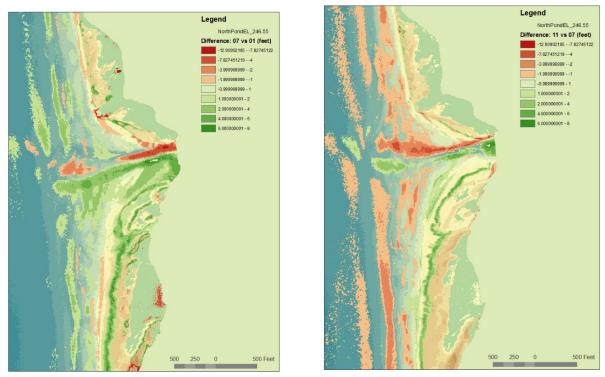
Figure 73: Volume changes near inlet. Difference between 2001 and 2007 (left). Difference between 2007 and 2011 (right)

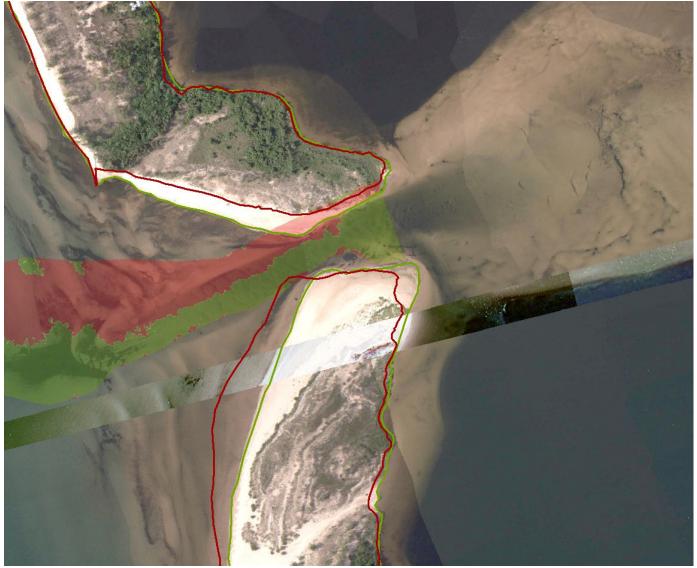
Figure 74: 2007 Base imagery with cut and fill overlay of channel location in 2007 and 2011 with corresponding shorelines. Uneven appearance is due to gap in imagery from 2007.

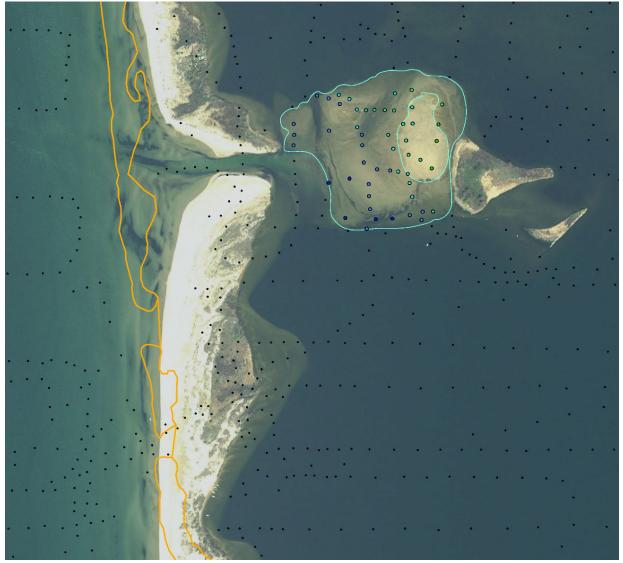
Figure 75: 1948 Bathymetric survey data with 1955 shoreline and shoal sketch from 2015 image.

Like LiDAR, bathymetric and GPS surveys create a series of points with X, Y and Z (elevation) values. Unlike LiDAR, a single depth or elevation value is provided for each observation. The number of point observations is relatively small, but may be adequate to create a digital surface model representing land elevations and water depths (Figure 75).

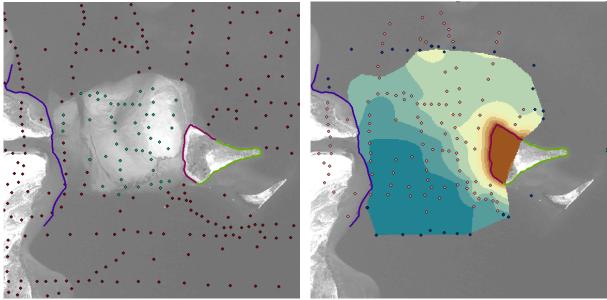
Figure 76: 1948 bathymetric points (left) and resulting bathymetry DEM (right)

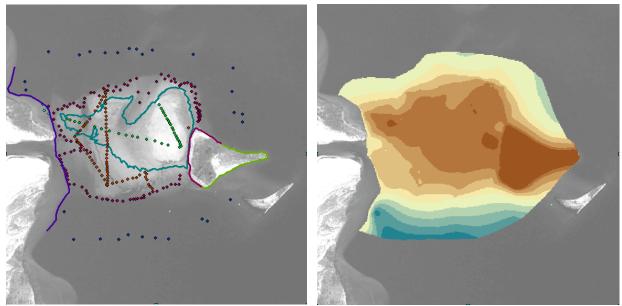
Figure 77: 2016 GPS points and lines (left) along with closure points from 1948 bathymetry. Resulting topobathymetry DEM (right)

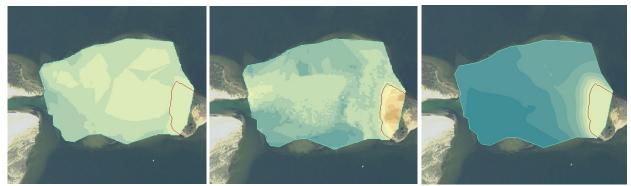
Figure 79: DEMs adjusted to extent of 2001 LiDAR data. 2016 (left), 2001 (middle), 1948 (right)

LiDAR data for the shoal area in 2001 does not extend to include the outer margins of the shoal, but is useful to explore as an intermediate measure in the shoal's development. A 2001 DEM was produced and all three coverages were clipped to the same area as defined by the limits of the LiDAR data. The resolution of the 2001 data shows substantially more detail than either 1948 or 2016 DEMS based on the greater point density (Figure 79).

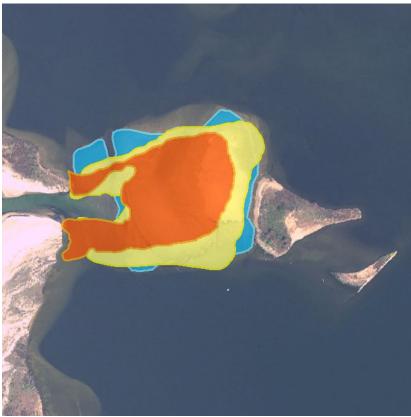
Figure 80: Shoal outlines derived from imagery by year - 2001 (Orange), 2011 (yellow), 2016 (blue). Shoal areas are similar for 2016 and 2011 (147,000 and 151,000 sq yds) while 2001 is less (99,000 sq yds)

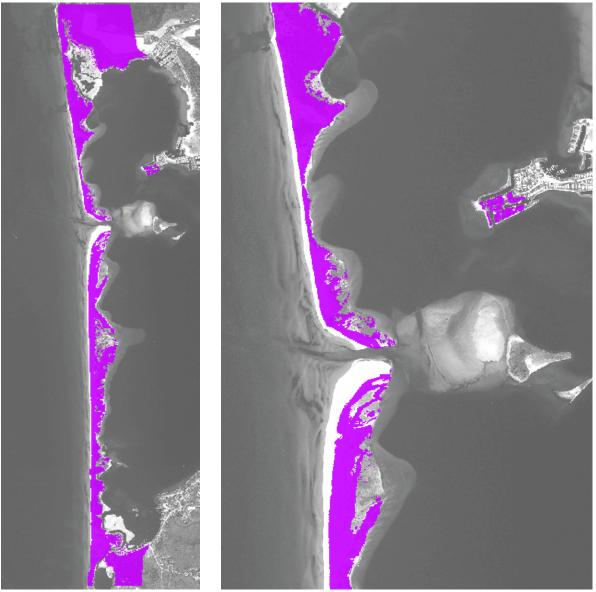
Figure 81: Land at elevation greater than 249 ft IGLD. Overall study area (left), Inlet area (right).

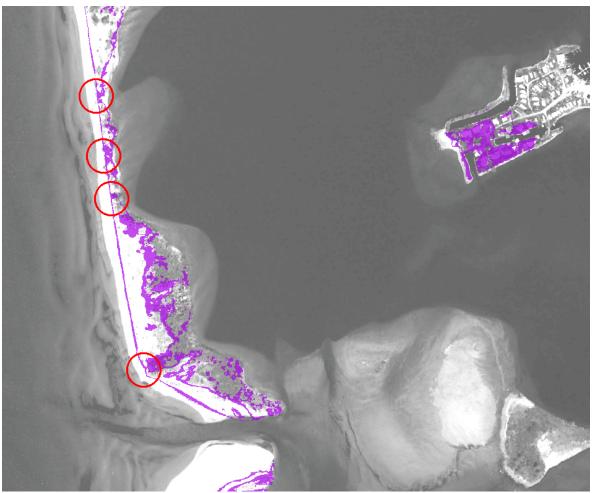
Figure 82: Elevations between 249 and 251 IGLD in purple. Four areas where the barrier is no more than 2 feet above high-water simulation at 249 feet are highlighted.

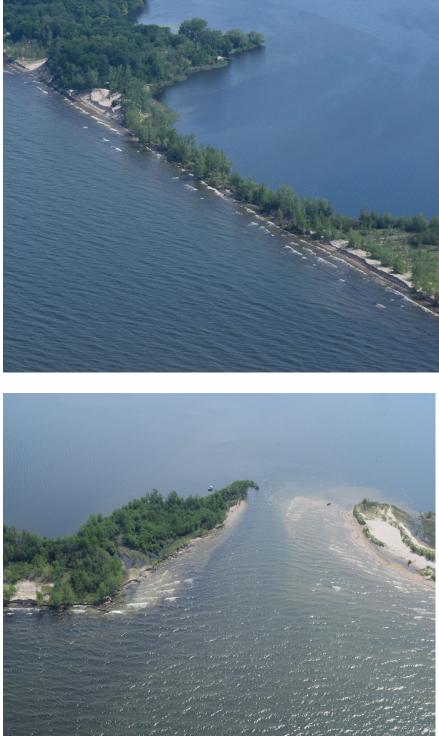
Figure 83: Low elevation sections of northern barrier. Low strand 625 m north of inlet (left), section at inlet northern elbow (right). Photography by Steadman and Hart.

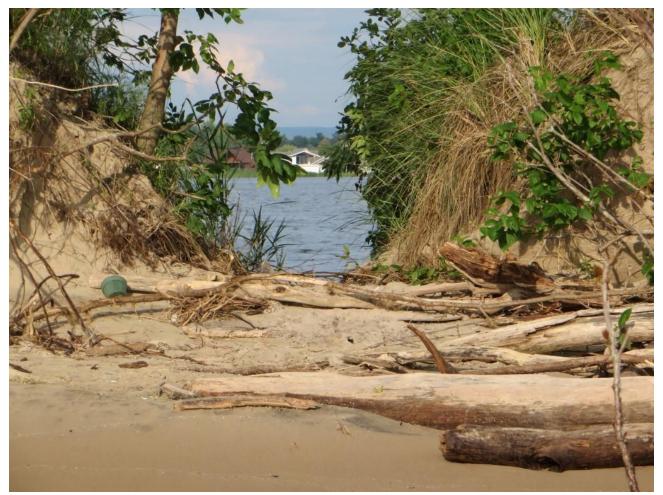
Figure 84: Overwash channel on North Spit Barrier, 16 July 2017. Dimensions: 3' wide, elevation 1.5' above lake level. Dimensions and photo by D.Youman.

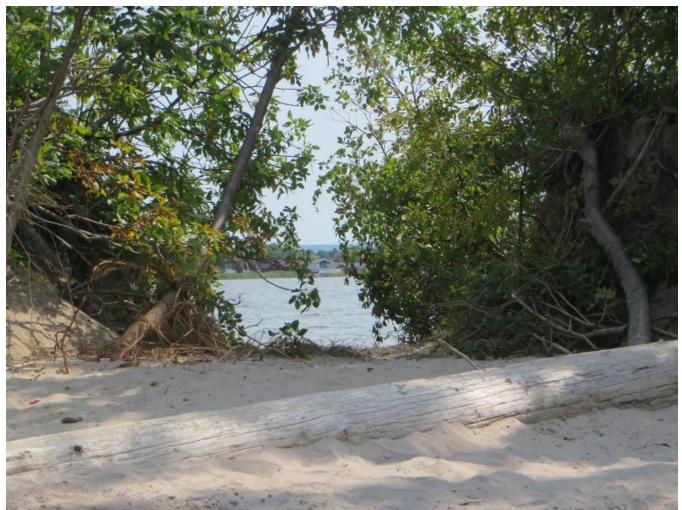
Figure 85: Same overwash channel shown in Figure 84 following August 4-5 storm. Photograph date: 16 August 2017. Dimensions 8' wide and 1.5' above lake level. Dimensions and photo by D. Youman

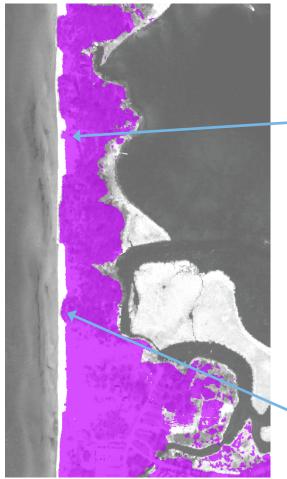
Figure 86: Lands on south barrier spit illustrating areas of shoreline armor and adjacent erosion. Left image shows all lands greater than elevation 249. Upper-right photo matching dune area in upper third of elevation map. Mid-right photo details armoring in upper photo. Lower-right photo showing area in lower third of map. Physical Geography Change Analysis of the Barrier Complex
