“Living Shorelines” An Historical Perspective from Chesapeake Bay

C. Scott Hardaway, Jr.
Geologist
Shoreline Studies Program
VIMS

“Living Shorelines”

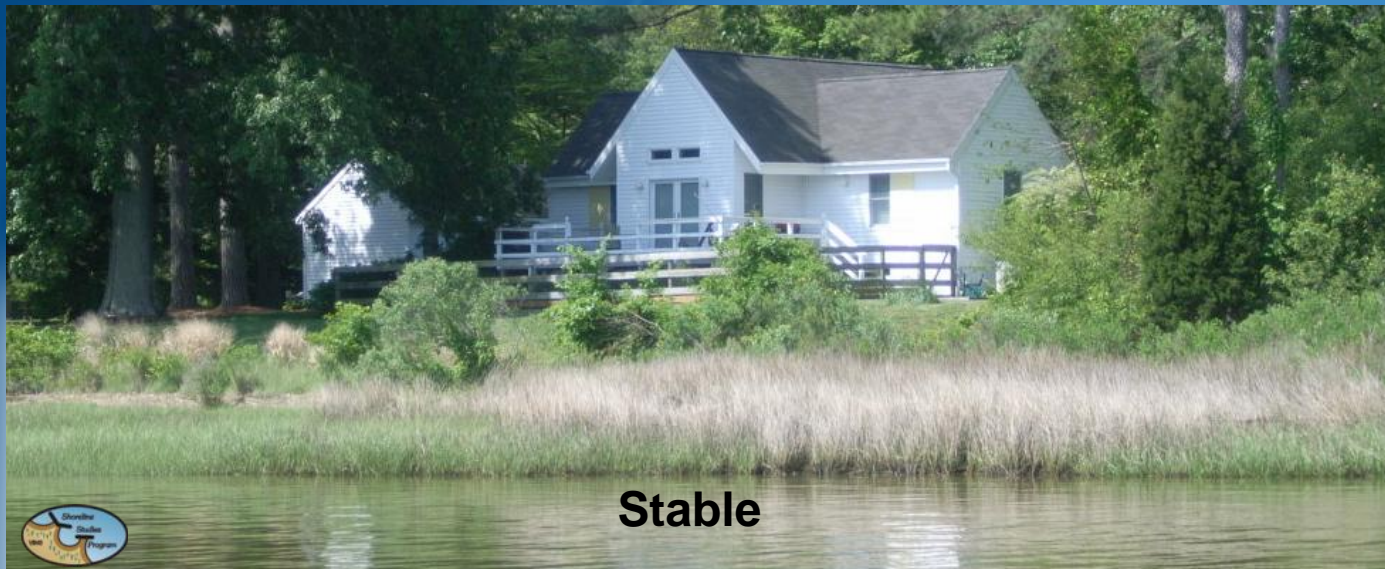
Six typical shoreline profiles around Chesapeake Bay. The stability of the bank face is dependent upon the width and type of shore zone features. Wide beaches/dunes and marsh zones can offer significant wave protection even during storms.

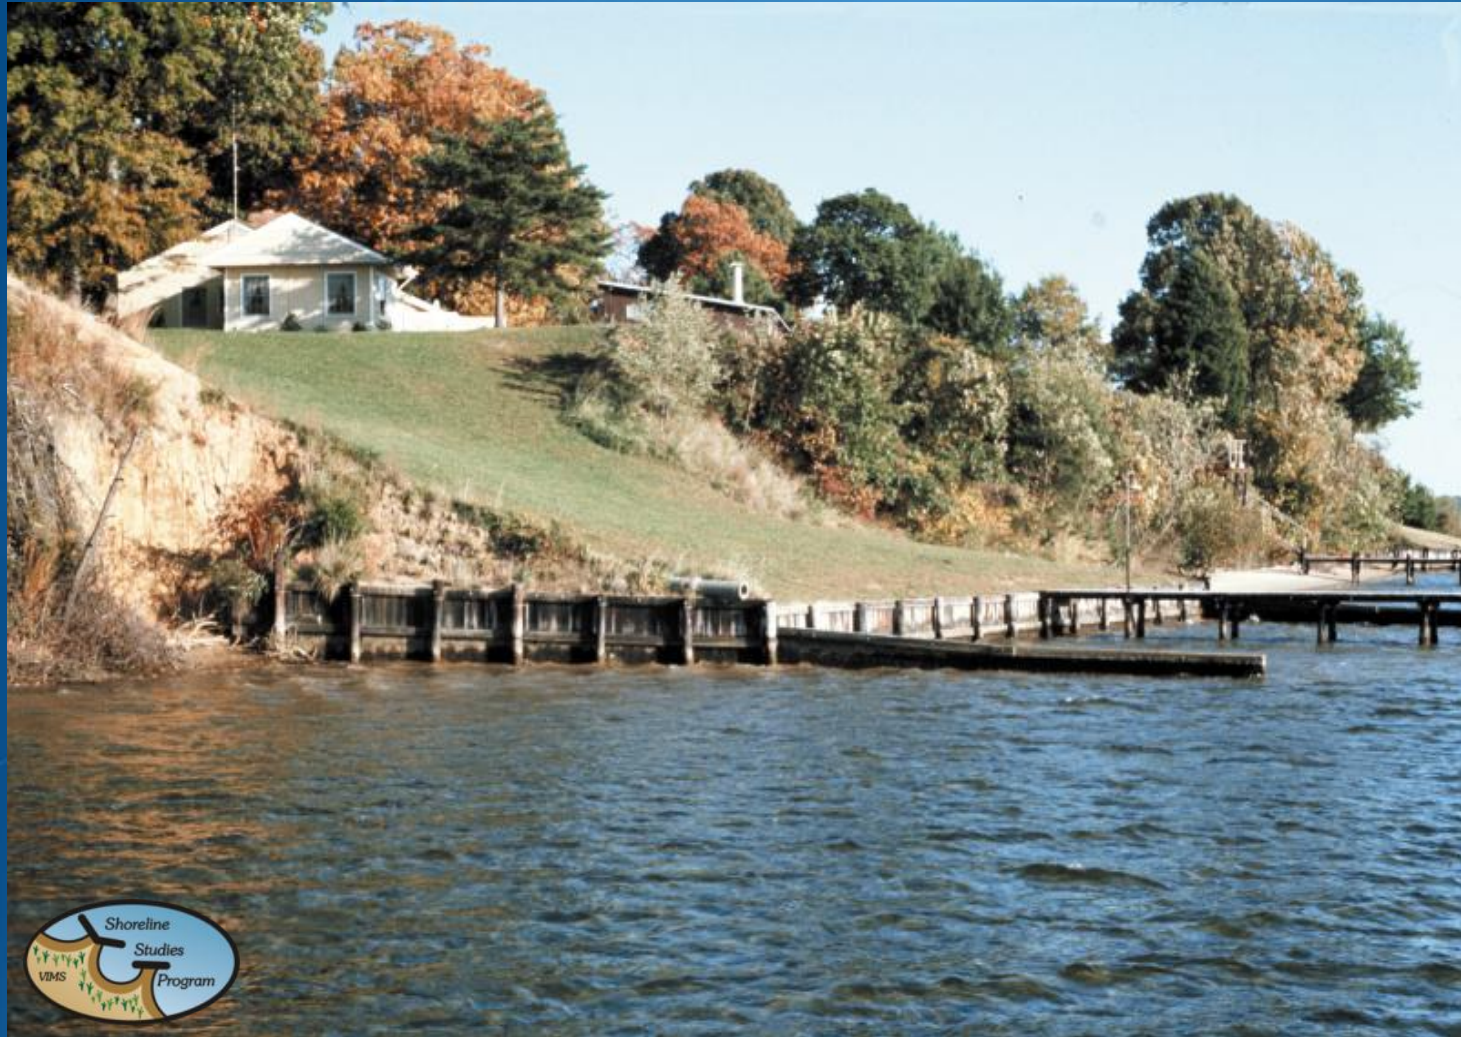
Bulkheads

Hard Shore Protection Strategies

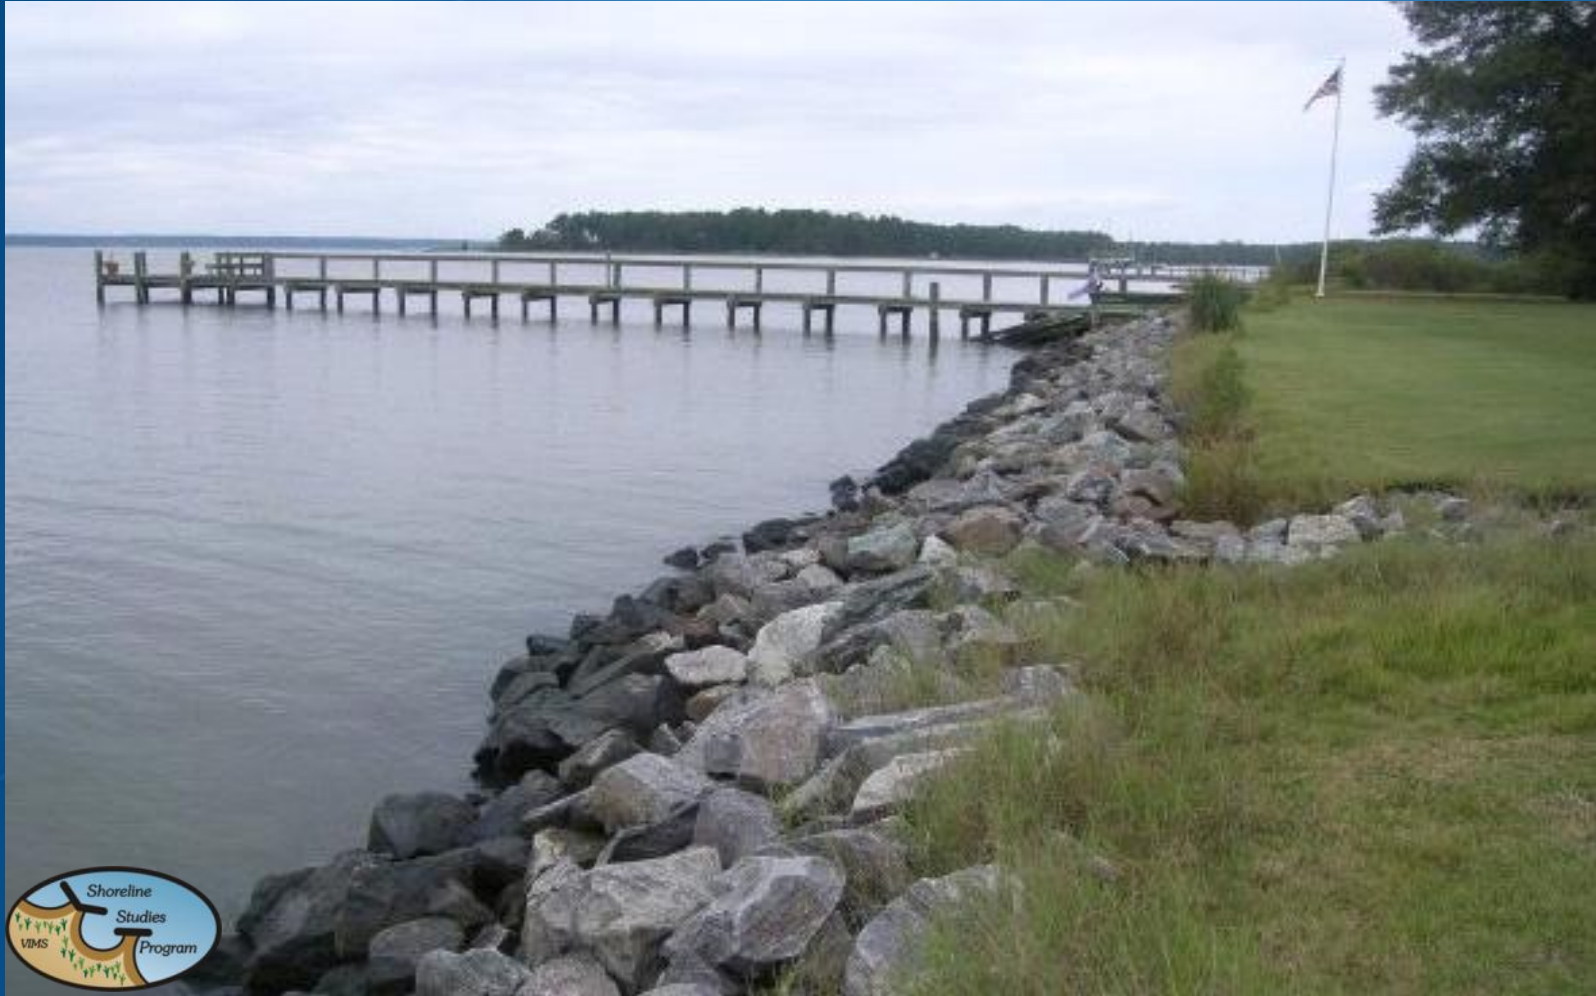
Revetments

Hard Shore Protection Strategies

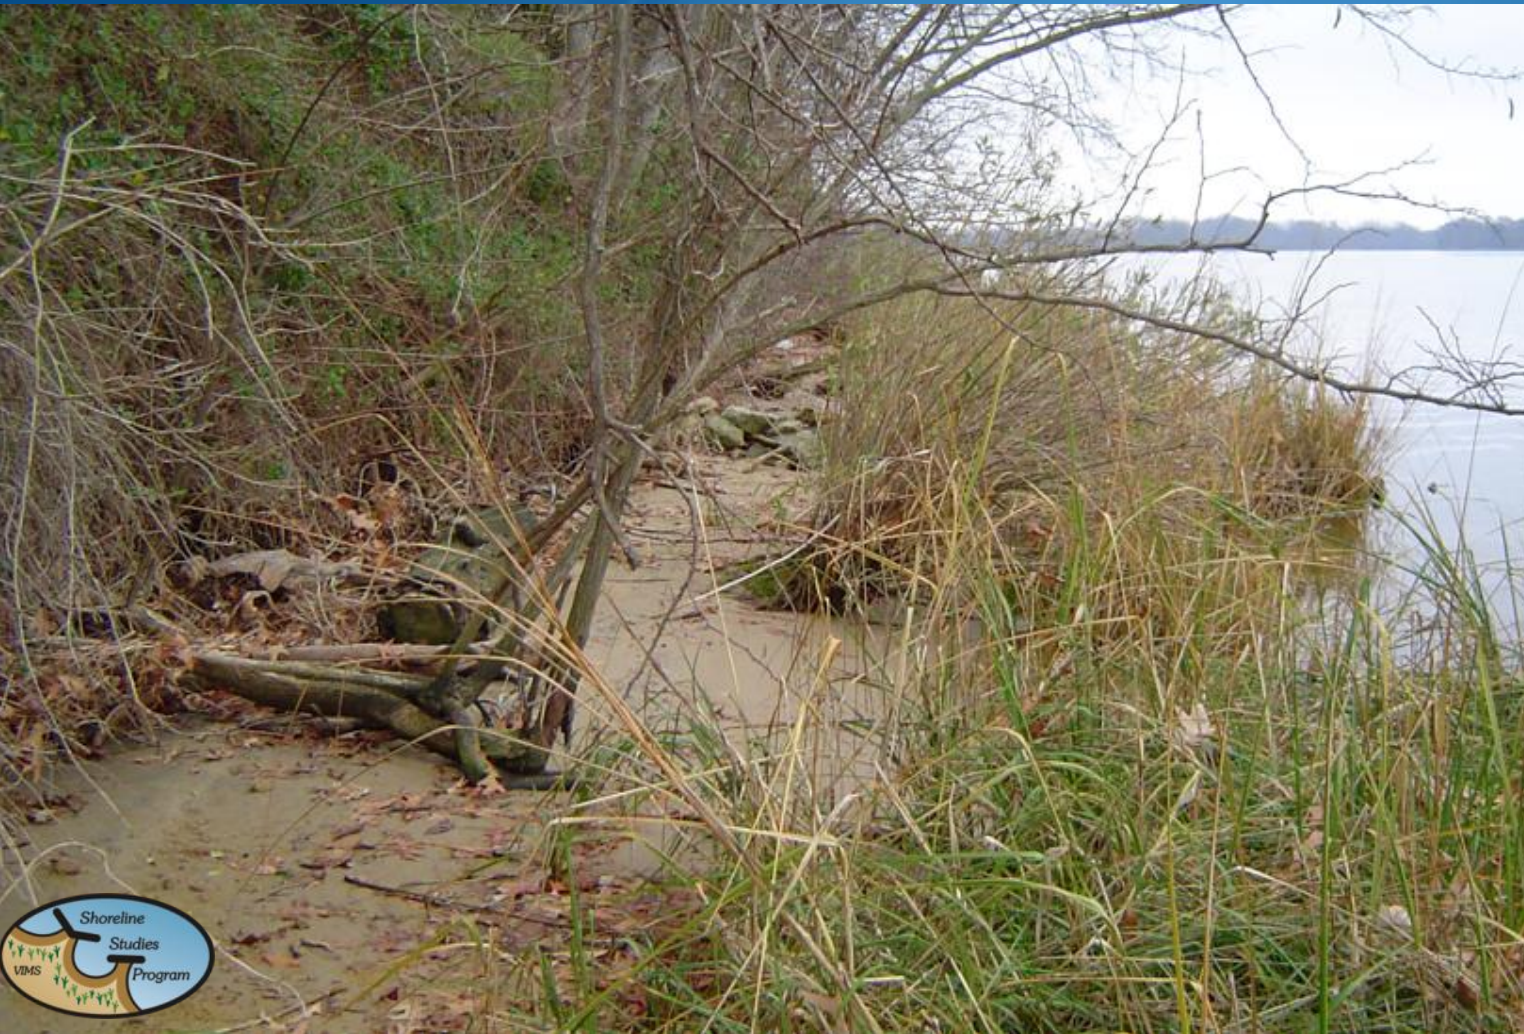
Wye Island South-Facing Shore

Loss of fill and shading by previously cut trees caused reduction in marsh fringe.

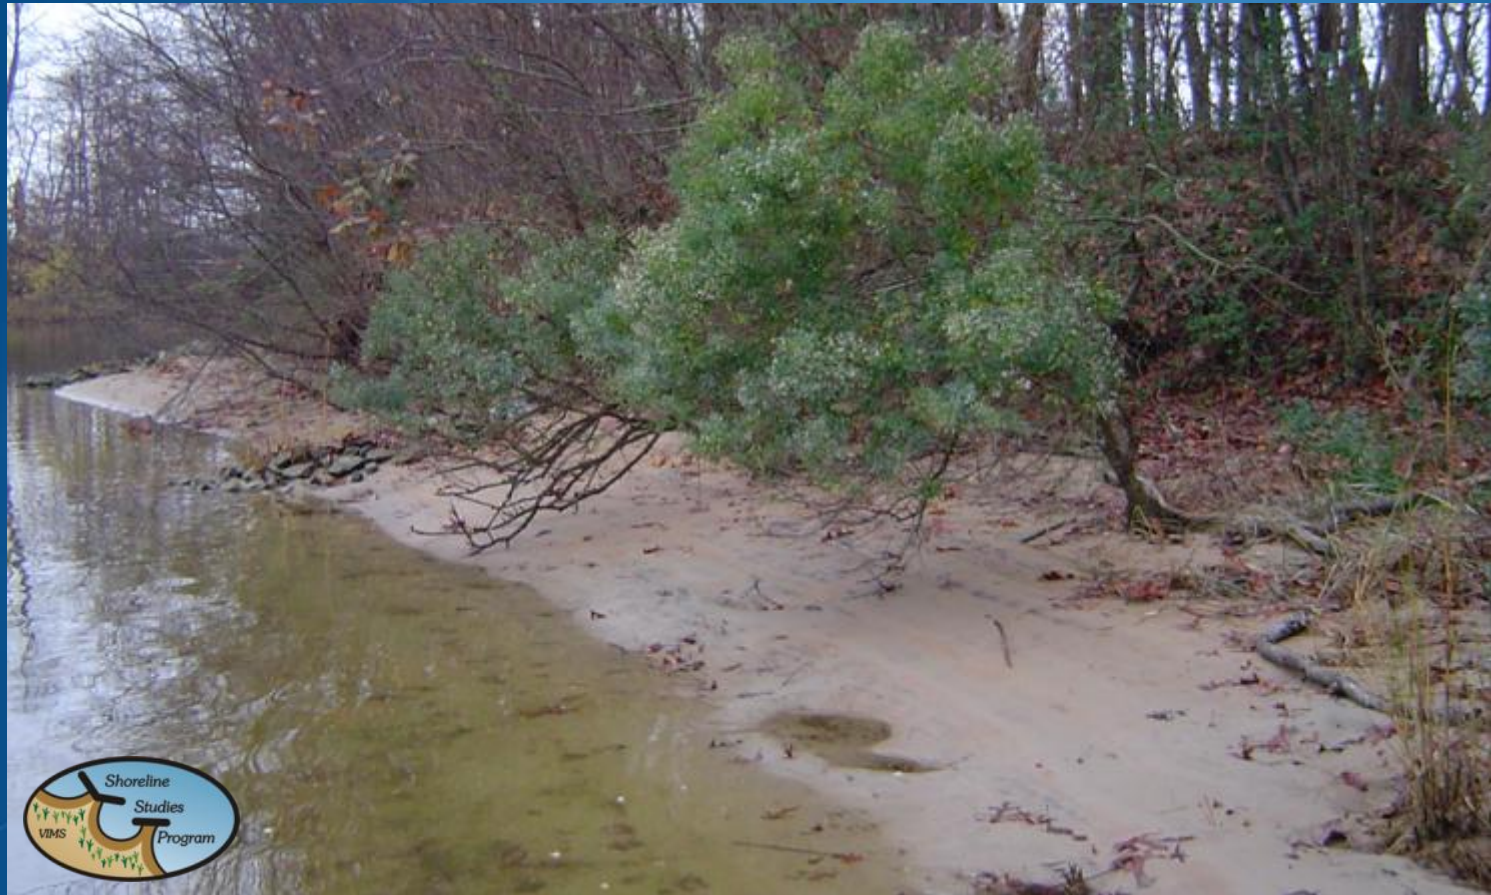
Wye Island North-facing Shore

21 years after construction
No marsh; too much shade?

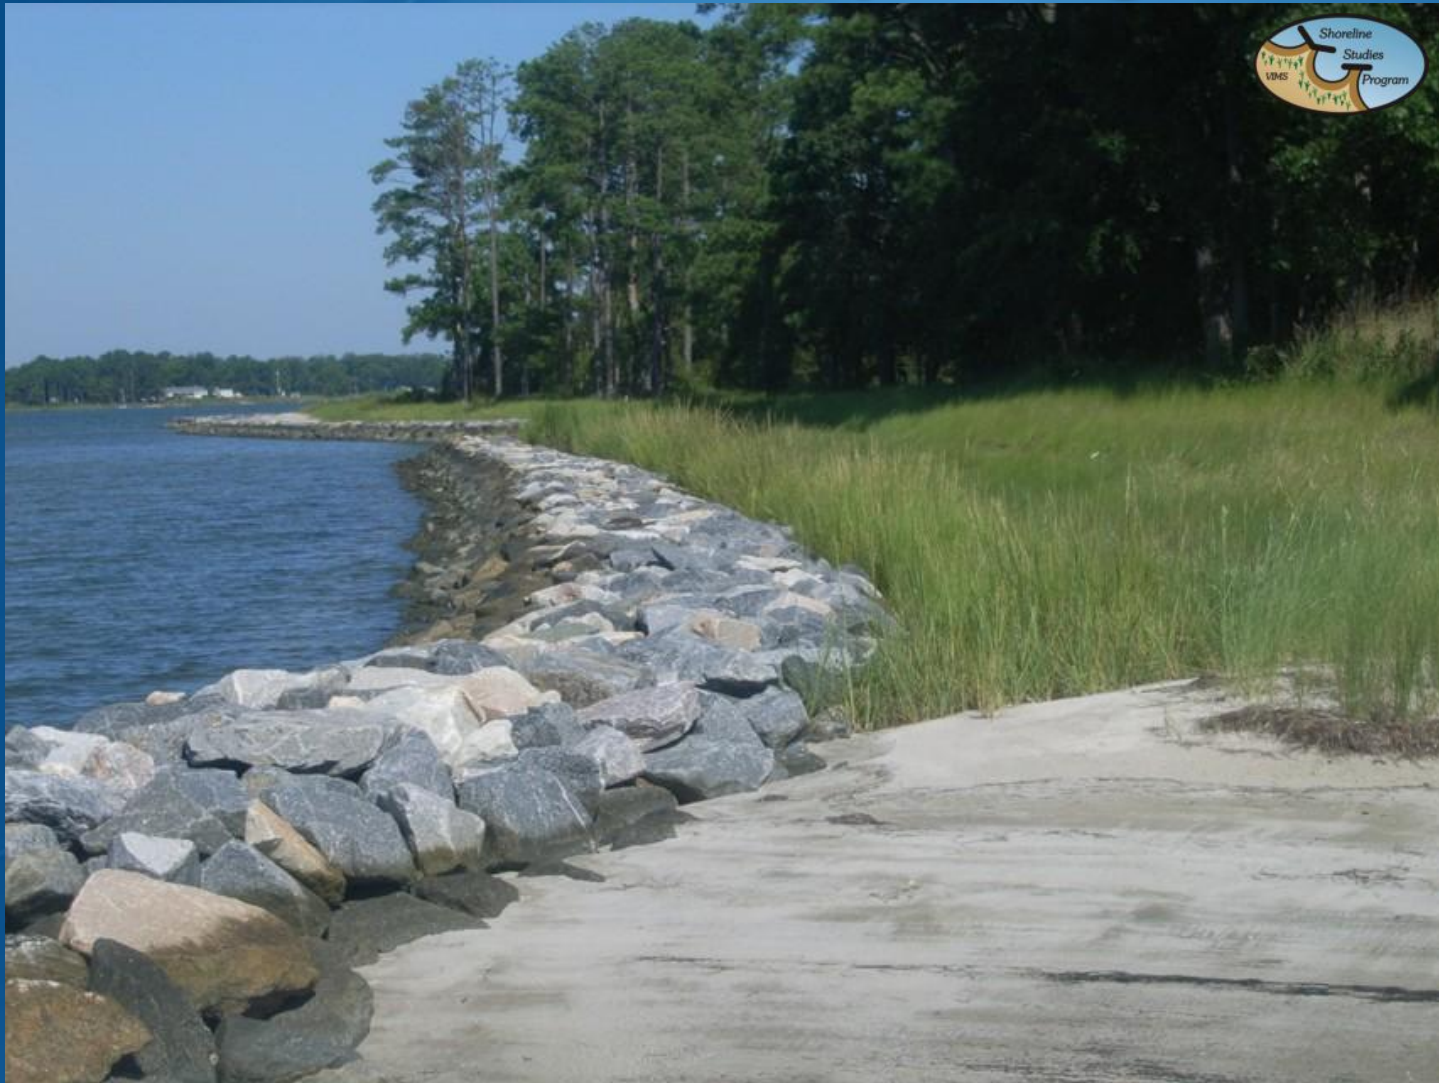
Mathews County, Virginia

Sill with marsh and pocket beach.

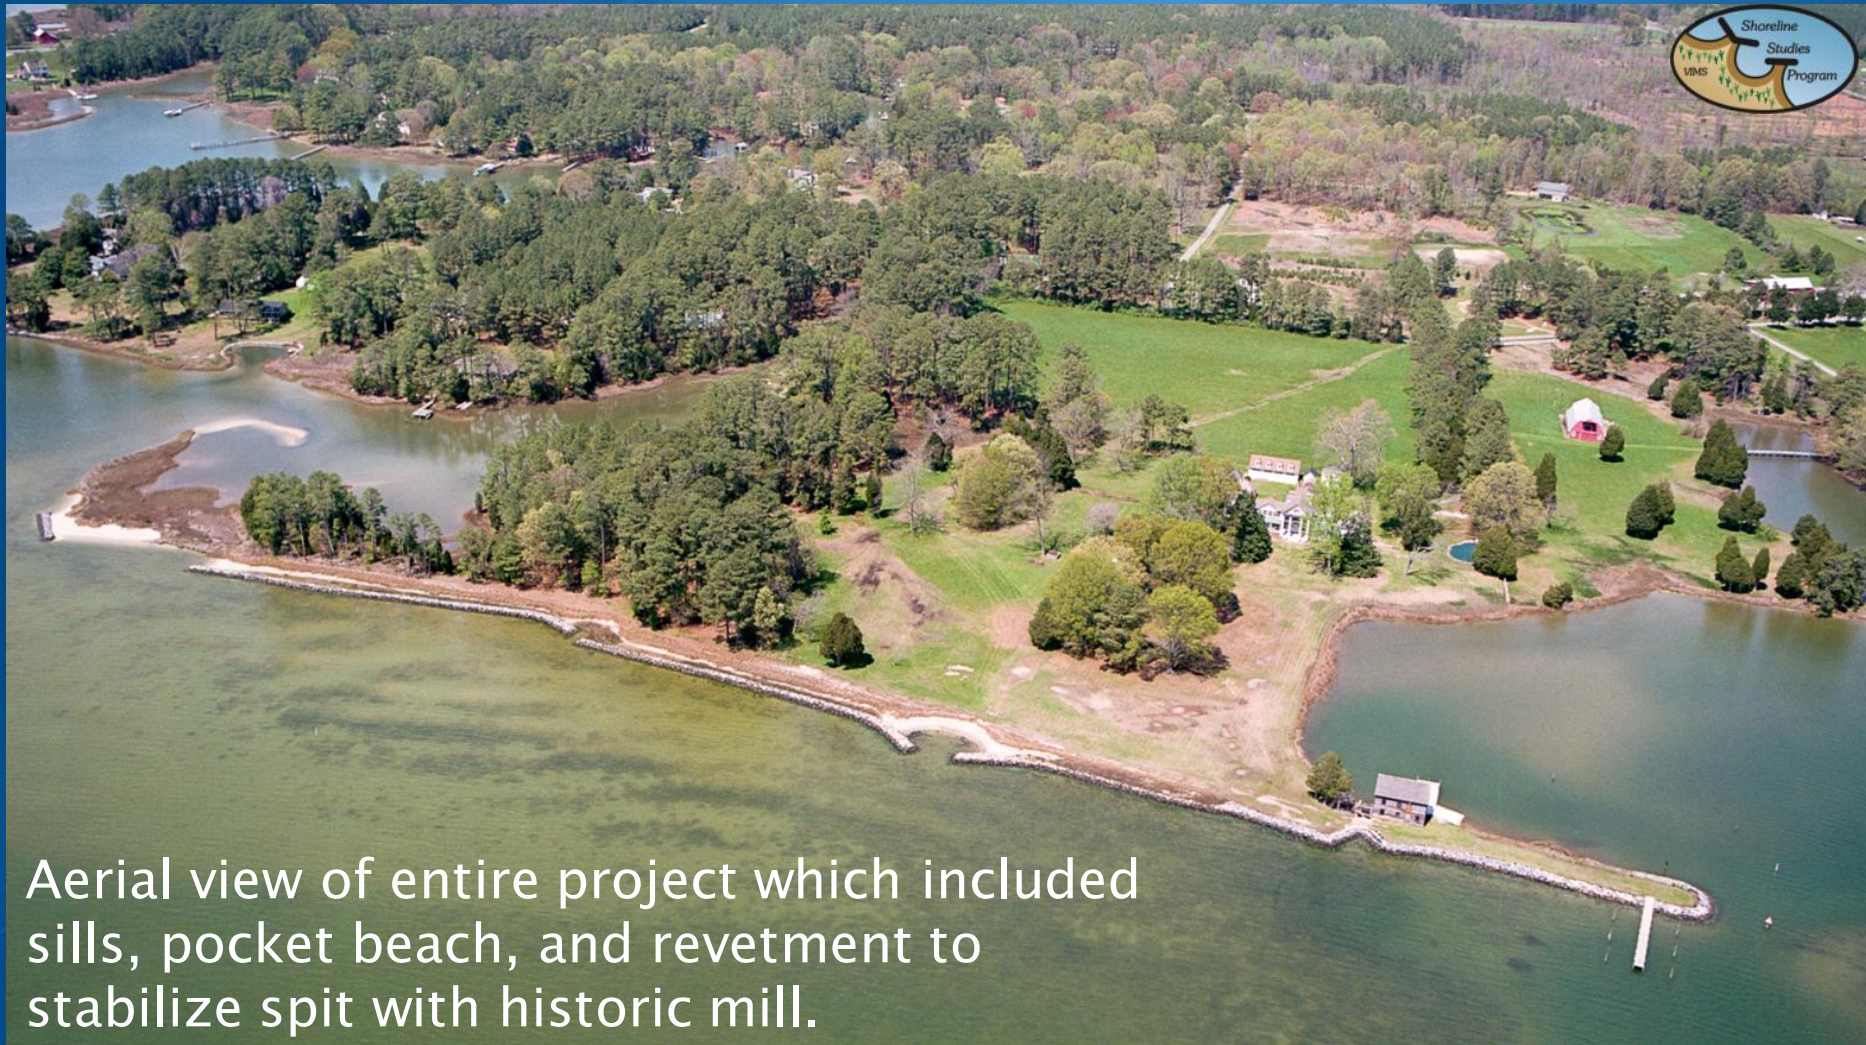
Mathews County, Virginia

Aerial view of entire project which included sills, pocket beach, and revetment to stabilize spit with historic mill.

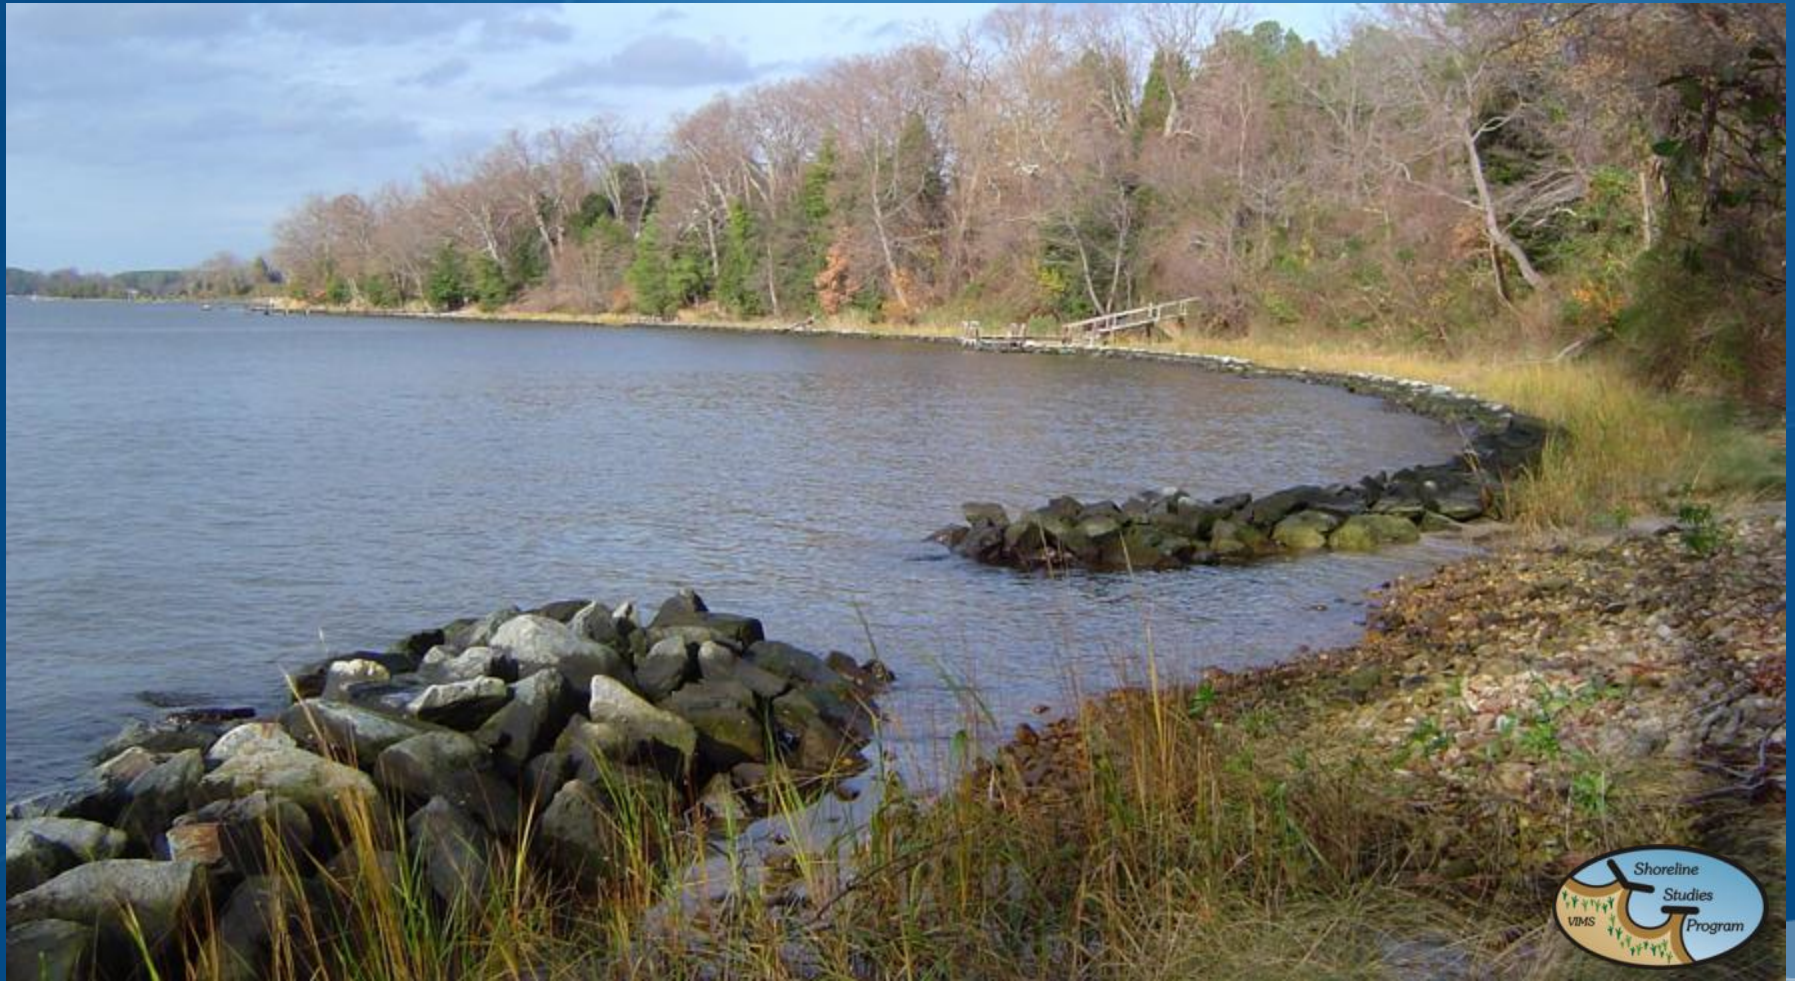
St. Mary's City Cobble in window to reduce scour

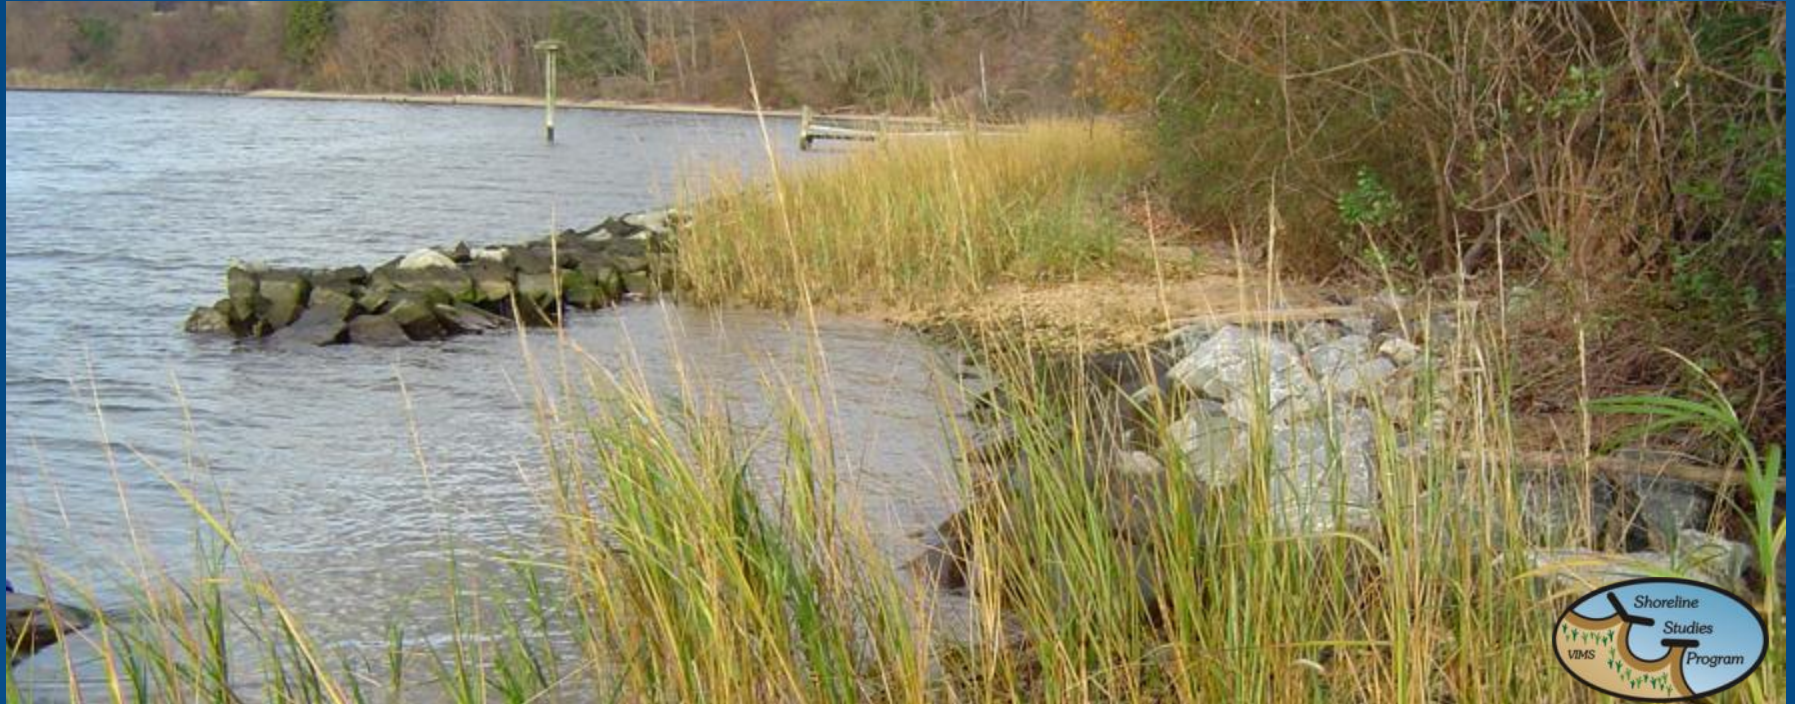
St. Mary's Sill

Small granite revetment in window
