Restoring Beaver Dam Creek

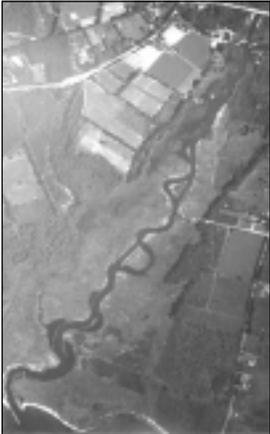
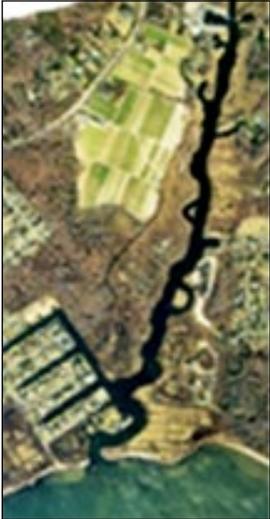
The original channel of Beaver Dam creek in 1938 when engineers began work to straighten its curves.

The same area today shows the channel was dredged and straightened mainly to accommodate boats going out into Great South Bay. Photo courtesy of Suffolk County Soil and Water Conservation

When Beaver Dam Creek was dredged in the 1920s and 1960s, the dredged materials were placed in the wetlands. Dikes constructed along the Creek prevented the tides from reaching the wetlands. As a result, habitat was lost for many important fish species including winter and summer flounder, striped bass, bluefish, blackfish (tautog) and forage fish species. Also lost was habitat for the many waterfowl, wading birds, and shorebirds that live and feed in wetlands.

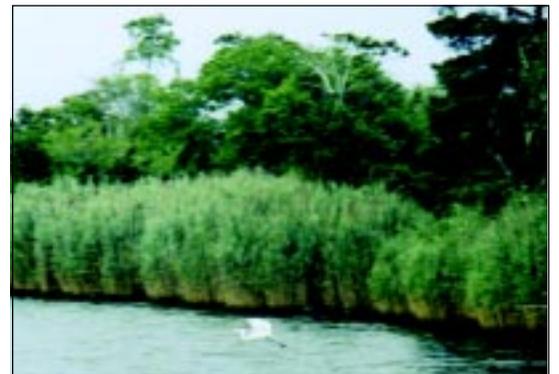
Restoration efforts will reduce the dominance of the common reed (*Phragmites australis*), found growing along the banks of Beaver Dam Creek. Photo by Barbara Branca

The emphasis of the actual restoration is removing the dredged spoils on the historical wetland areas, opening some of the dikes to allow regular tidal flow, and controlling invasive plant species, particularly common reed (*Phragmites australis*). These activities will allow for natural marsh functions to return, as well as the plants and animals dependent on wetlands. The work will be done on land owned by the Post-Morrow Foundation and the Suffolk County Parks, Recreation and Conservation Department. A small-scale project on a three-acre piece of Post-Morrow Foundation land has already been successfully restored. The goal is to restore more acres in the future.

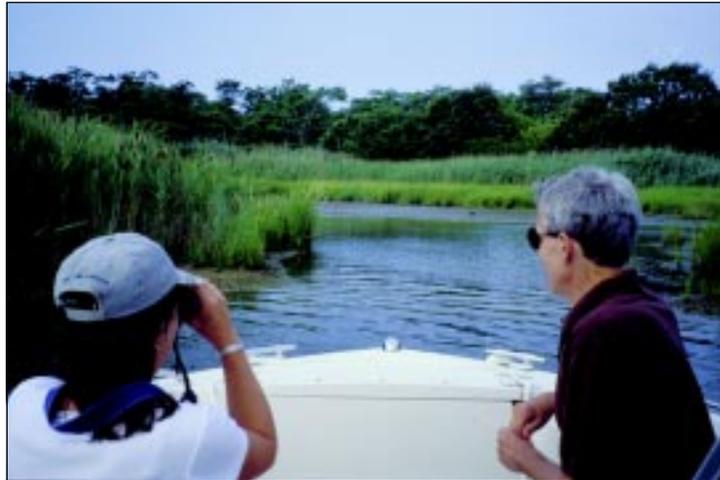
Cindy Patterson of Ducks Unlimited explains to Robert Kent how the common reed and dredged material were successfully removed from a three-acre site. Now in its place is smooth cordgrass (*Spartina*) that appears shorter and lighter green than the surrounding area. Boat courtesy of Joe Harder

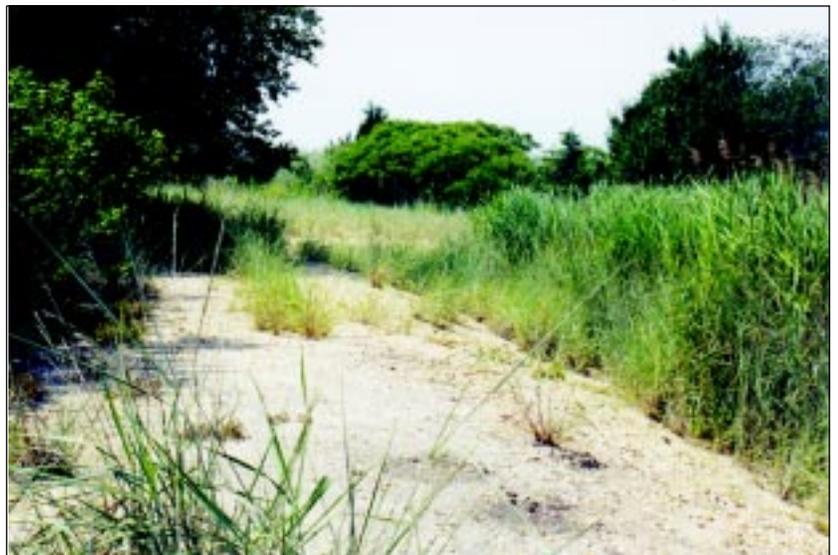
As the channel was straightened, dredged spoils were dumped into the wetlands, covering native vegetation and destroying fish and wildlife habitat.
