Vegetation Use in Coastal Ecosystems

INFORMATION BULLETIN 198

A Cornell Cooperative Extension Publication

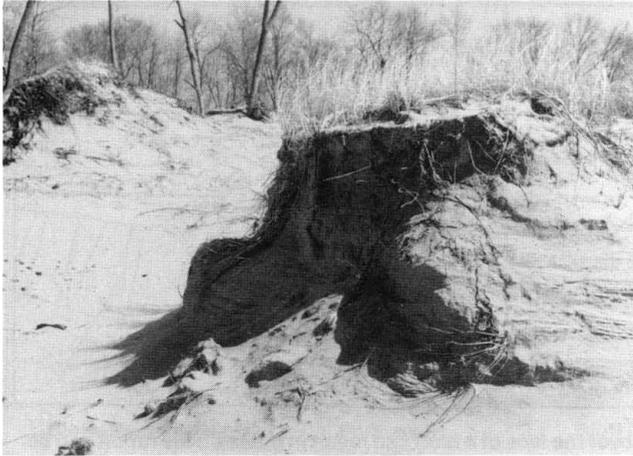
Figure 6. When the wind blows a hole in a dune, a blowout is formed. Storm waves may then cut a channel through to the land or bay behind, destroying property that had previously been naturally protected.

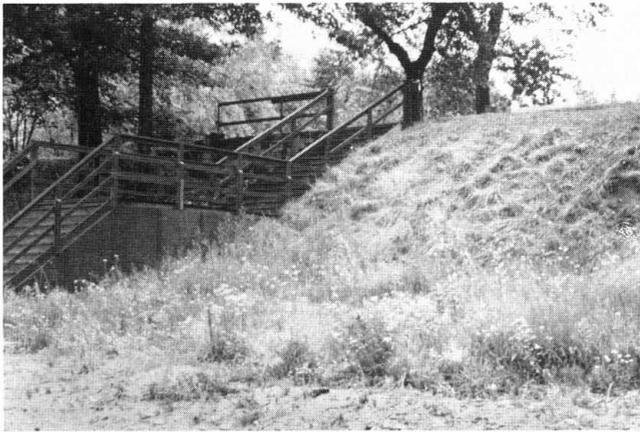
Figure 11. Pedestrian traffic on bluffs can destroy the natural vegetation, allowing the formation of gullies. Instead of surface pathways, wooden stairs should be constructed for access up and down the bluff.

Narrow pathways on bluffs, where the natural vegetation has been trampled and killed, can become deep gullies, cut by runoff from above. Such gullies may enlarge very rapidly. Instead of surface pathways, wooden stairs should be constructed for access up and down the bluff. These stairs should be at least 12 inches above the soil surface. Slats should be spaced at least $\frac{1}{4}$ inch apart to allow light penetration to the soil underneath (fig. 11). Some plants such as Virginia creeper can get enough room and light to establish themselves and thus help prevent erosion under the stairs.

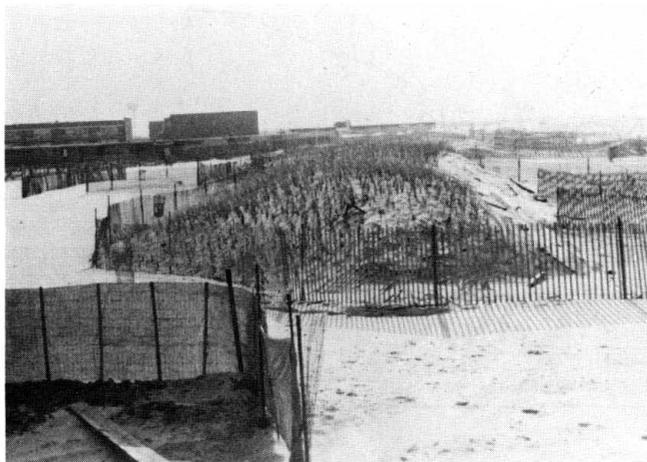
Figure 17. The “new” dunes were fenced to reduce the amount of foot traffic and planted with beachgrass.

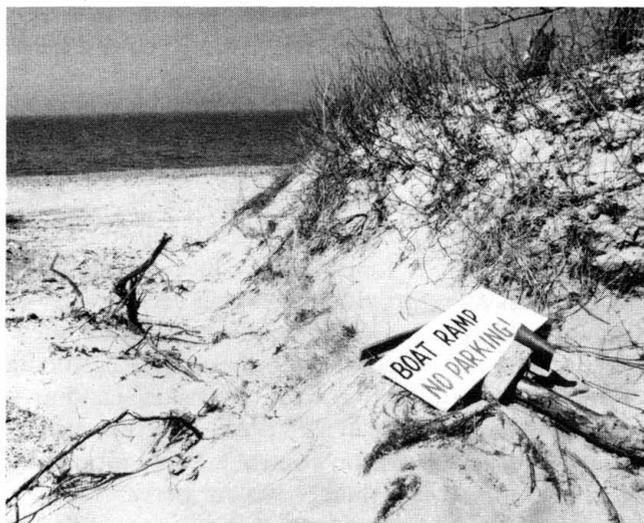
Figure 20. The beach and dunes at Deer Creek had already been severely degraded by past sand-mining operations, the use of the area as a recreational vehicle park, and wind erosion.

The beach and dunes had already been severely degraded by past sand-mining operations, the use of the area as a recreational vehicle park, and wind erosion (fig. 20). The Deer Creek dunes are open to westerly winds blowing over a fetch of up to 141 miles, at speeds sometimes exceeding 40 miles per hour. Periodic episodic erosion along the eastern Ontario dune system has reached

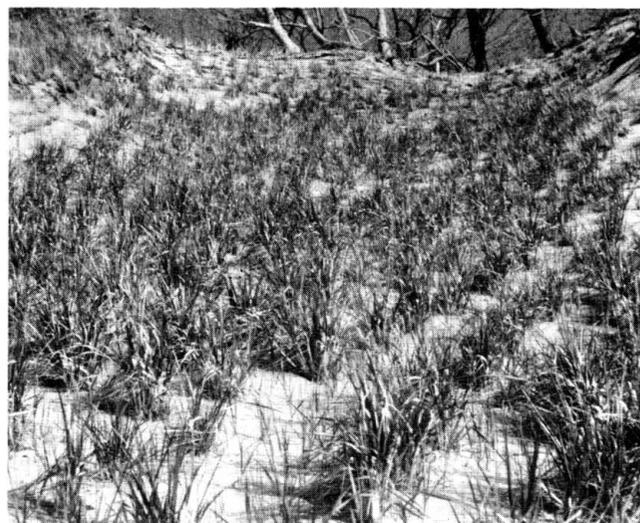
Figure 21. A 6,000-square-foot blowout on the lakeward side of the backdune was planted with Cape variety, with an 18-inch spacing.

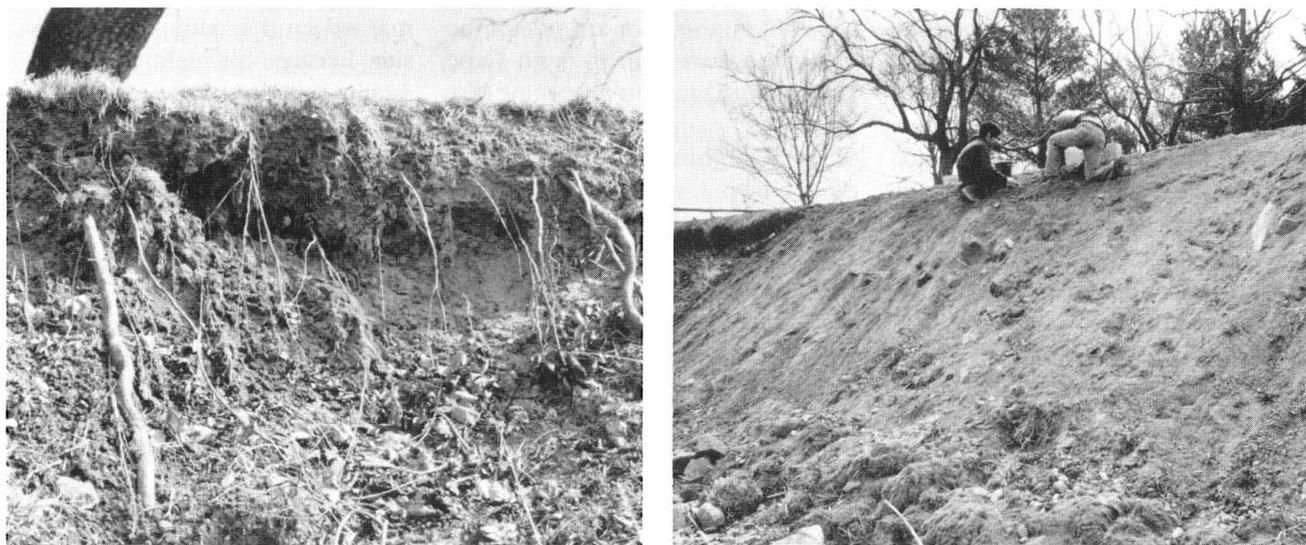
Figure 22. The B. Forman Park Demonstration Project involved smoothing a steep, moderately eroding coastal bluff to a gentler slope and planting that slope with a variety of deep-rooted conservation vegetation.

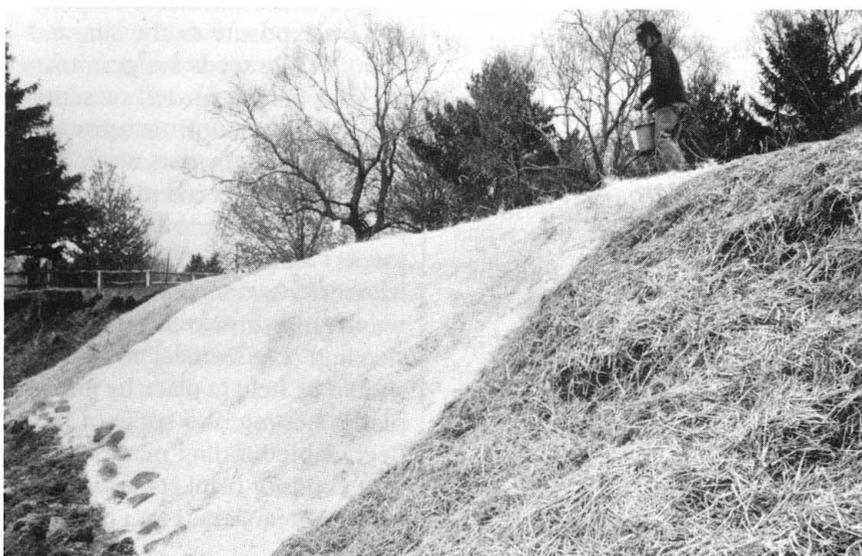
Figure 23. Straw, held in place by jute and plastic netting (left), and excelsior blanket mulch (right) were critical in protecting the seed, transplants, and soil against the elements.

The project team was concerned that a bare, regraded slope just seeded or planted with transplants could be particularly susceptible to surface erosion by wind and rain. Soil moisture could also be rapidly lost by exposure to the sun and wind, threatening the survival of both seeds and transplants. The team decided that it was critical to mulch the plots to protect the seed, transplants, and soil against the elements. The demonstration project used straw and excelsior blanket mulch, held in place by jute and plastic netting, on different test plots (fig. 23).

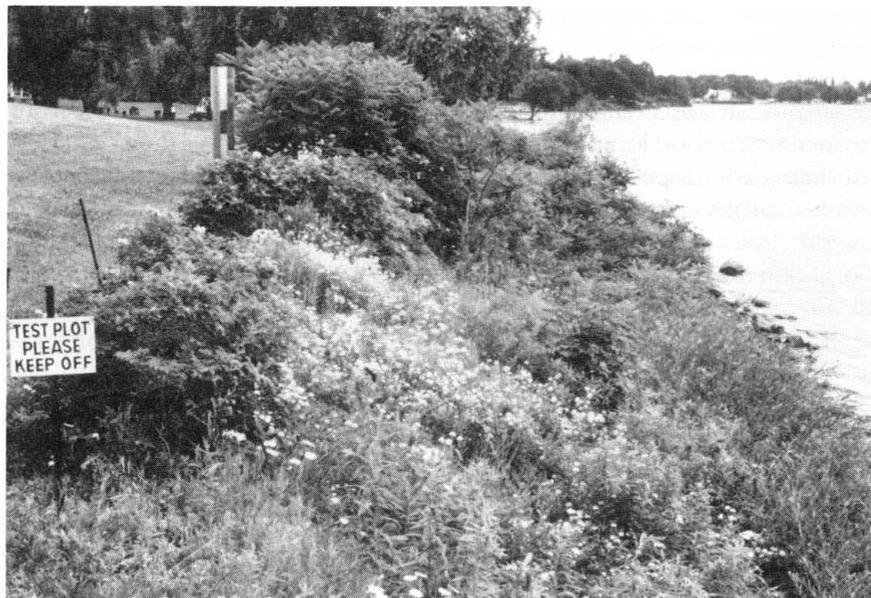
Figure 24. The project's buffer strip is now dense enough to discourage foot traffic over the bluff; the crownvetch/flatpea cover on the face of the slope has choked out all but the most vigorously growing sumac and bamboo grass.
