Nature-Based Shoreline Workshop *Sustainable Beaches*

Charles Shabica, Ph.D., P.G.

Shabica & Associates
Sustainable Coastal Solutions

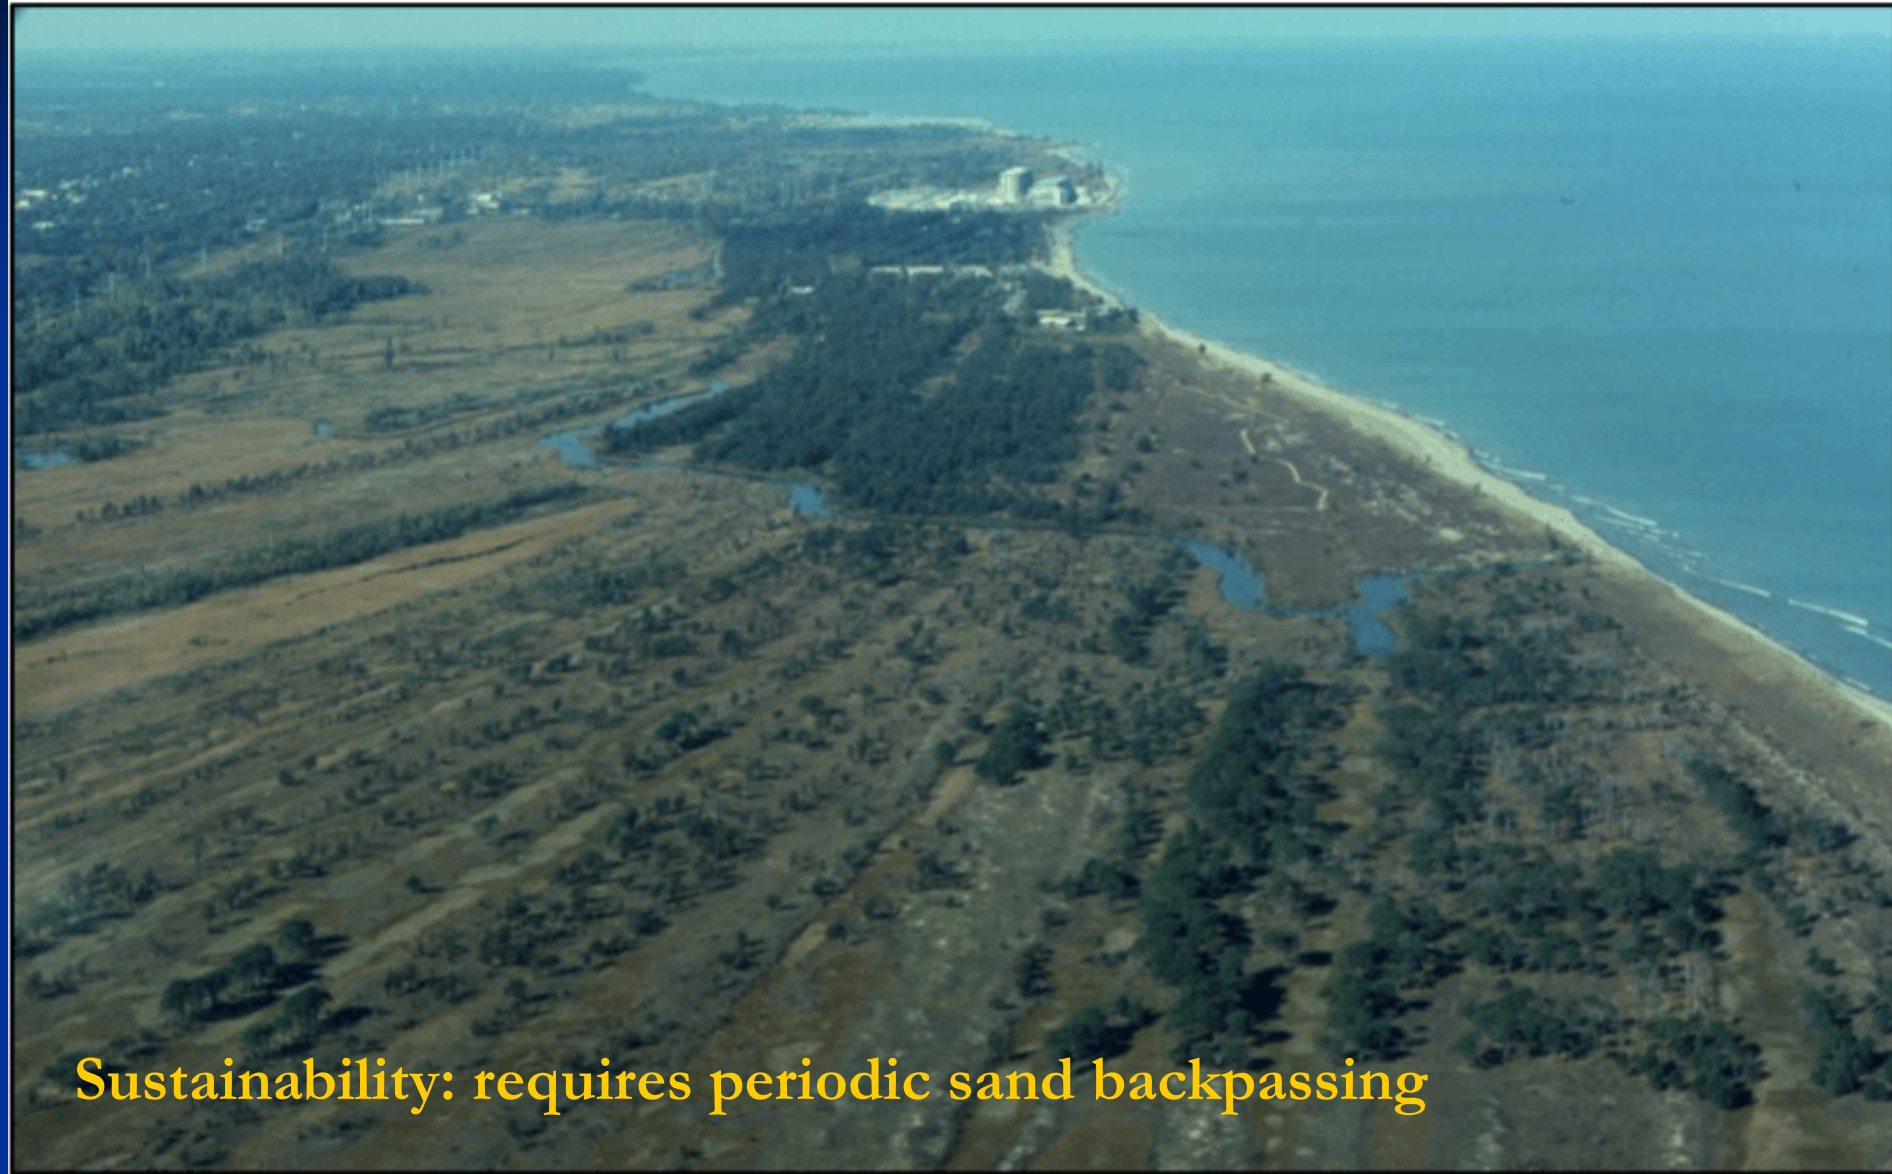
Sandy Coast: Illinois Beach Park, Lake Michigan. Problem: Diminished sand supply updrift, sand chokes Waukegan Harbor downdrift

Sustainability: requires periodic sand backpassing

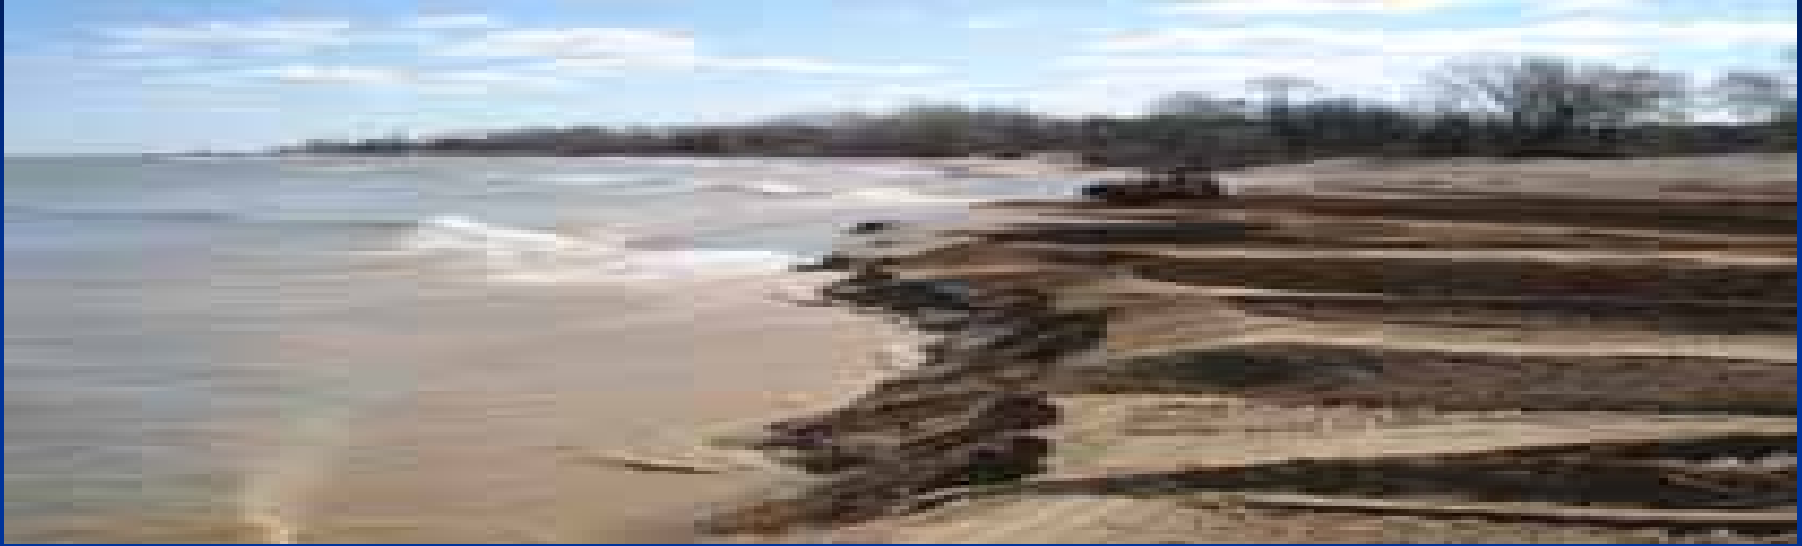
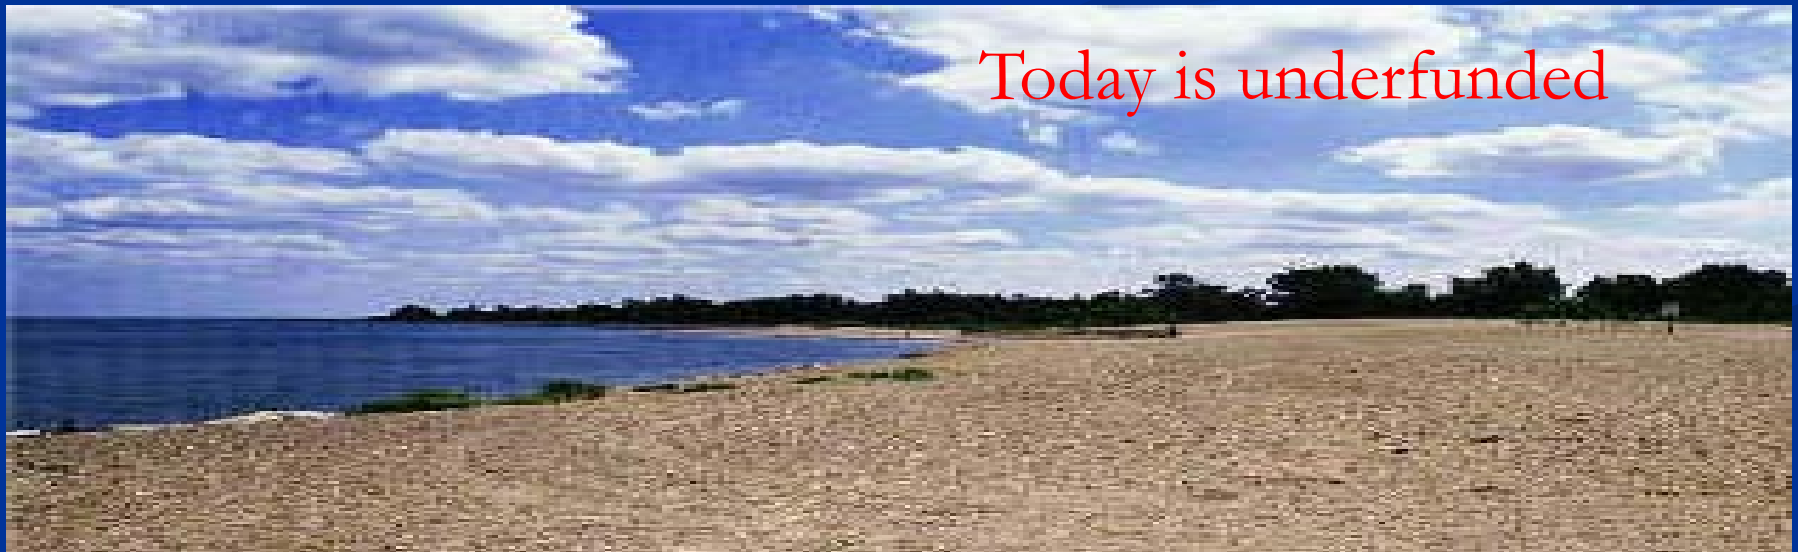
Beach nourishment or sand backpassing has worked in the past for Illinois Beach State Park

Today is underfunded

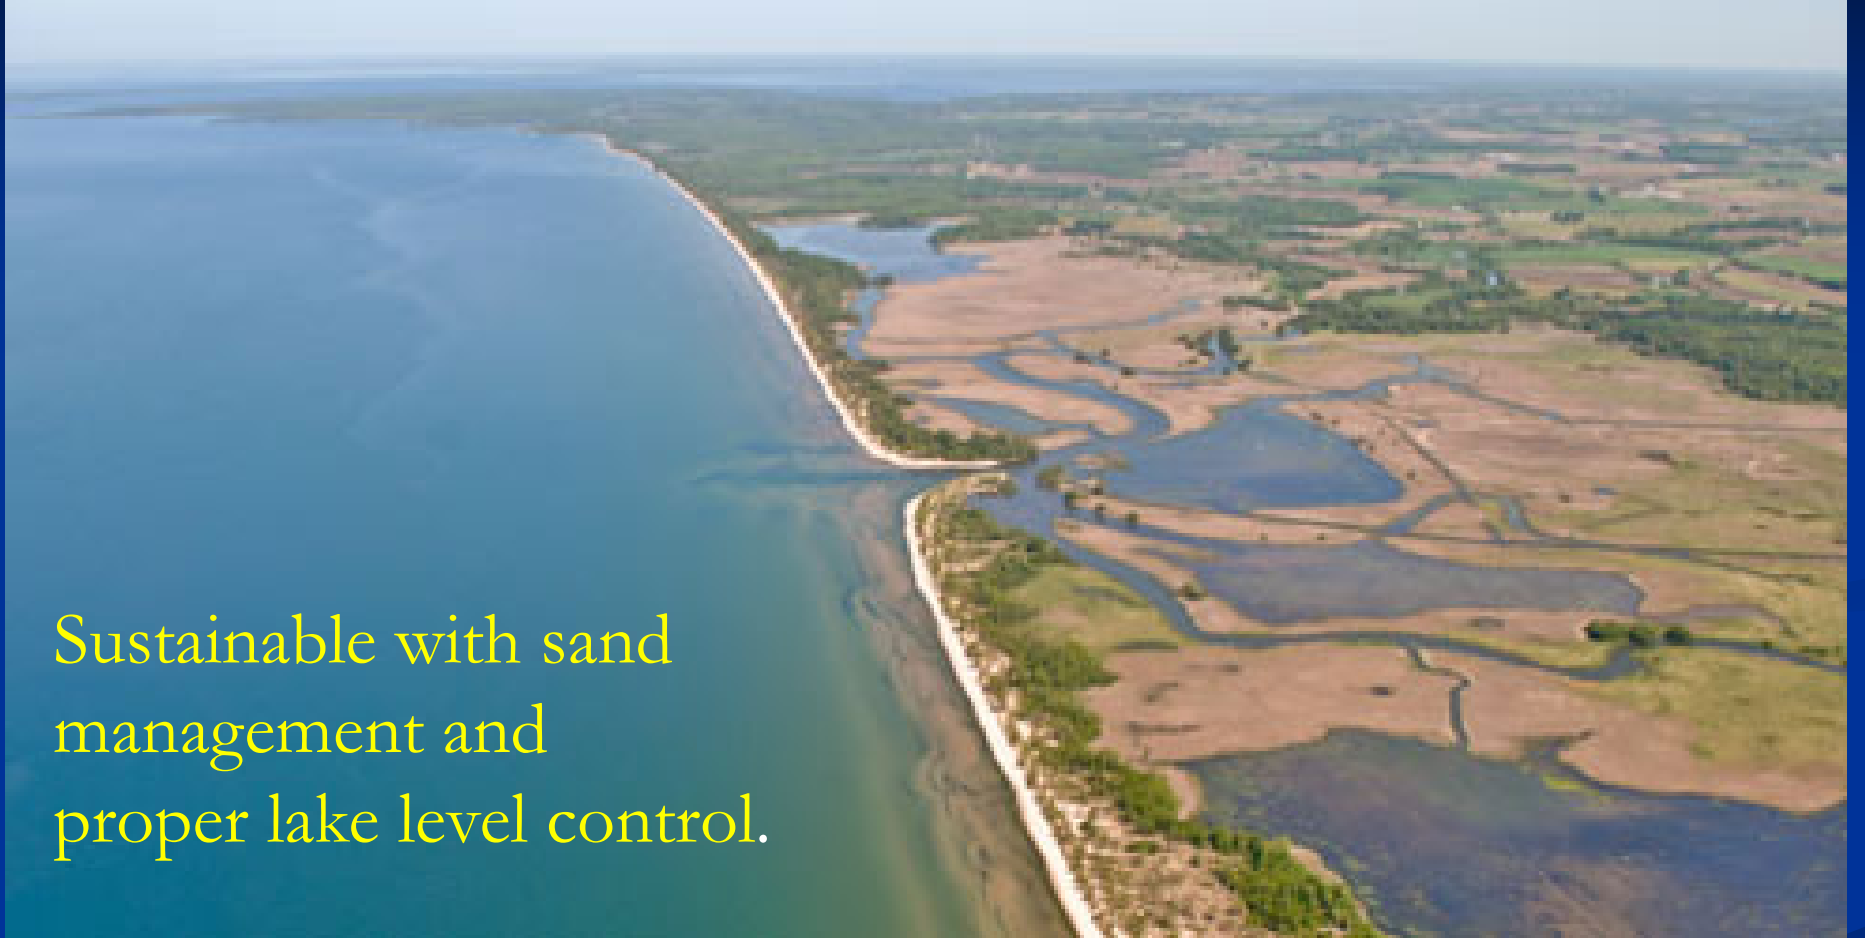
Sandy Coast: Lakeview Wildlife Mgmt. Area, NY Lake Ontario: Naturally Eroding coastal sand plains and wetlands. Problems?

Sustainable with sand
management and
proper lake level control.

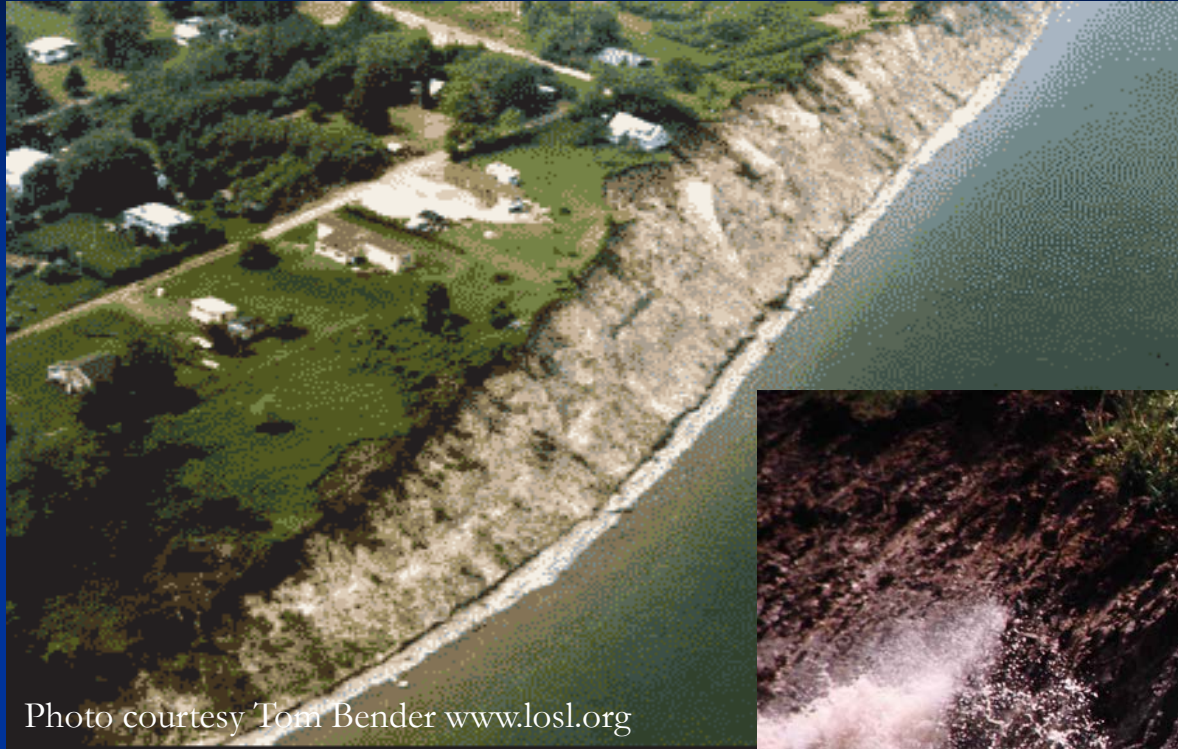
Natural Eroding Bluffs and Ephemeral Beaches. Southern shores of Lakes Michigan, Erie and Ontario

Narrow beaches at
low lake levels

No beach at high
lake levels

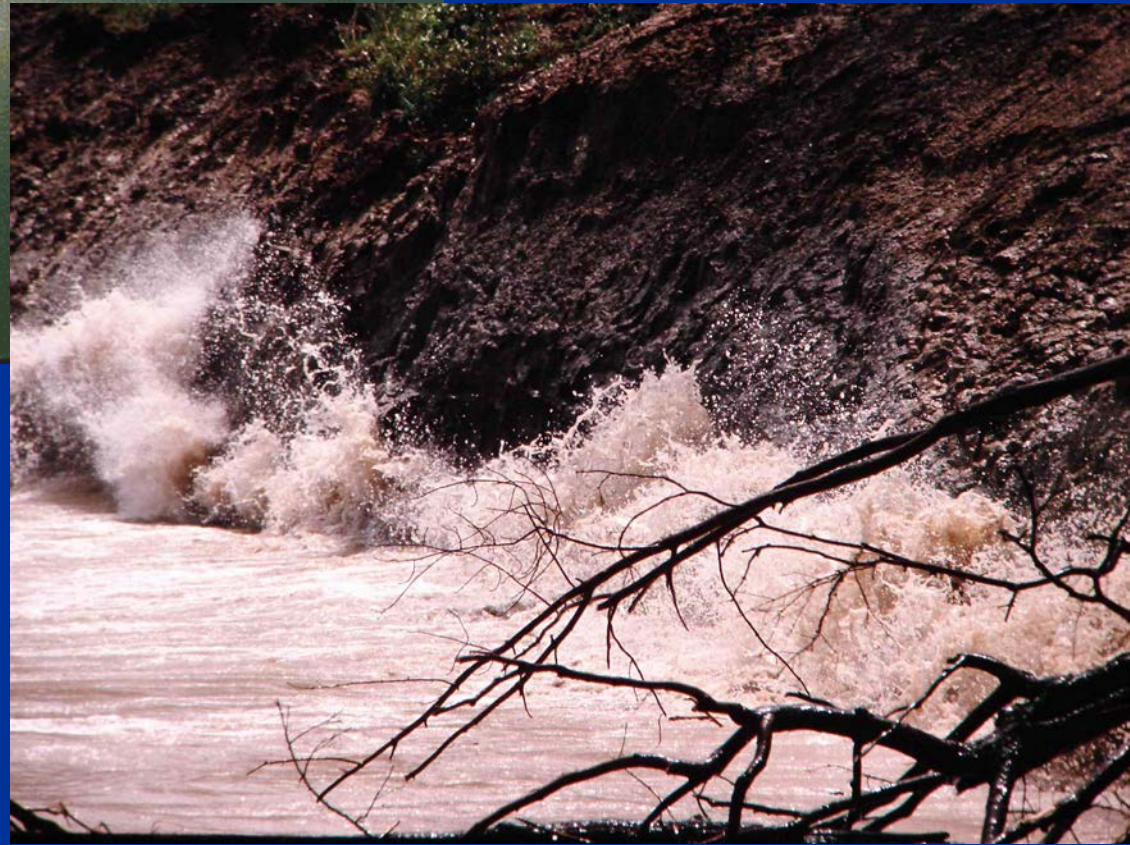
Eroding Cohesive Clay Bluffs and Ephemeral Beaches.

Loss of Natural Sand Beaches: Armoring bluffs to protect real estate, building dams on rivers and building jetties to protect harbors, all have reduced the sand supply to the system (*sand starvation*). Today, natural beaches are rare in Great Lakes urban areas.

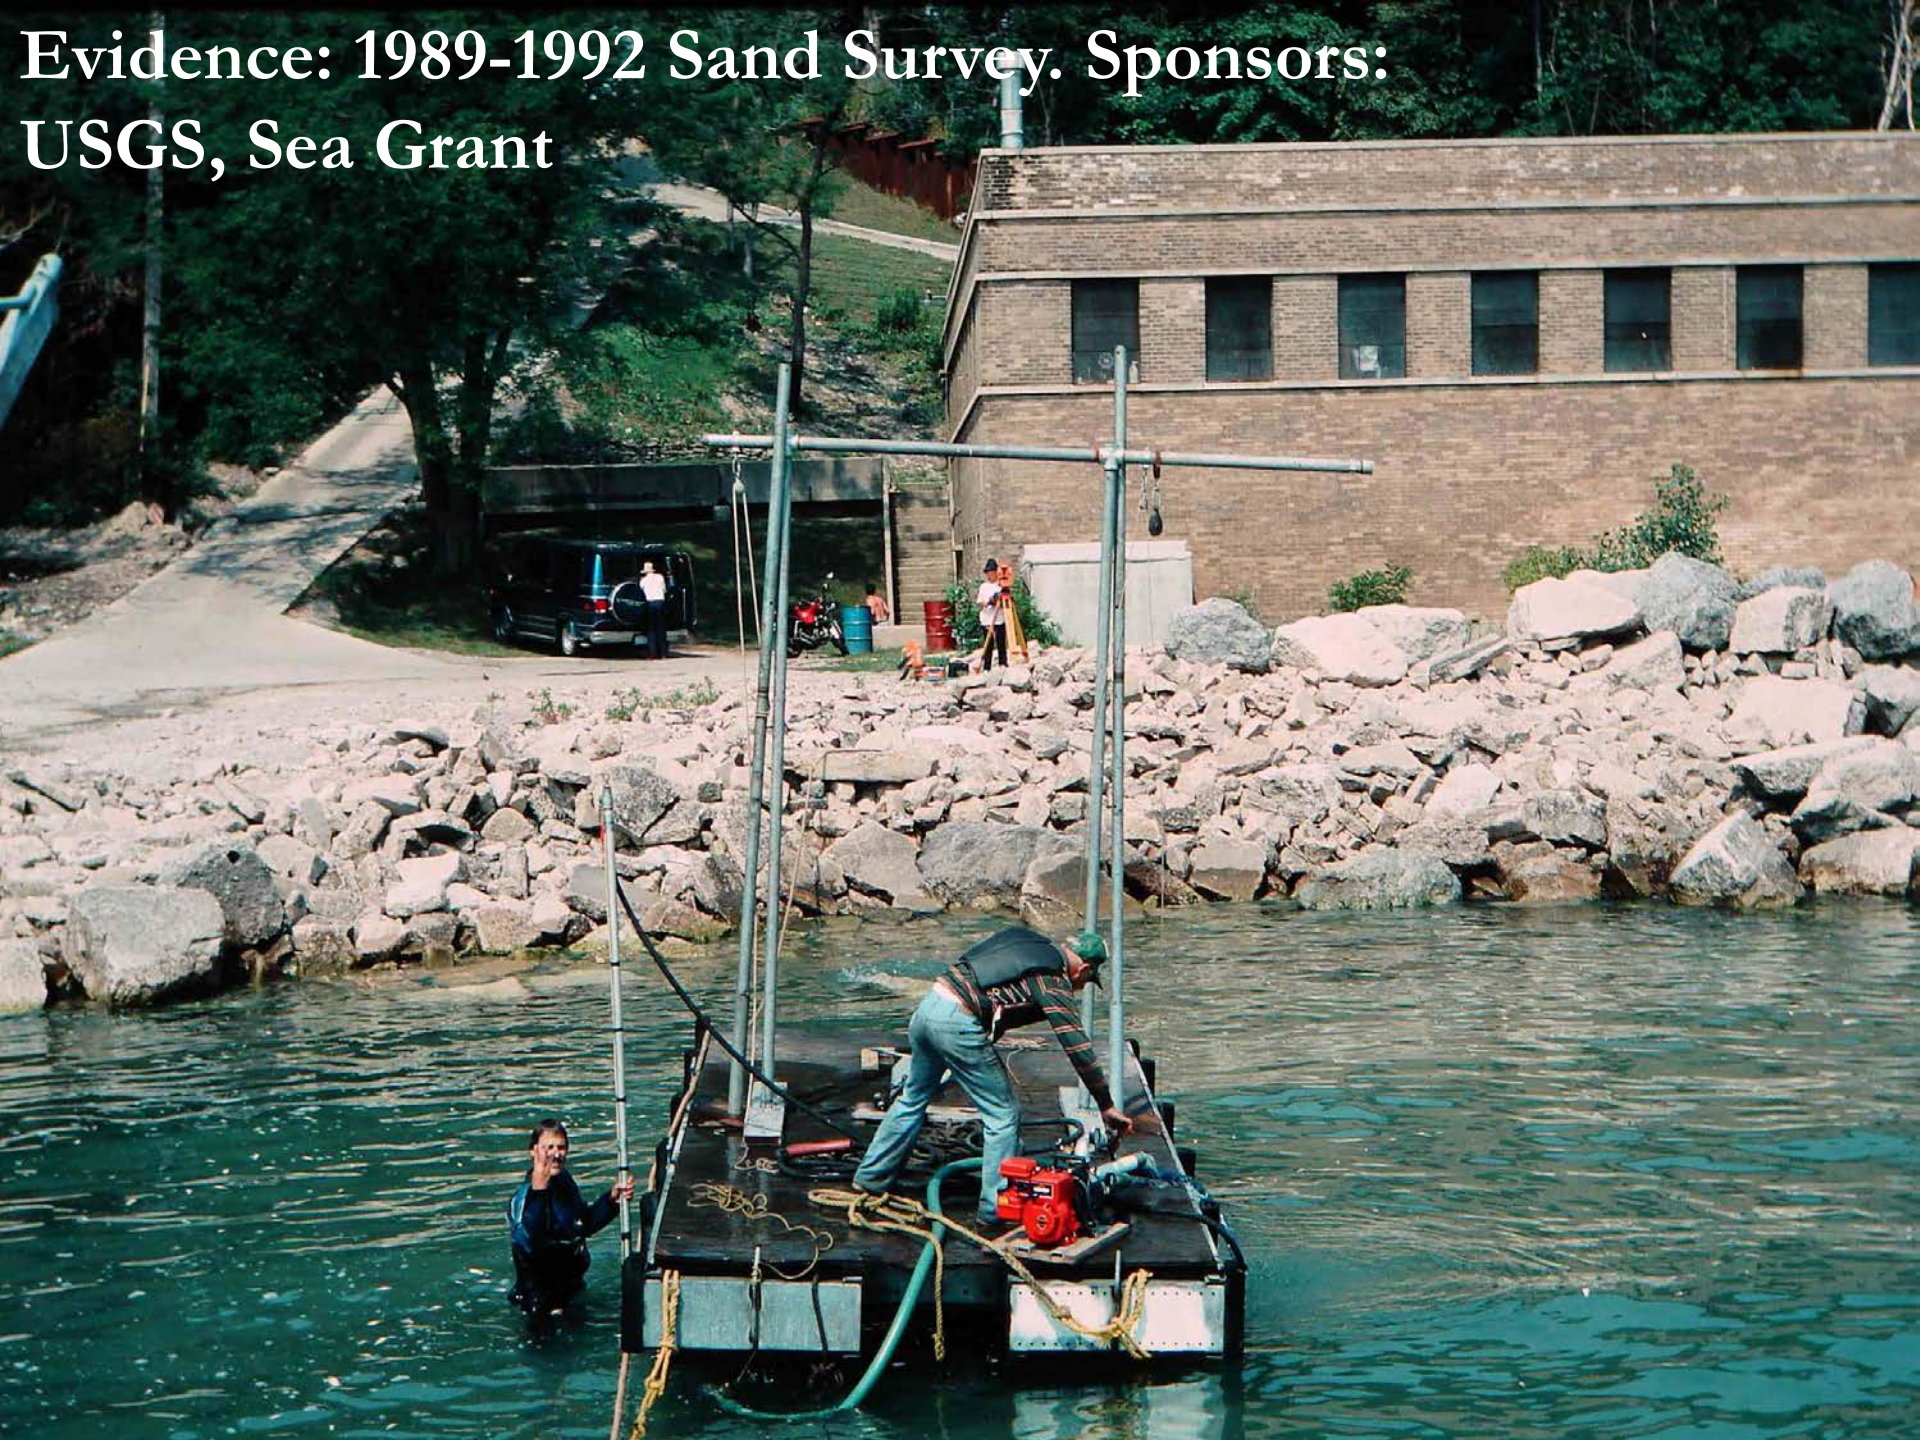
Evidence: 1989-1992 Sand Survey. Sponsors:
USGS, Sea Grant

The nearshore lakebed is eroding clay. Thin sand deposits

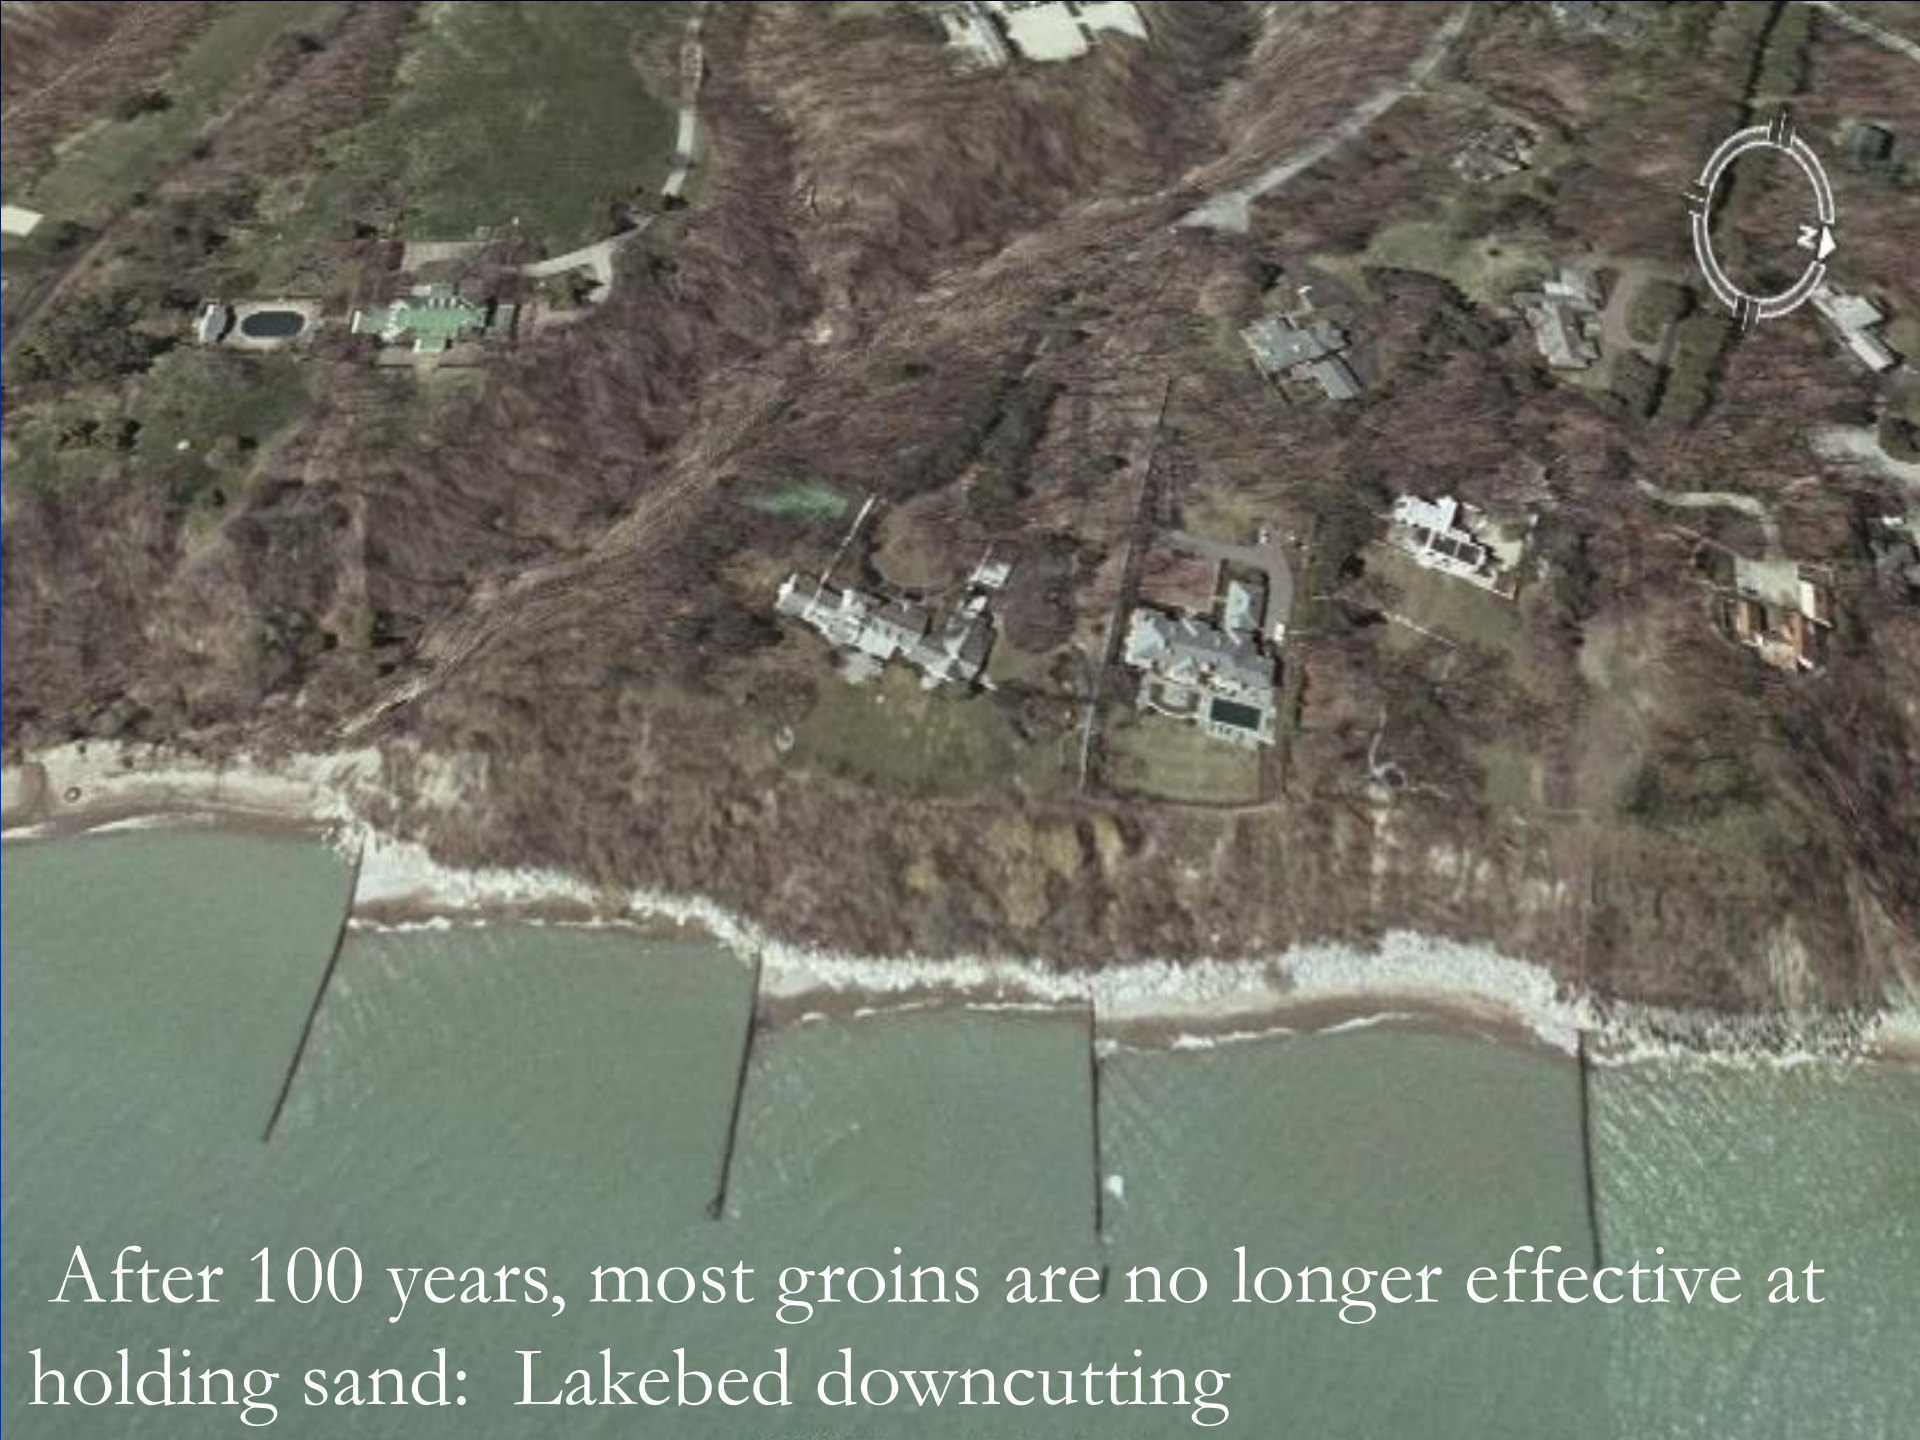
After 100 years, most groins are no longer effective at holding sand: Lakebed downcutting

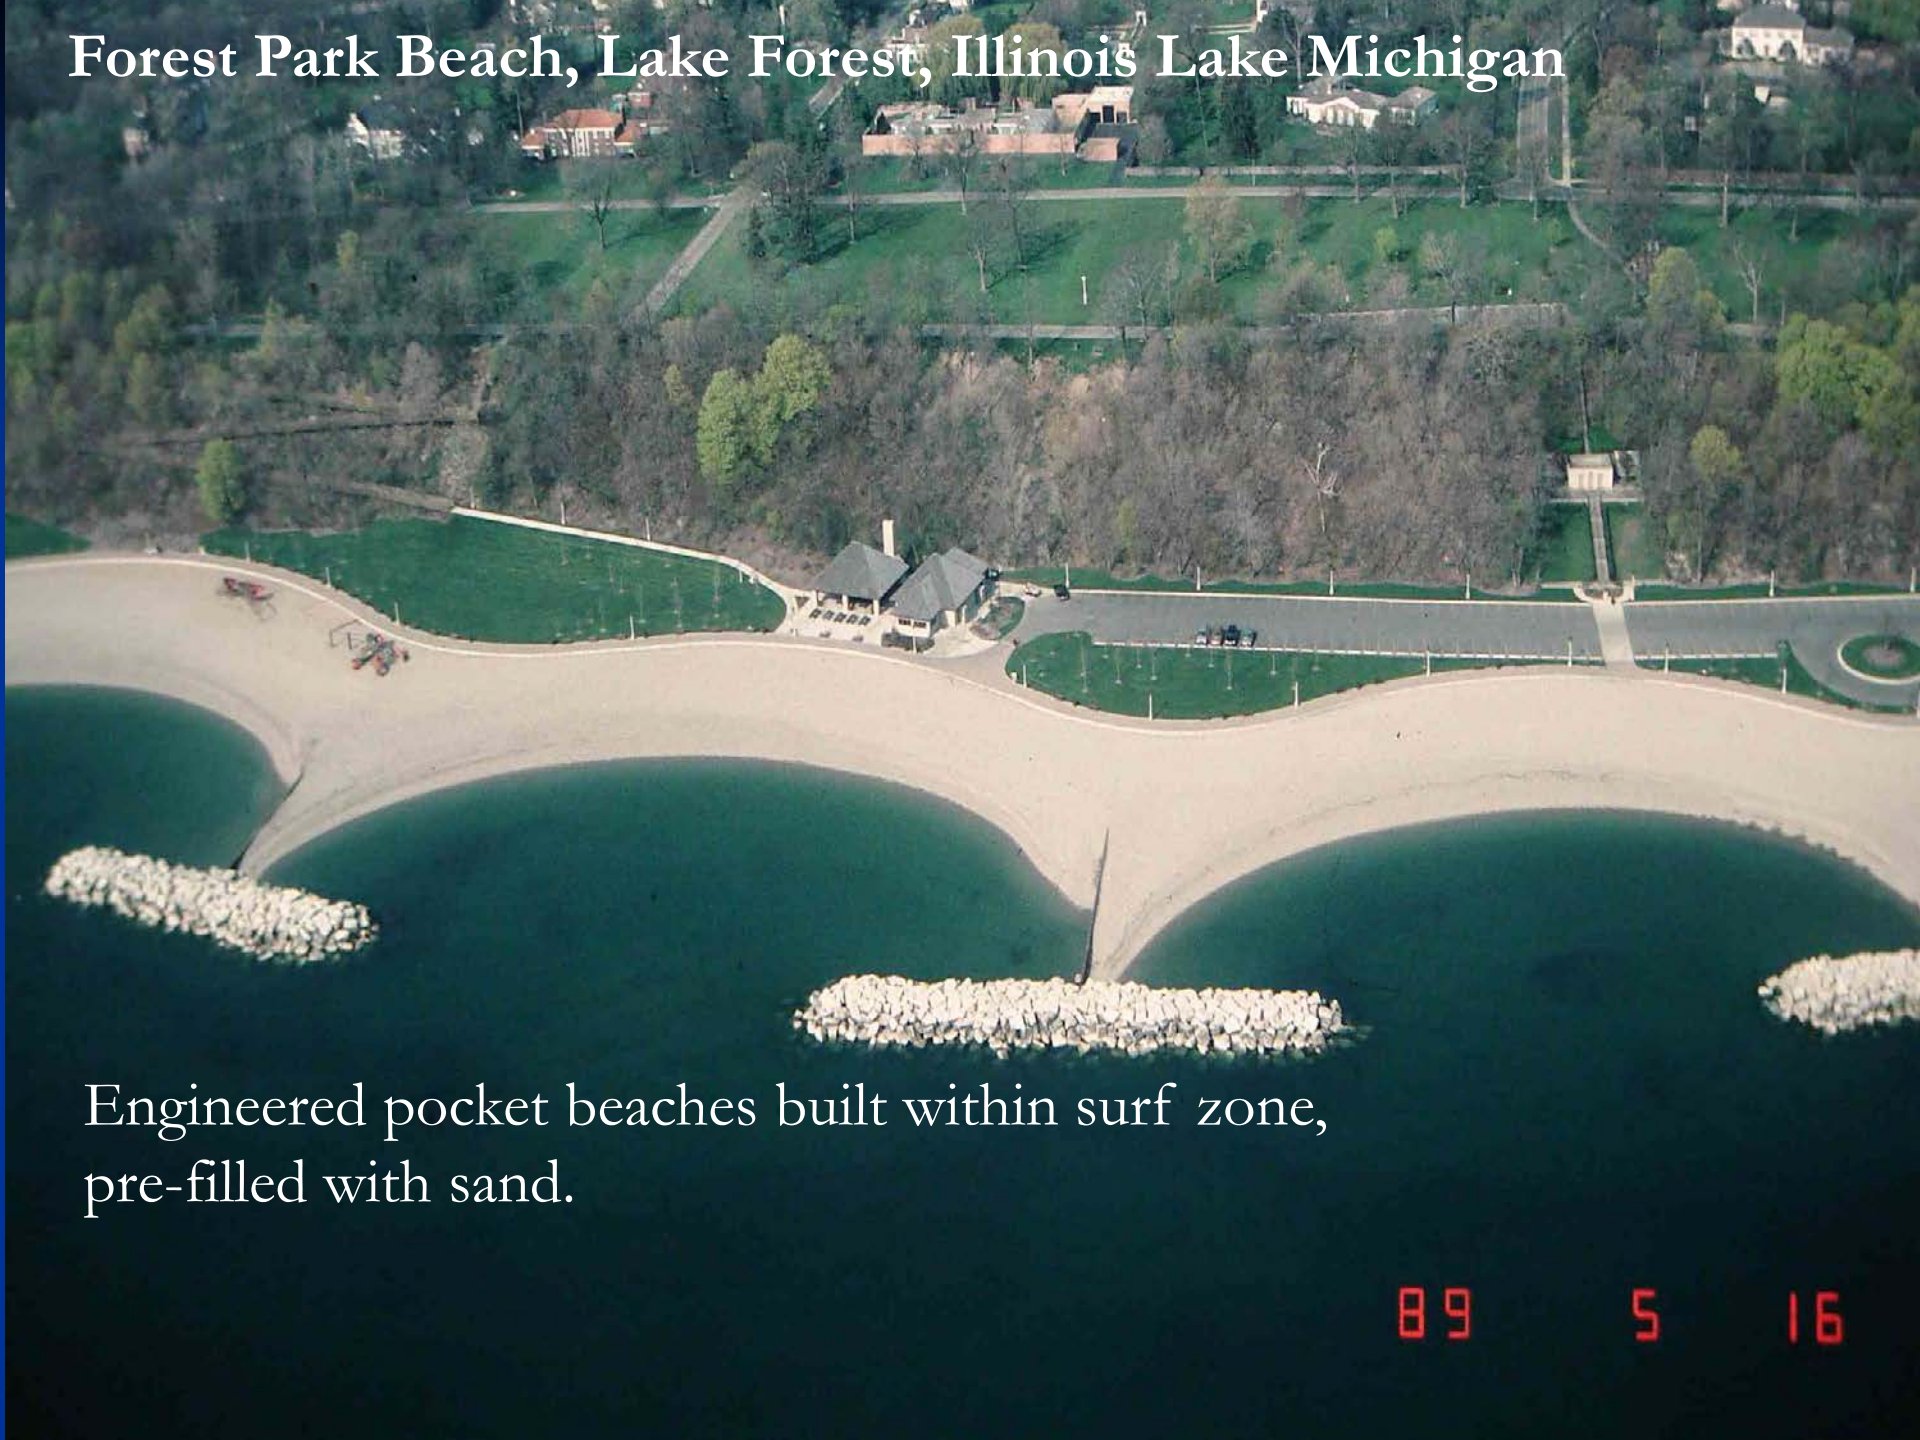
Forest Park Beach, Lake Forest, Illinois Lake Michigan

Engineered pocket beaches built within surf zone,
pre-filled with sand.

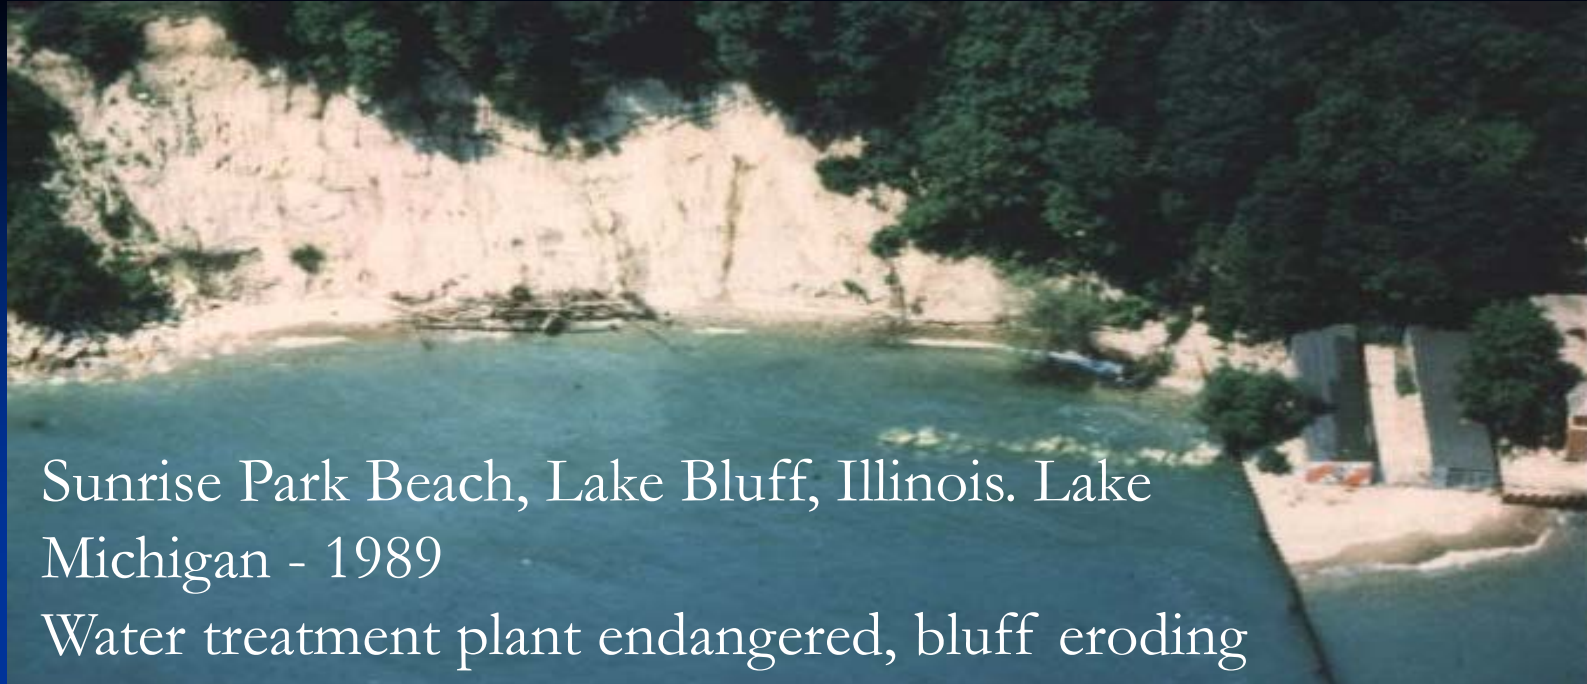
Sunrise Park Beach, Lake Bluff, Illinois. Lake Michigan - 1989
Water treatment plant endangered, bluff eroding

New Pocket Beach 1992

Sunrise Park Beach named ASBPA Top Restored Beach 2012

20+ years of monitoring - requires
approx. 2% new sand annually

Bluff Stabilized with
native plants

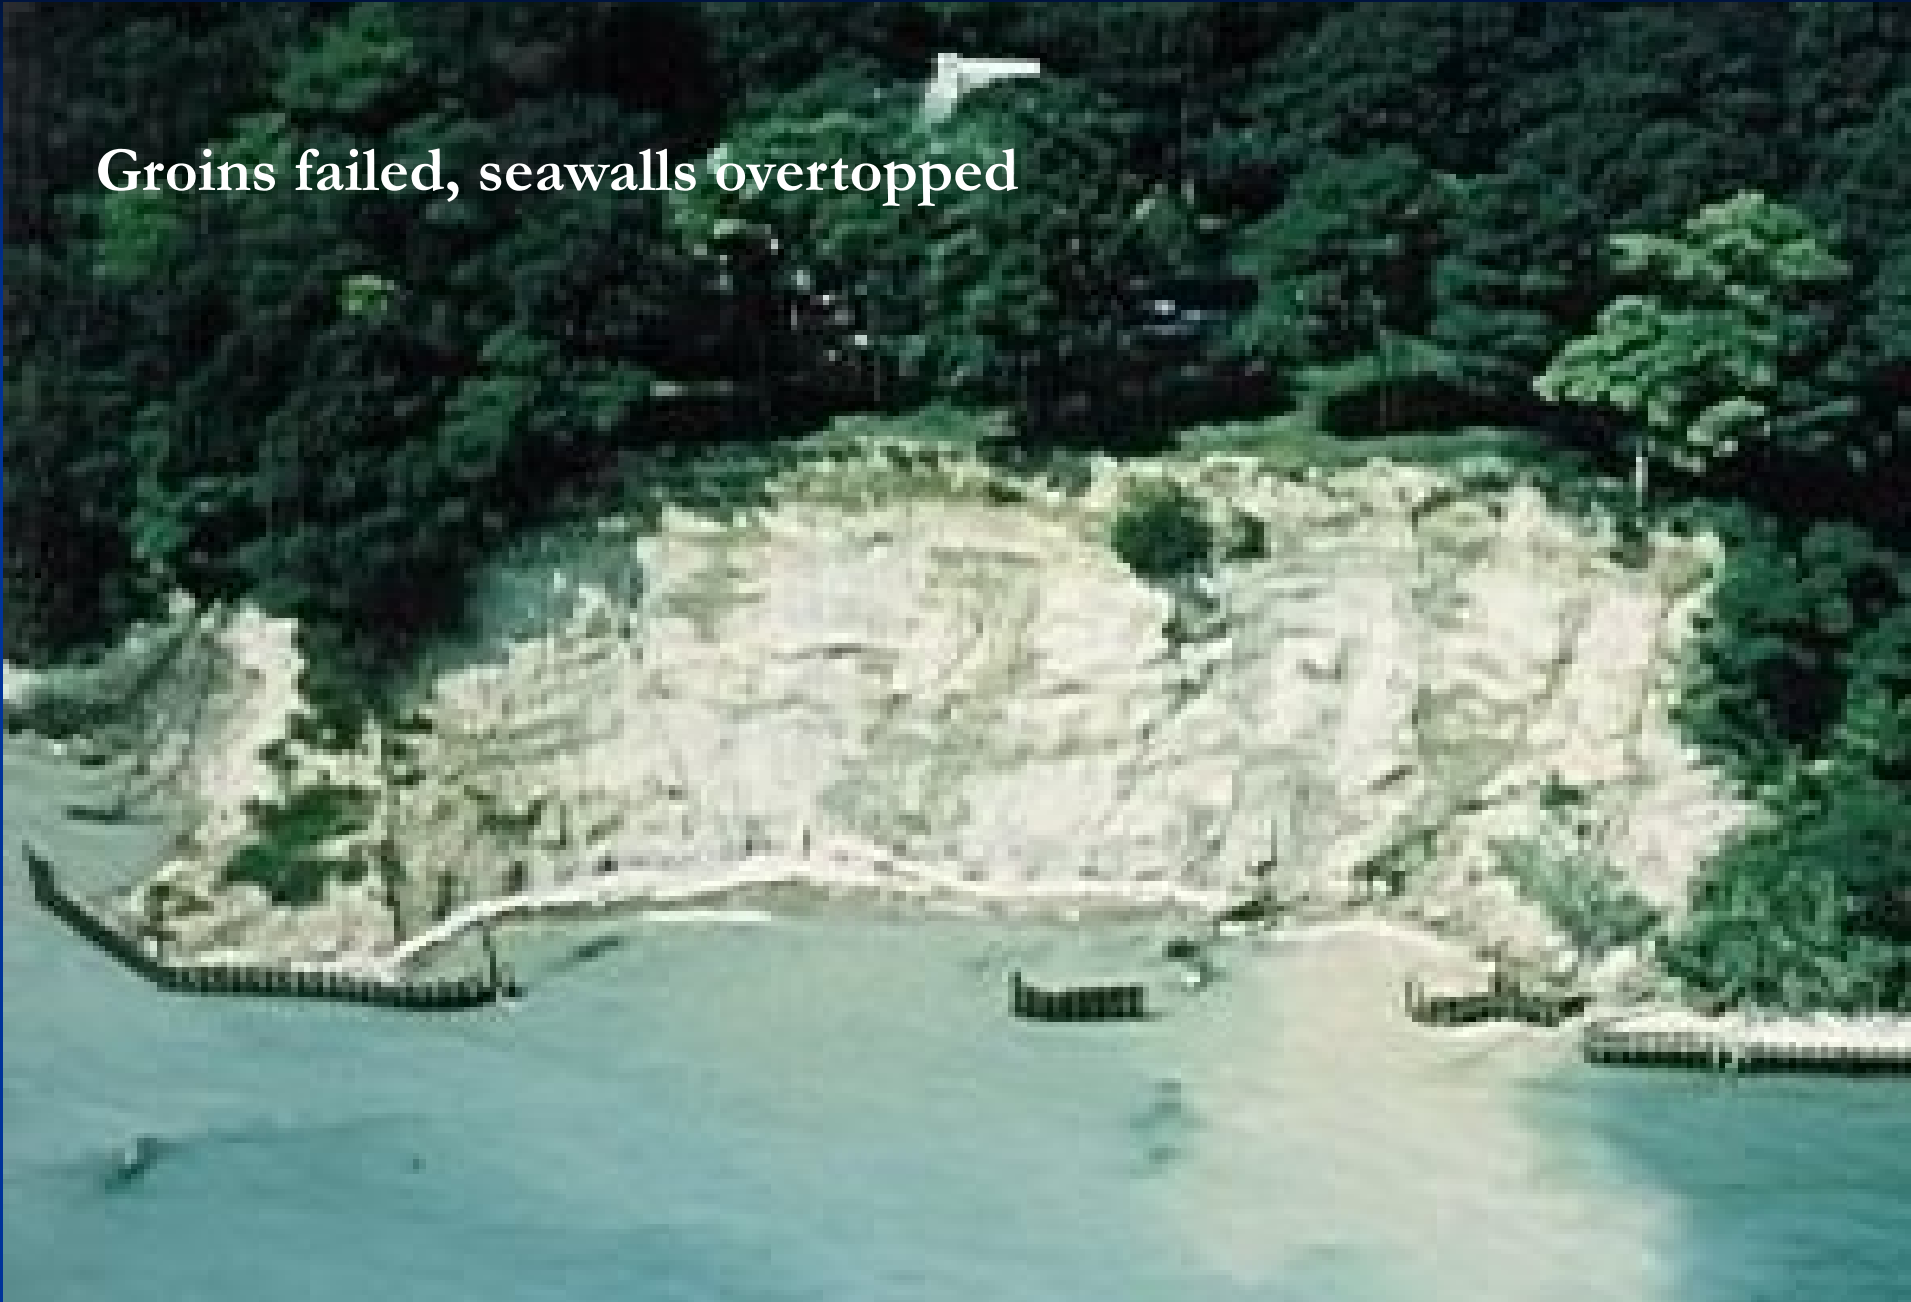
Worst Coastal Site – Illinois State Geological Survey.

Groins failed, seawalls overtopped

New Pocket Beach and Bluff Restoration 2002

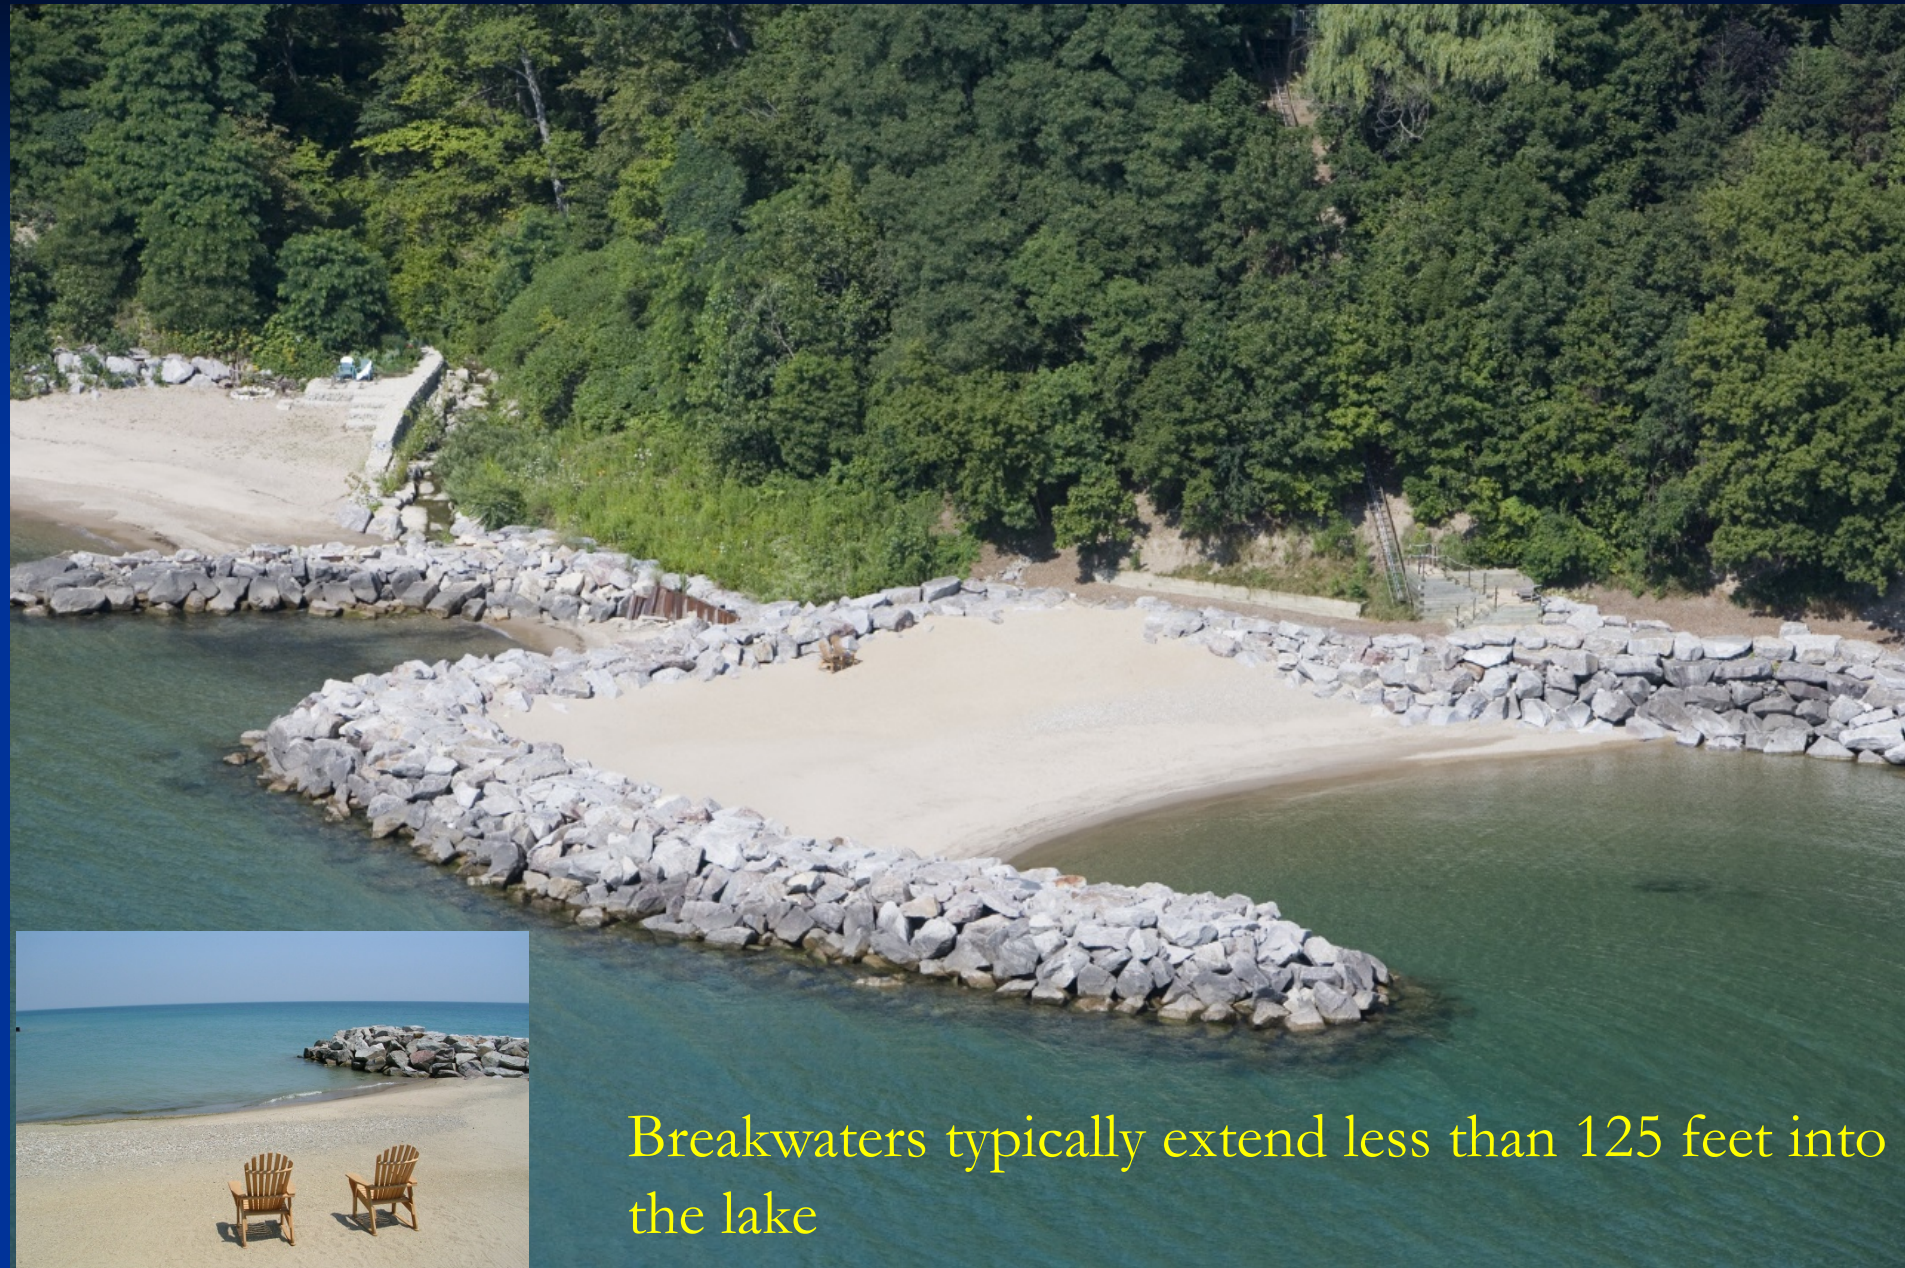
Breakwaters typically extend less than 125 feet into the lake
