Nature-Based Shoreline Workshop *Sustainable Beaches*

Charles Shabica, Ph.D., P.G.

Shabica & Associates
Sustainable Coastal Solutions

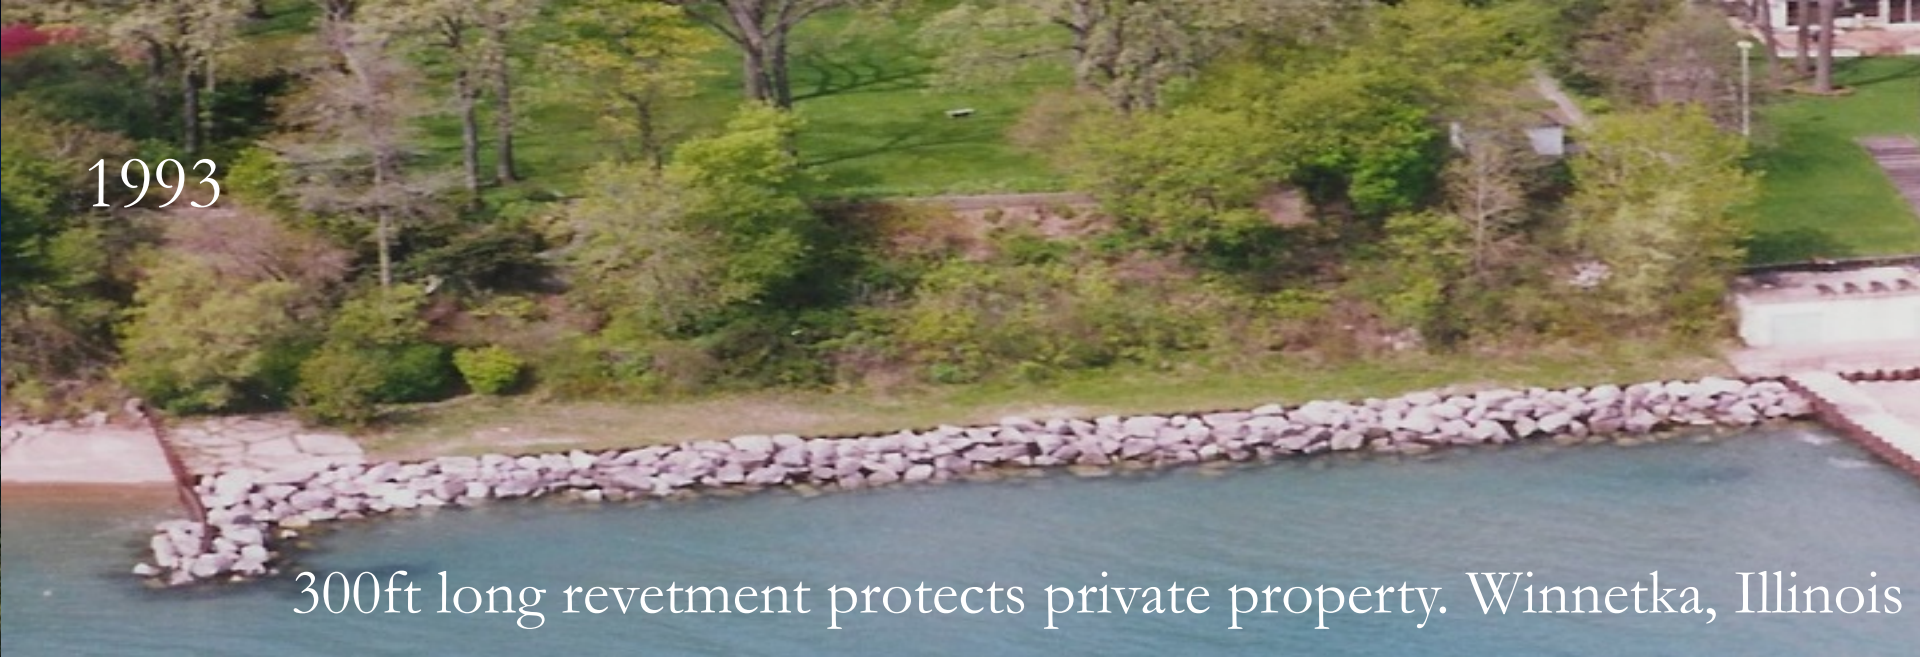
300ft long revetment protects private property. Winnetka, Illinois

Replaced with pocket beach.

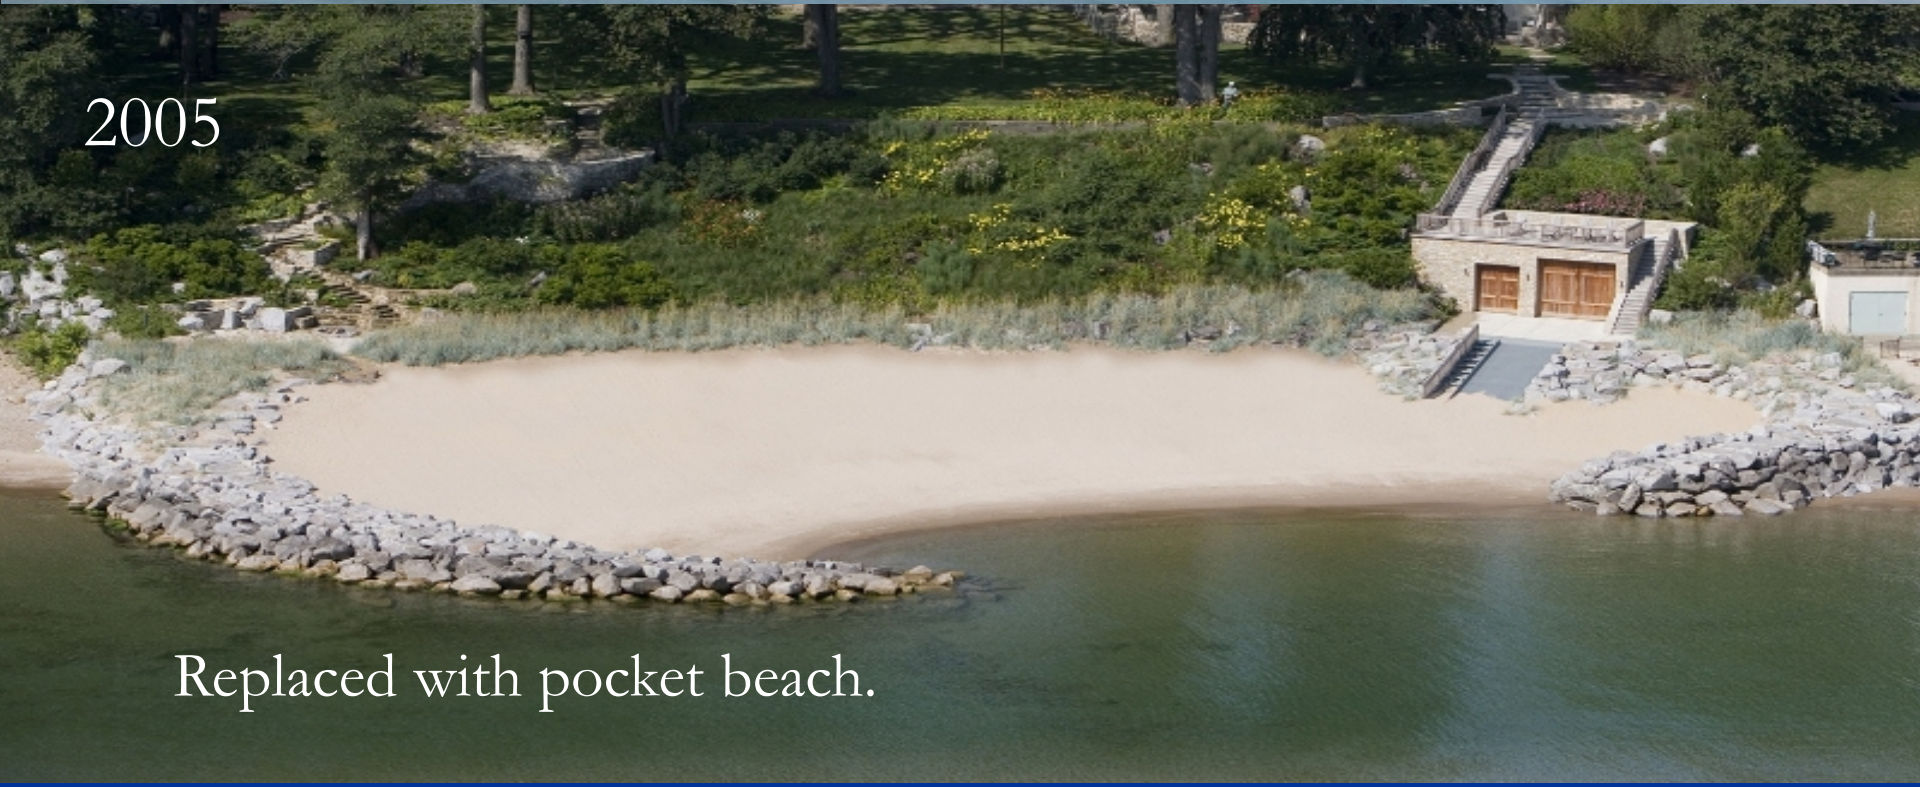
New breakwaters are engineered to provide beach protection at a range of lake levels.

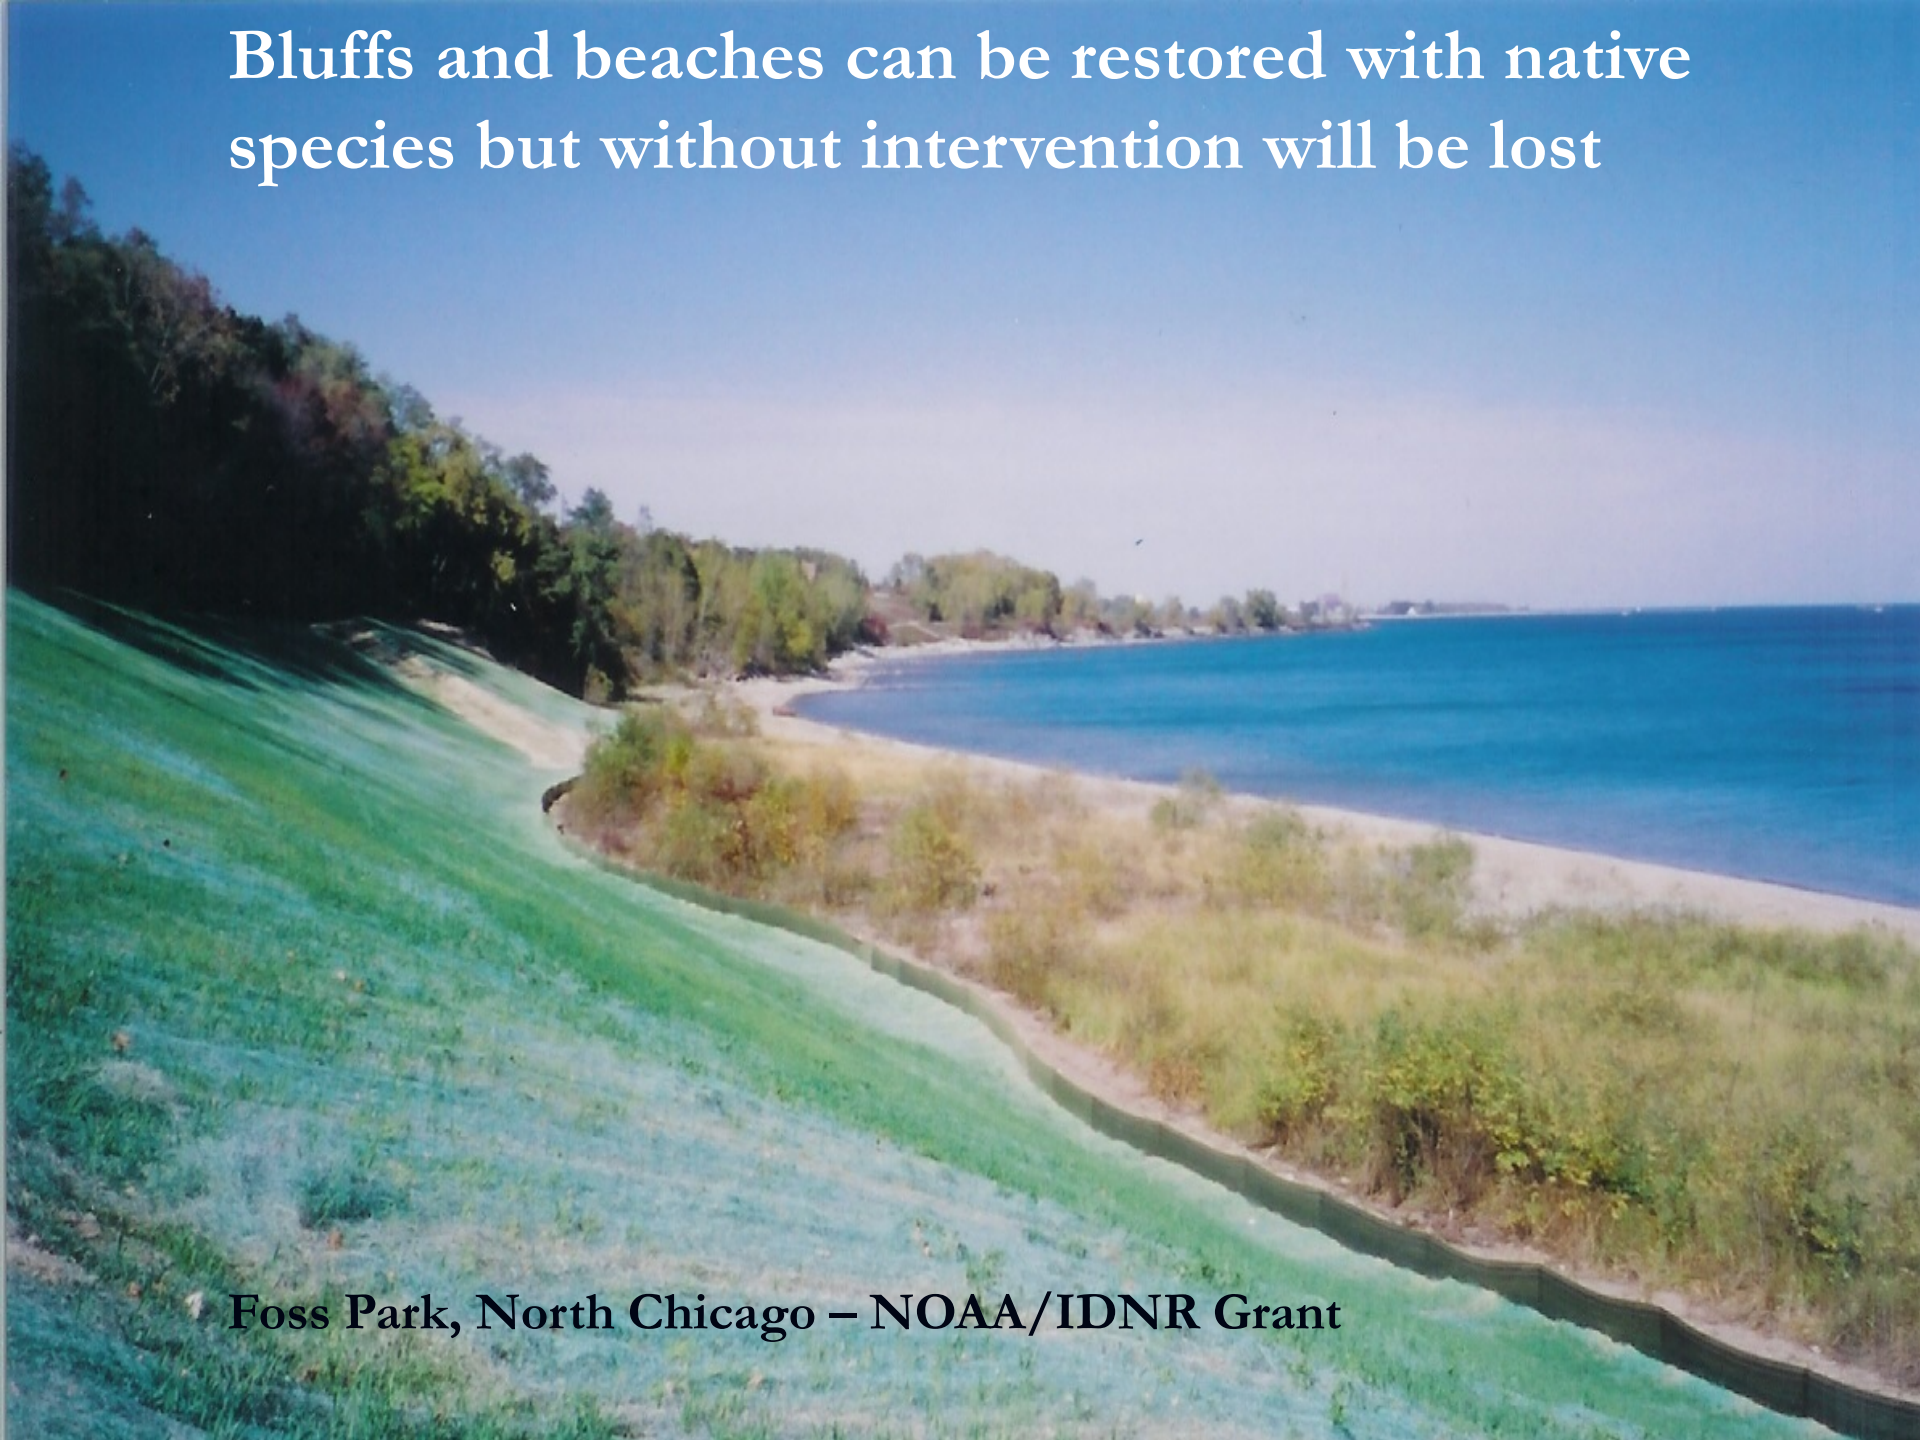
Foss Park, North Chicago – NOAA/IDNR Grant

Bluffs and beaches can be restored with native species but without intervention will be lost

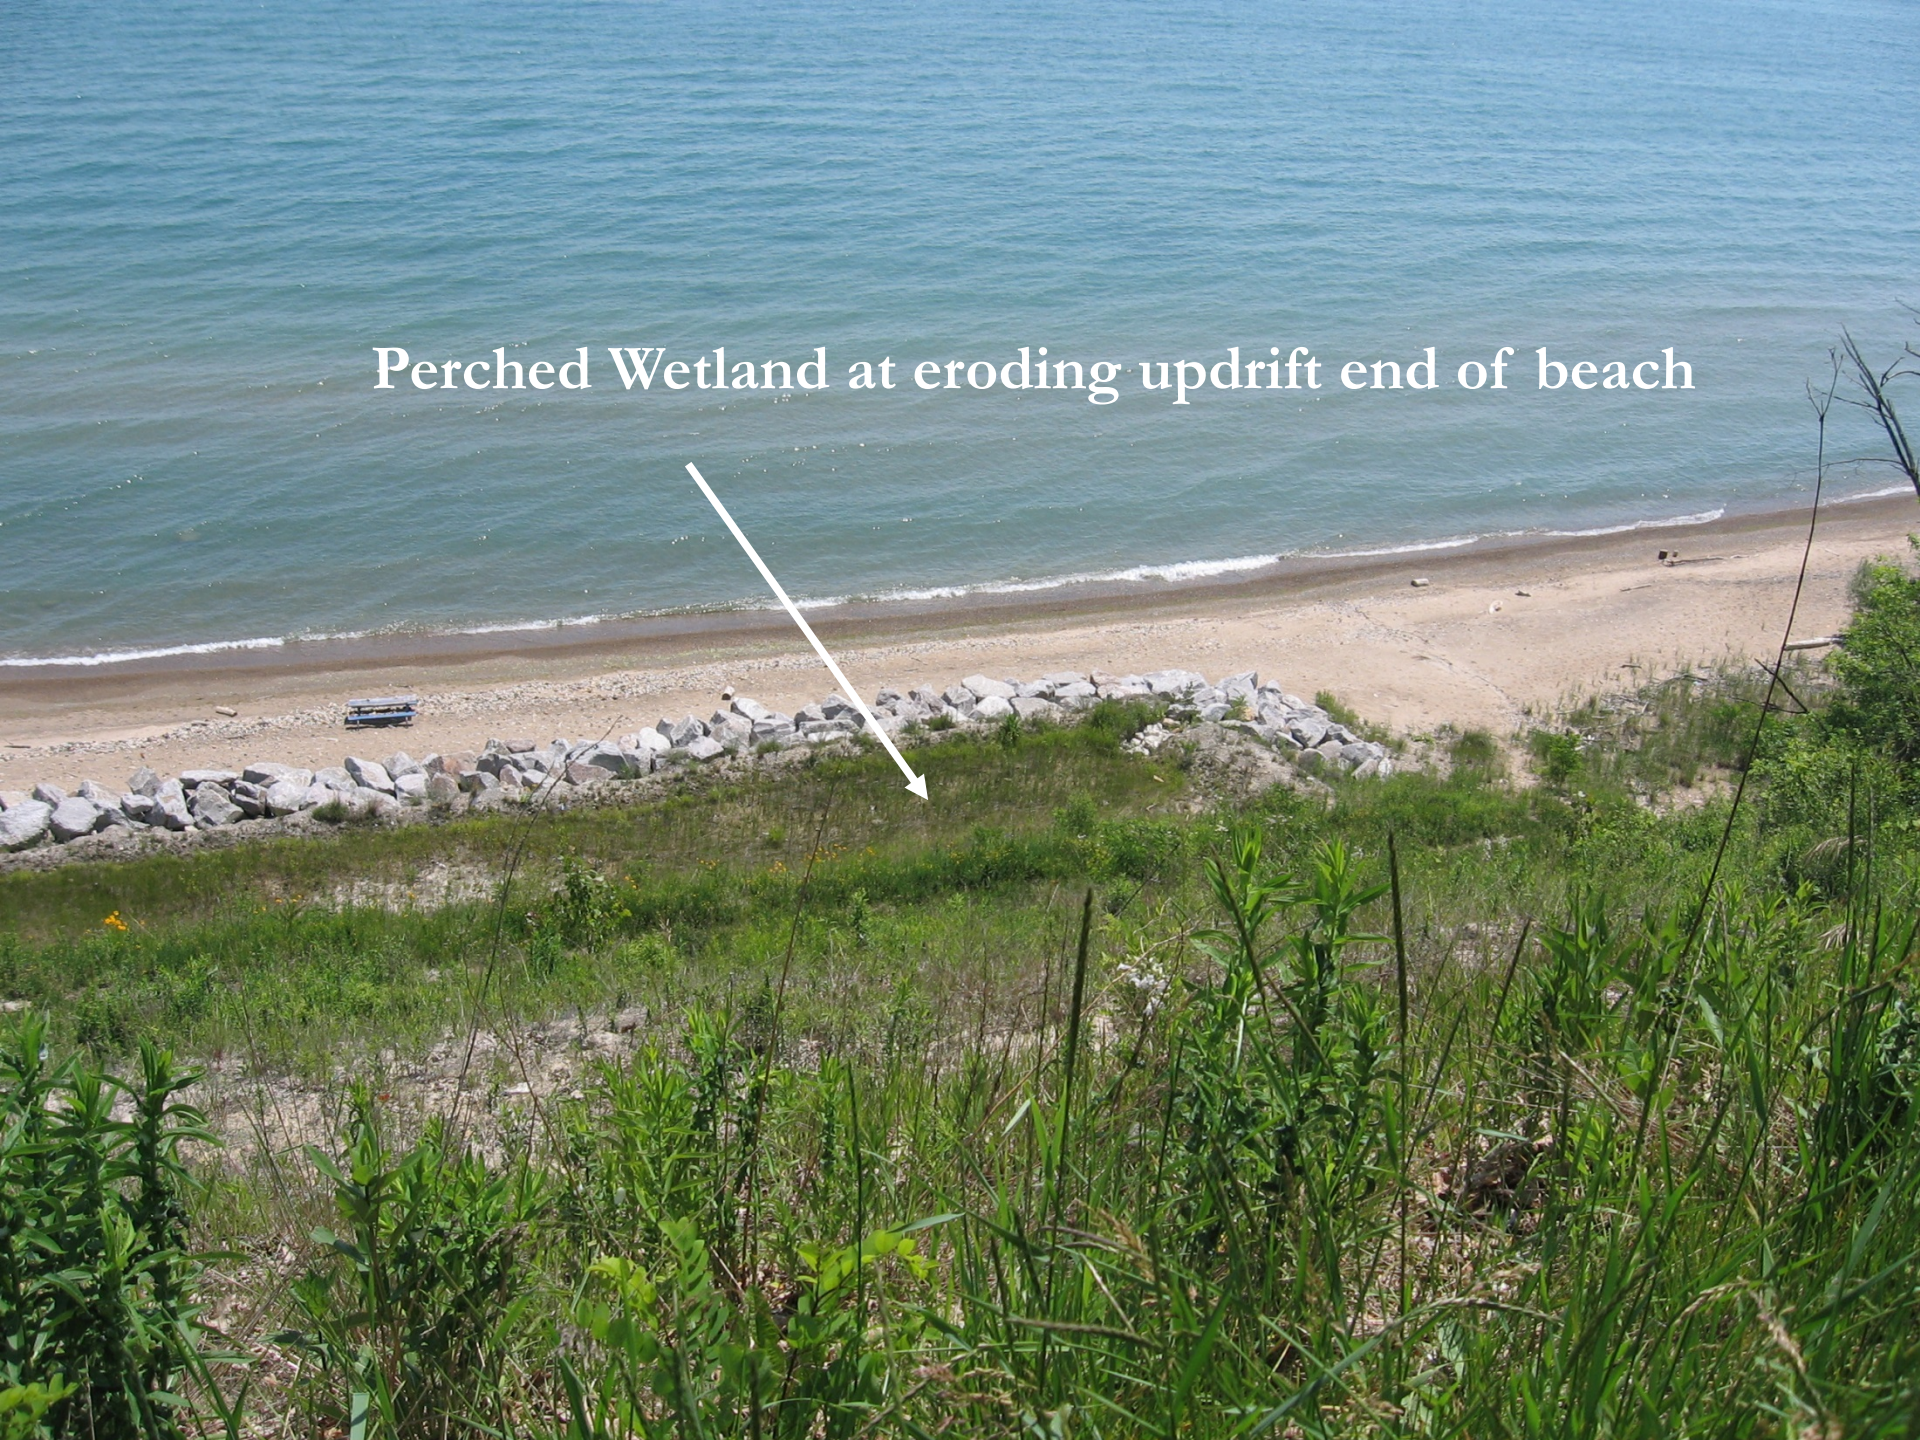
Perched Wetland at eroding updrift end of beach

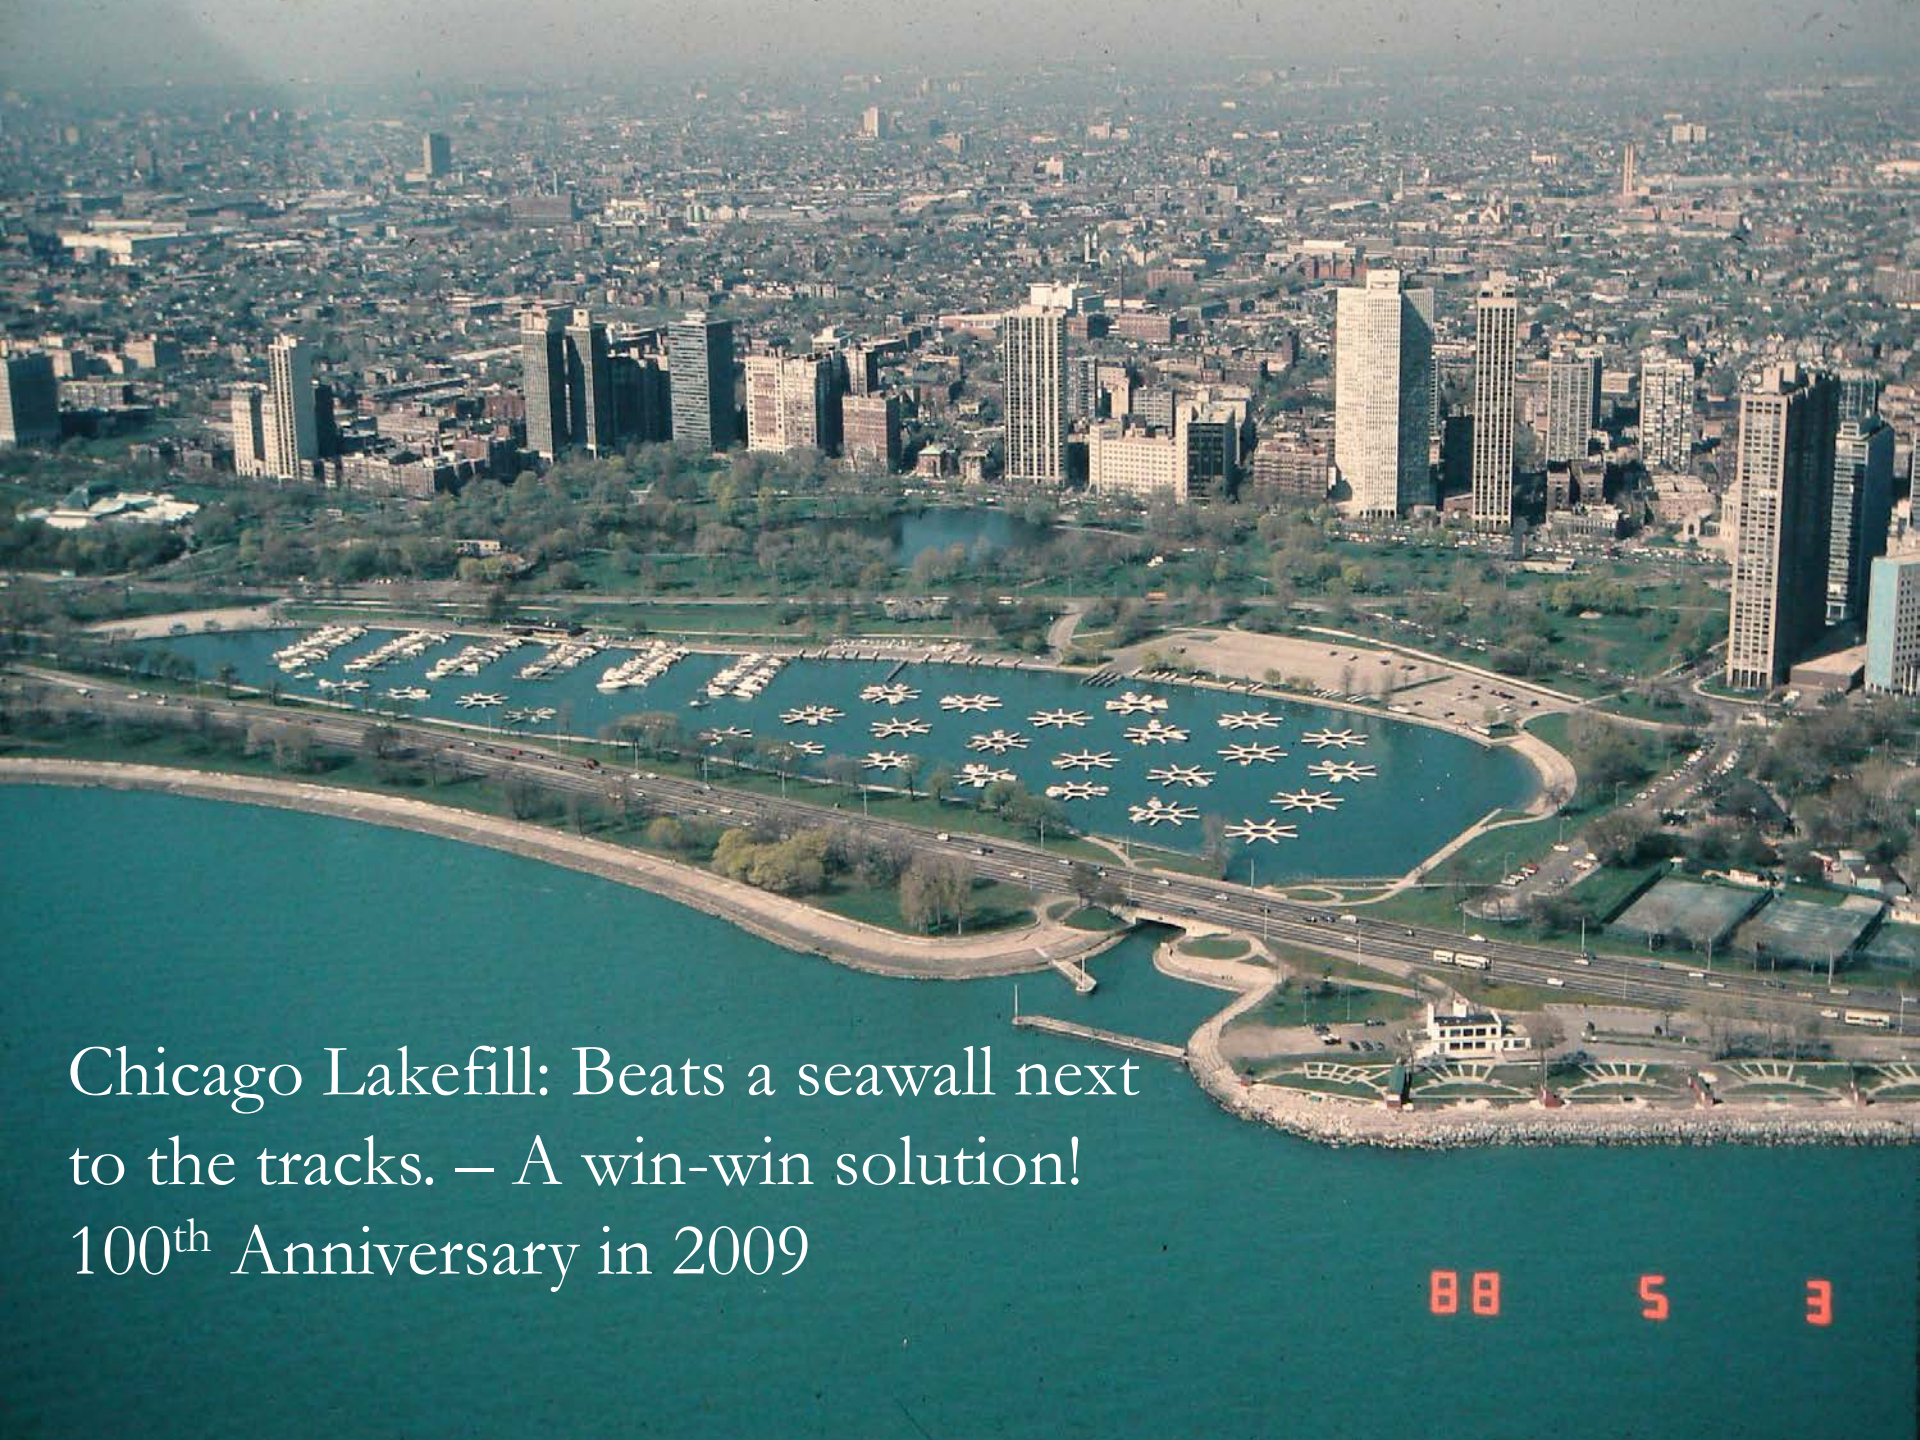
Chicago Lakefill – 24 miles of
higher elevation parkland: A
buffer against intense storms,
and rising lake levels

Chicago Lakefill: Beats a seawall next
to the tracks. — A win-win solution!
100th Anniversary in 2009
