How Much Land Has Been Lost?

OBJECTIVES

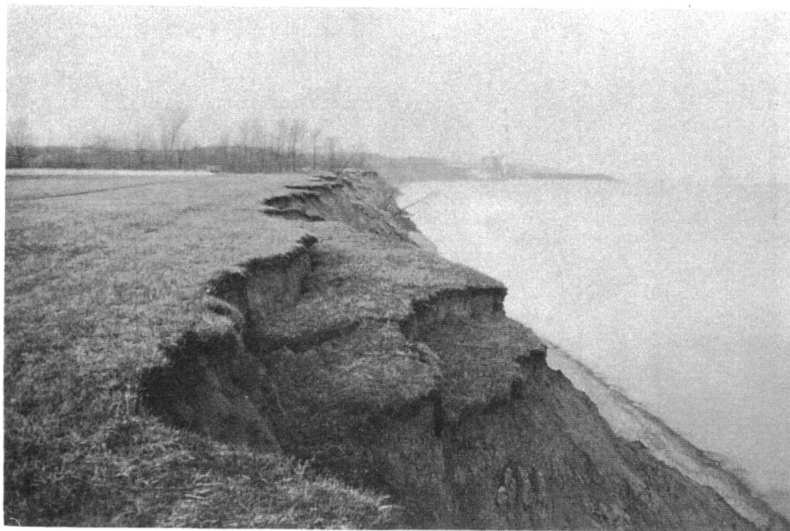
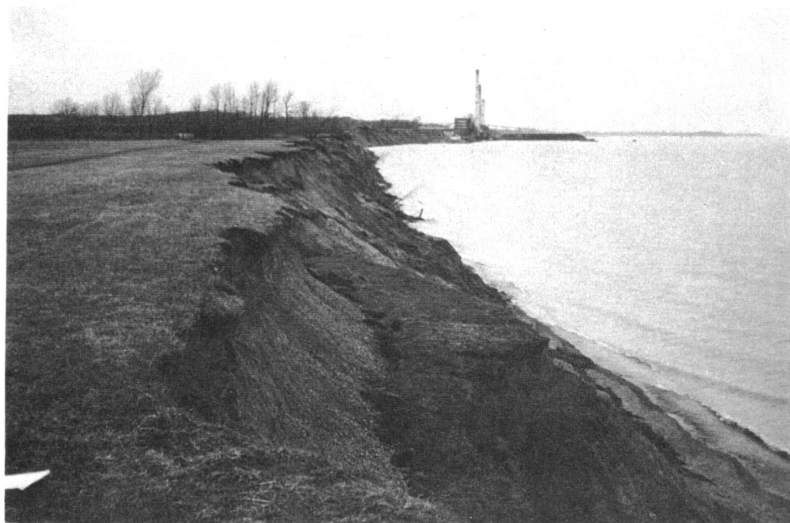
Site 2D – North: "Note the large slump that is broken into three major pieces in photo 12/3/81. . . Photo 4/1/82 shows the remains of the slump failure. It is evident that the supporting soil of the slump block partially disintegrated, resulting in the downward movement of the slump. Also note the development of bluff overhang above the slump in photo 4/1/82. This overhang is not significant in photo 12/03/81. The remaining loose soil material above the slump is a remnant of the supporting soil structure before crumbling away, resulting in bluff overhang. . . (T)he scalloped shaped bluff edge in photo 12/3/81 is becoming more bowl-shaped in photo 4/1/82. Several slump events ranging from 4 feet by 2 feet to 75 feet by 10 feet have been observed at this location. In general, the bluff slope shown in photo 4/1/82 is becoming steeper." (Racine County Coast Watch Program Final Report, 1982, p. 85)

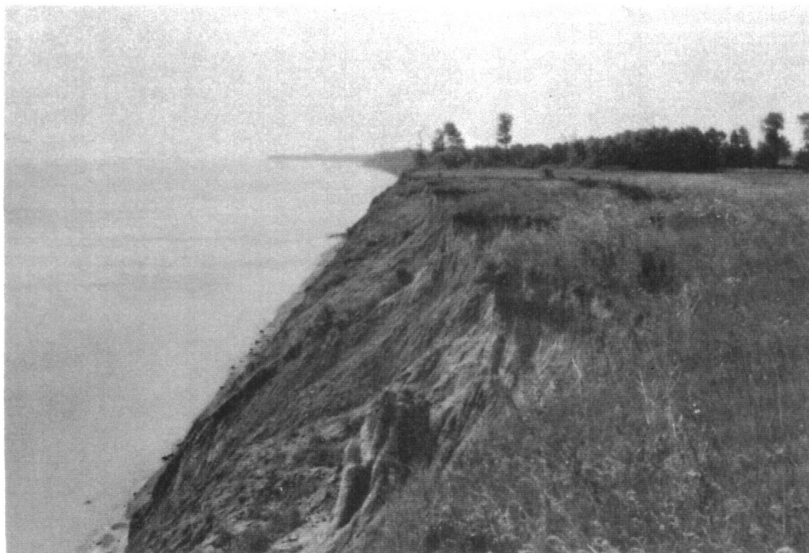
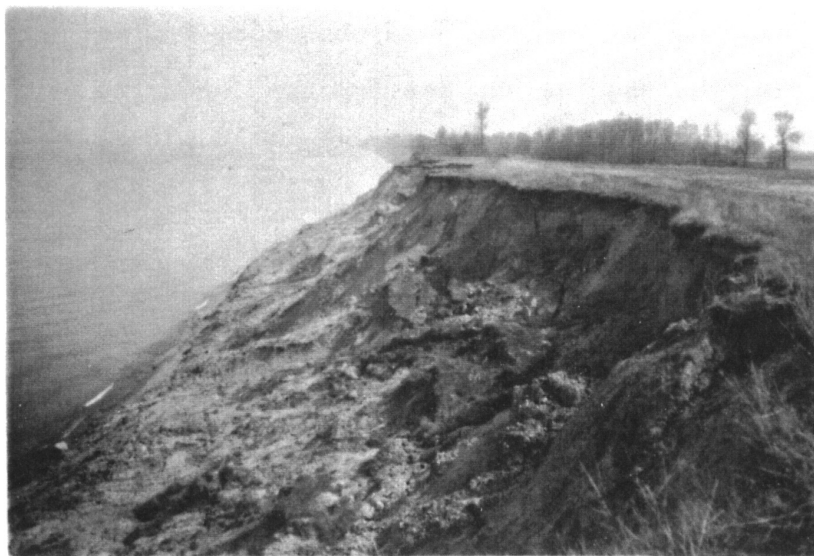
Site 1C-South

Site 1C – South: "Photo 8/1/80 shows that the bluff edge was "scalloped" shaped and the bluff slope was steep. This site is subjected to wave attack that erodes the solid material from the bluff toe. . . . Photo 5/14/82 shows large slumps that detached from the bluff edge and slid down the bluff face. Recorded observations indicated that slump pieces vary greatly in size and range from 1 x 1 foot to 50+ feet long and 12 feet wide. The bluff edge has changed from the scalloped shaped to a bowl-shaped retreat. . . . The major slumps occurred over a 4-month time period in 1982." (Racine County Coast Watch Program Final Report, 1982, p. 83)

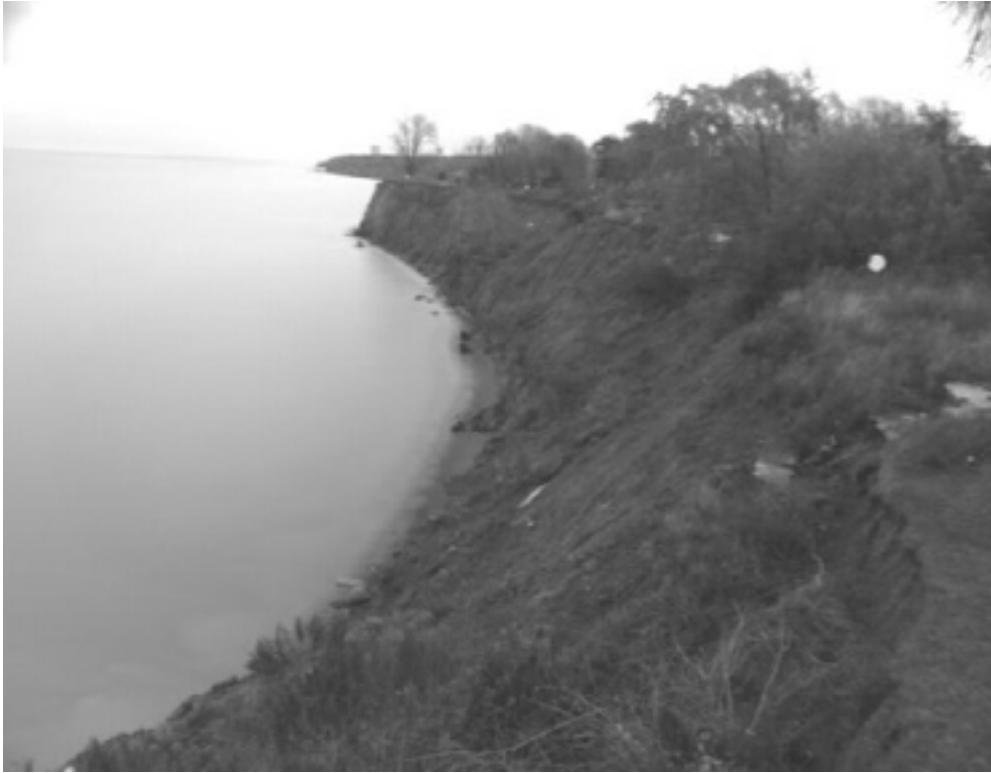
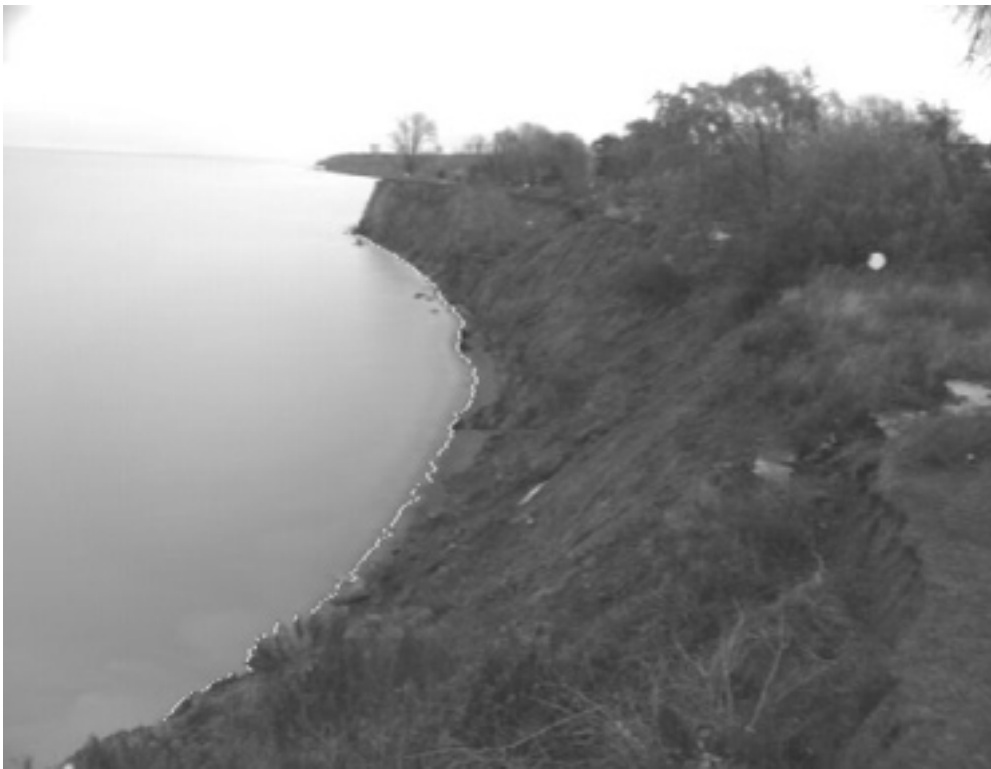
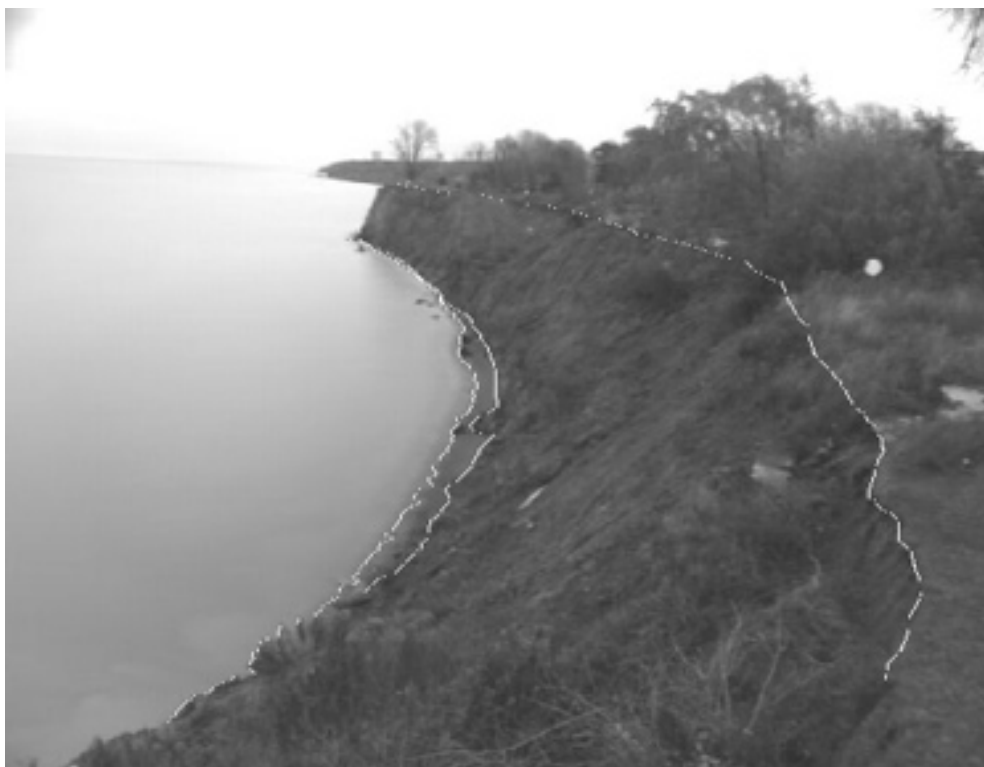
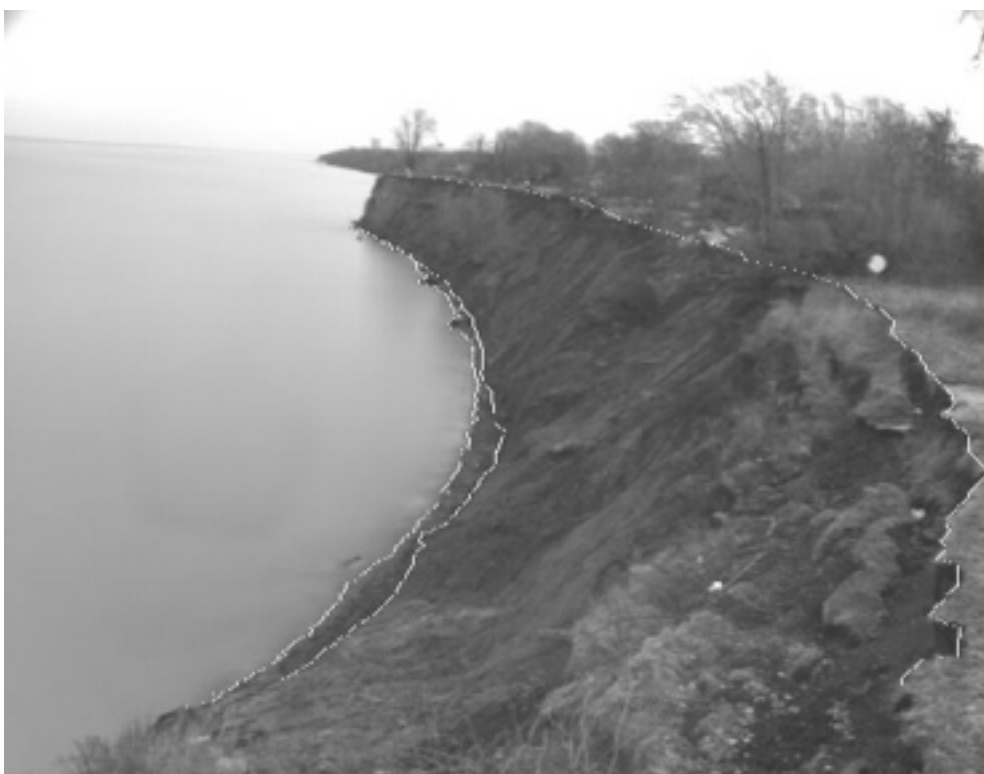
The above photographs are examples of remote video monitoring of the shorelines you have examined in this activity. Investigate more images of Lake Erie and at other sites by exploring the Internet address <http://stimpy.er.usgs.gov>.
