General Maintenance Guidelines

Wooden Bulkheads

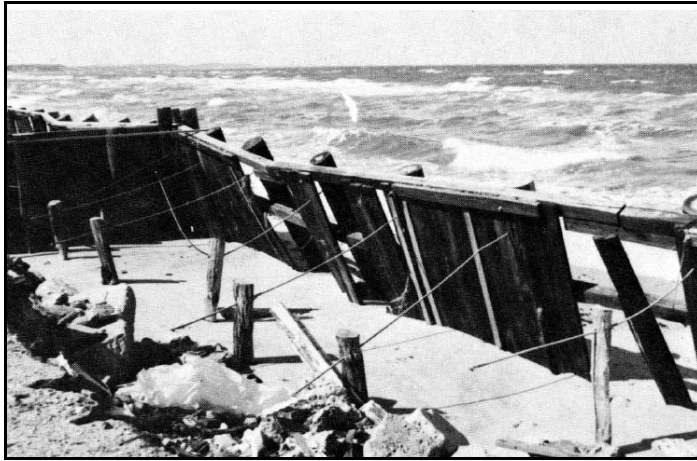
Figure 1. The ever-present energies of nature can quickly reduce human efforts to control shoreline erosion to picturesque, but useless, remnants.

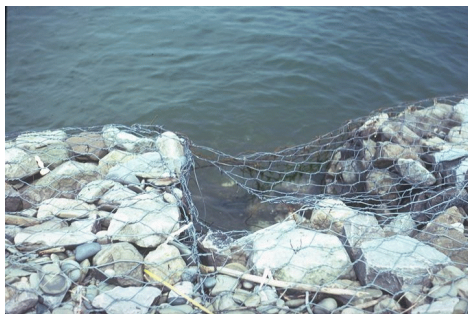
Figure 9. Gabion weakened by broken wires and spilled stones

Stones within gabion baskets may settle, leaving voids, decreasing structural strength, and allowing movement of the stone that can damage the mesh. Broken wires can also cause stones to spill (Fig. 9). If this occurs in a basket without other units stacked on top of it, open the basket, pack it tightly with 4- to 8-inch stones, and rewire the lid shut, taking care not to cut or damage the PVC coating if present (in salt water environments, polyvinyl chloride coating is used on the wires of gabions to protect them against corrosion). Adjacent gabions must remain tightly laced along the entire perimeter of all contact surfaces.

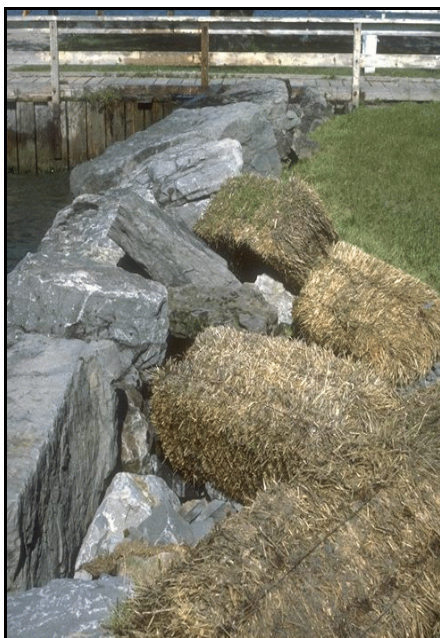
Figure 10. Uneven settling or displacement of revetment stones can be caused by a loss of fine materials as a result of poor filtration

It is possible that soil behind or beneath the revetment has been slowly eroded away by water that has washed over the stones or has run off the land behind the structure. Look for spaces or voids behind or beneath the stones. Check for uneven settling of stones in some areas of the revetment. This is commonly caused by a failure of the underlying filter material to prevent the soil under the structure from being washed out between the stones. Two alternatives present themselves: remove the stones in the affected area, install new filter material as described earlier, and replace the armor stone; or, place new armor stone on the surface over the settled stones. The former is more expensive, but may last longer, increase the structure's overall strength, and be more effective by preventing future loss of soil from behind the structure. The latter, though less costly, does nothing to eliminate the cause of the problem, but could extend the life of the structure for a shorter period of time. If there are voids or hollows forming just behind the top of the structure it is an indication that the structure is too low for the wave conditions and is being overtopped by incoming waves. In such cases the "best" alternative is to add onto the structure

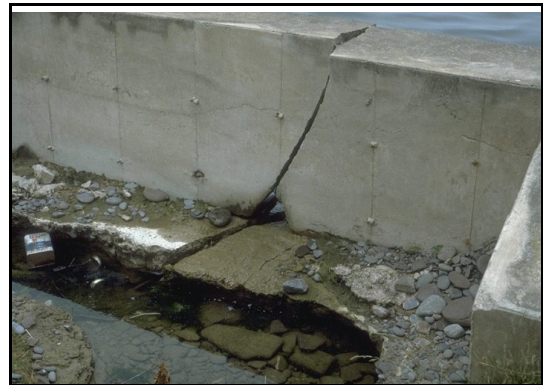
Figure 12. Poor drainage and poor filtration resulted in loss of fill from behind this bulkhead

Major cracks in a concrete structure or a bowing-out of the wall may signal a drainage problem. Weep (or drainage) holes are important for relieving the pressure of water that can build up behind an impermeable concrete structure. These holes should be inspected to make sure they are not plugged up (or to make sure they were installed in the first place). If you can find what looks like a row of holes in the face of the wall above the waterline, watch them for a flow of water out of them during periods of heavy rainfall or snowmelt. If the wall is more than 20 years old, it's likely that sediment has built up and is blocking drainage holes. Weep holes should be cleaned out if they are not draining. If you can't find any weep holes, contact a contractor to see about having some installed (don't do this work yourself; improperly performed, drilling the wall could reduce its strength and lead to premature failure). Weep holes should always have filter material at their landward end to prevent soil from being lost through them (Fig. 12).
